Test Report

WIND AND WATER TEST TO THE REQUIREMENTS OF AS2047

PRODUCT – MD65IN Inwards Swing Door

REPORT NO. – AZHK251207

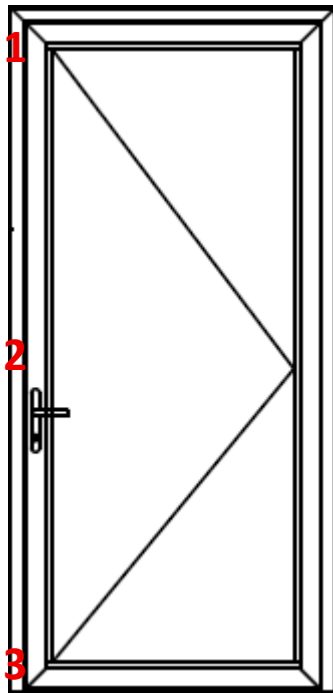
Figure 1 Transducer Locations

7.2 Deflection Test

Setup 1				
Structural Member	Mullion 1, 2, 3			
Span Length	2430 mm			
Transducers Used	1, 2, 3			
Maximum Allowable Deflection	24.3 mm			
Test Deflection Ratio of Sample	1 (mm)	2 (mm)	3 (mm)	Net Deflection (mm)
Positive 400 Pa	0.21	0.55	0.29	0.30
Negative 400 Pa	-0.17	-0.99	-0.68	0.57
Positive 800 Pa	0.44	1.05	0.62	0.52
Negative 800 Pa	-0.69	-2.00	-1.53	0.89

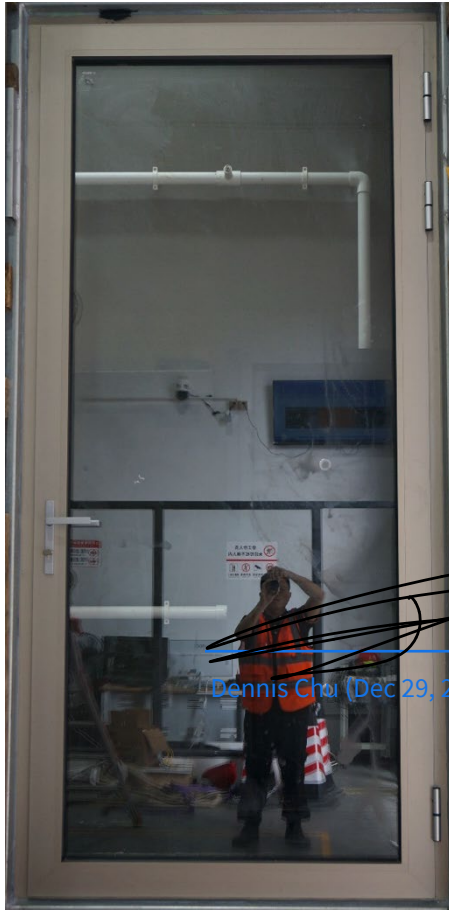
Figure 2 Photo of the test specimen after testing (Fully Closed)

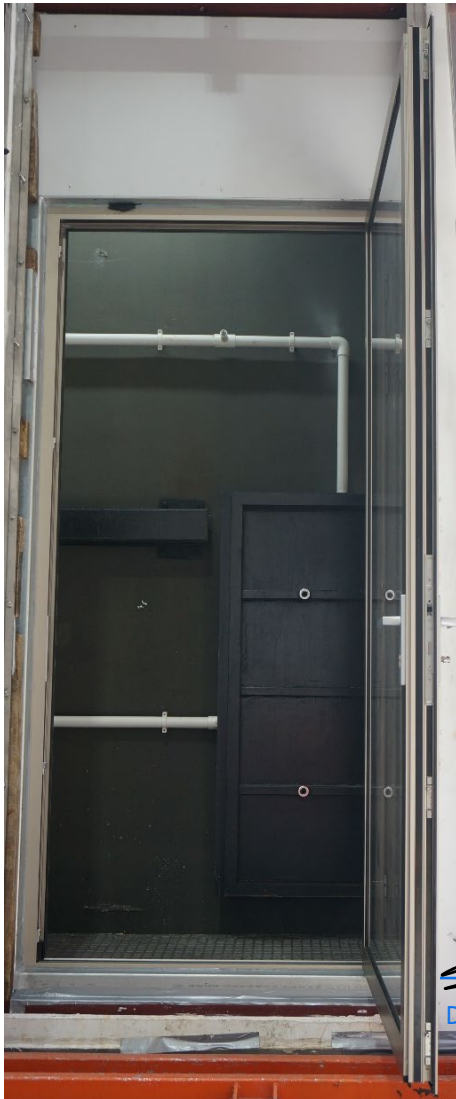
Figure 3 Photo of the test specimen after testing (Fully Opened)

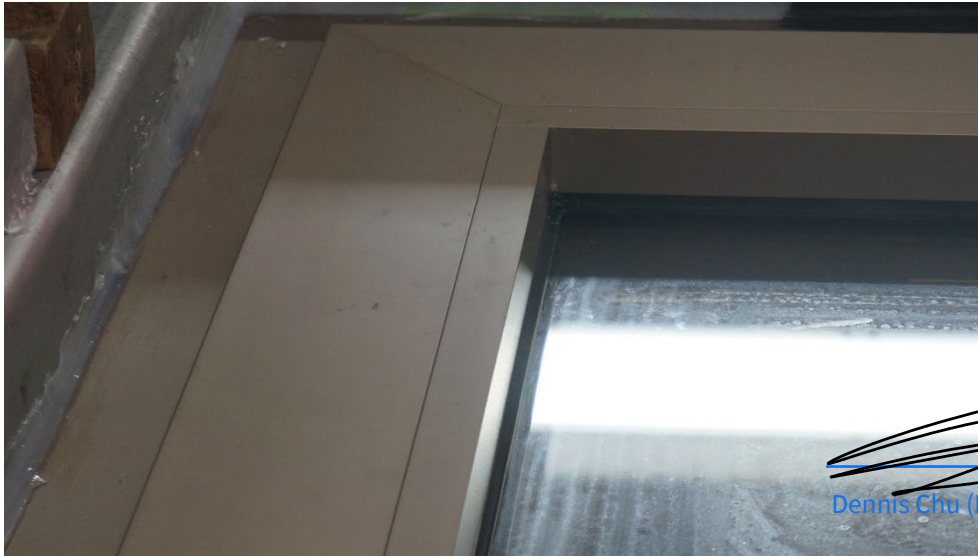
Figure 4 Photo of Head-jamb junction (Left) of the Inwards Swing Door

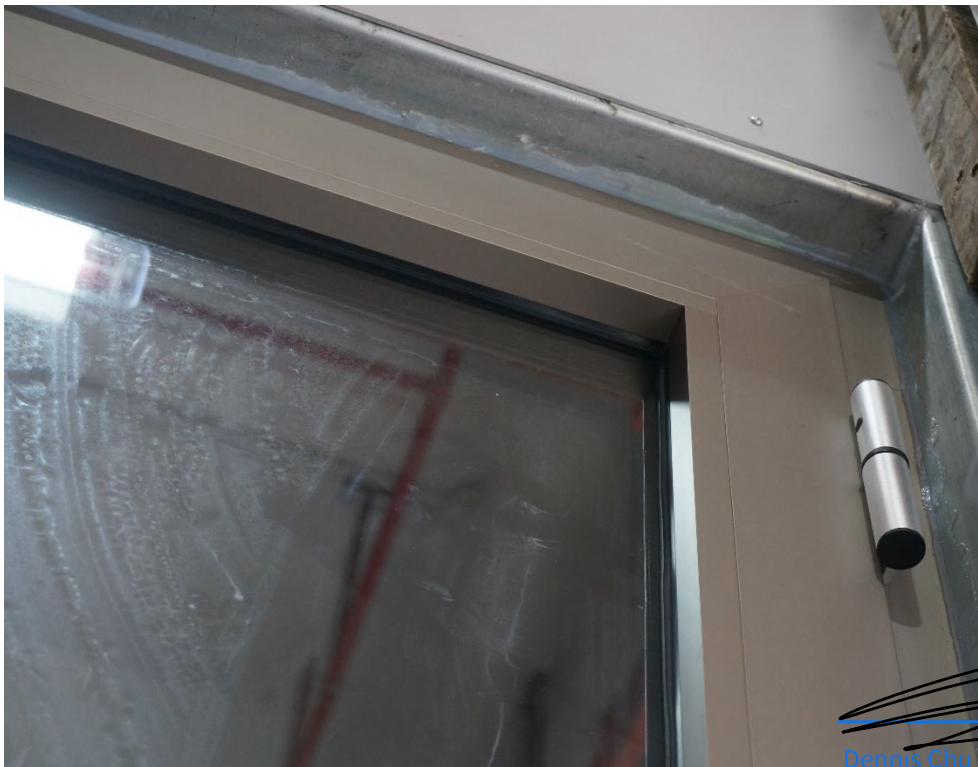
Figure 5 Photo of Head-jamb junction (Right) of the Inwards Swing Door

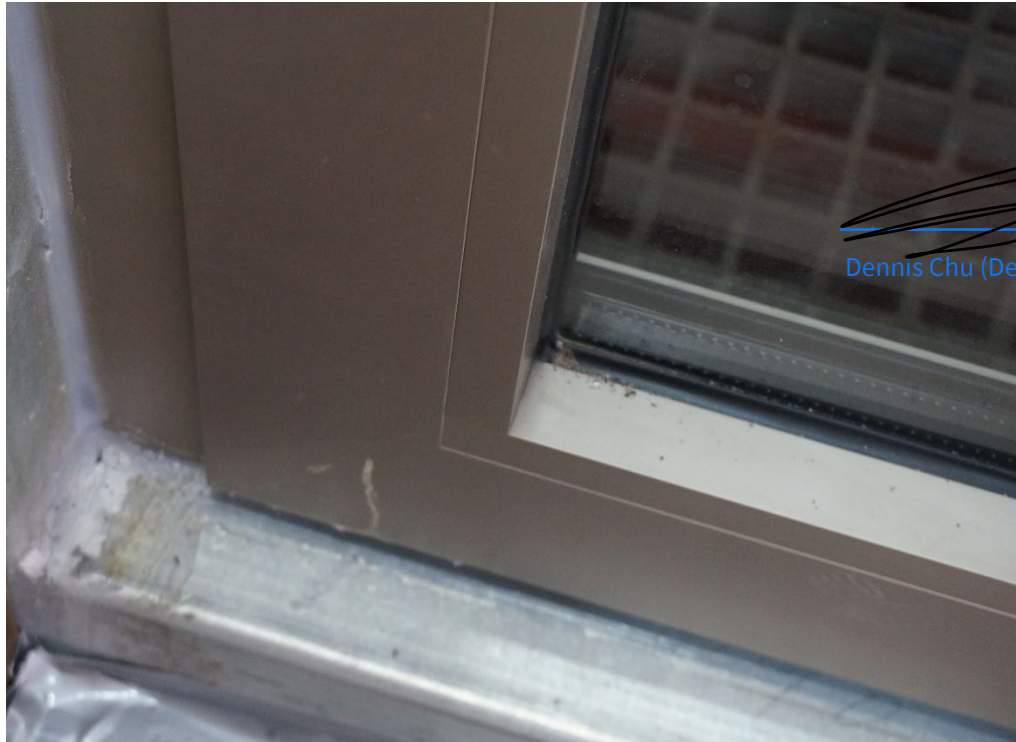
Figure 6 Photo of the Sill-jamb junction (Bottom Left corner) of the Inwards Swing Door) (Showing White Traces Left by Transparent Waterproof Coating on Surface)

Wet Down Complete – 5 minutes	Yes
Maximum Pressure Applied to Sample	300 Pa
Time Pressure Held for	15 minutes
Leakages Observed	Nil
Observations	No Observable Water Leakage Transparent Sealant applied on site on exterior and interior surfaces of Window Assembly (See Figures 6 ,18 & 20)

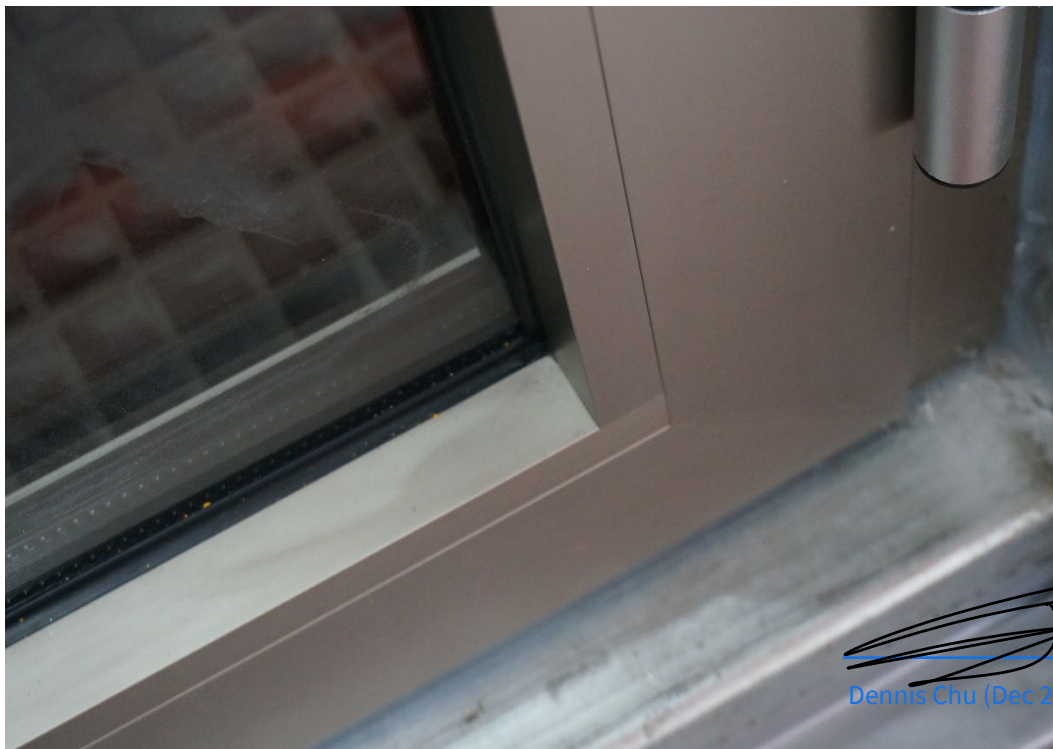
Figure 7 Photo of the Sill-jamb junction (Bottom Right corner) of the Inwards Swing Door)

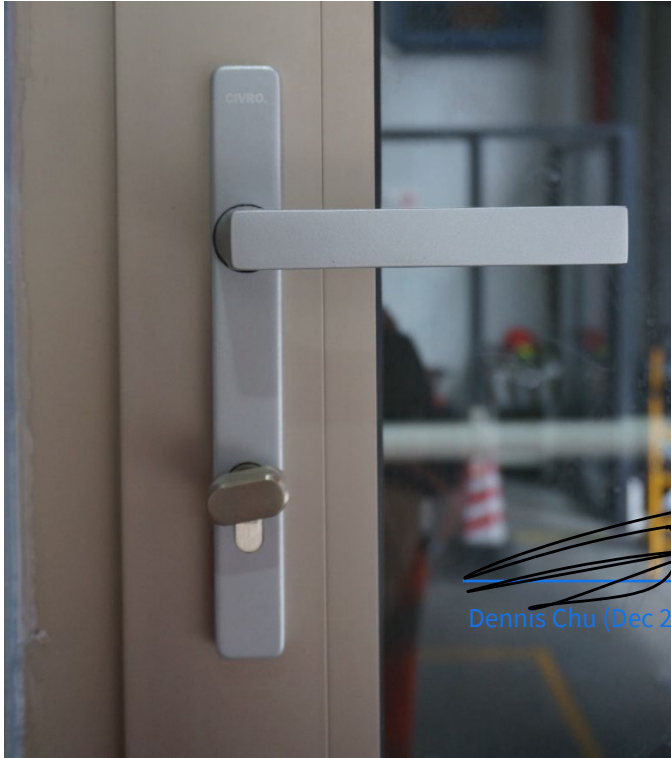
Figure 8 Photo of Hardware

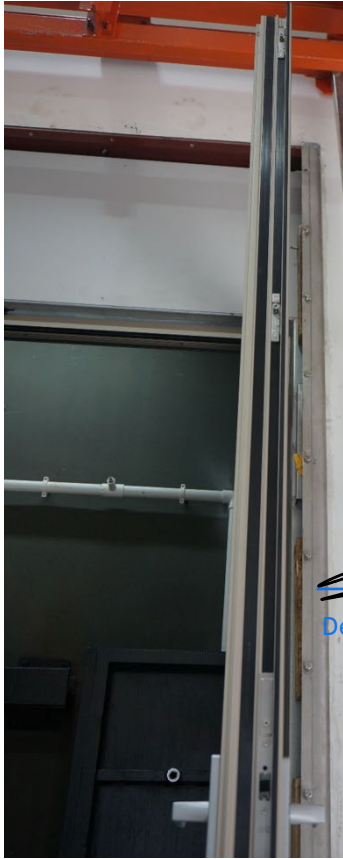
Figure 8 Photo of Lock Stile (Top)

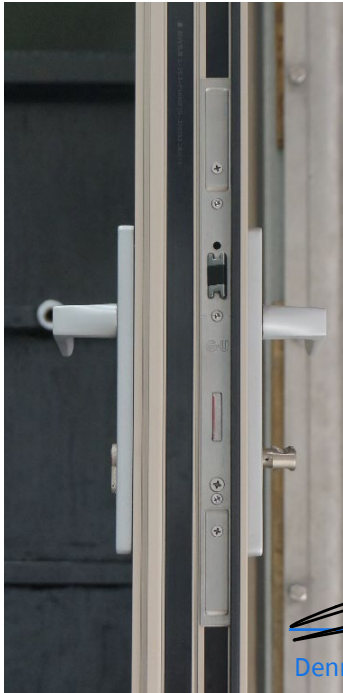
Figure 9 Photo of Lock Stile (Handle)

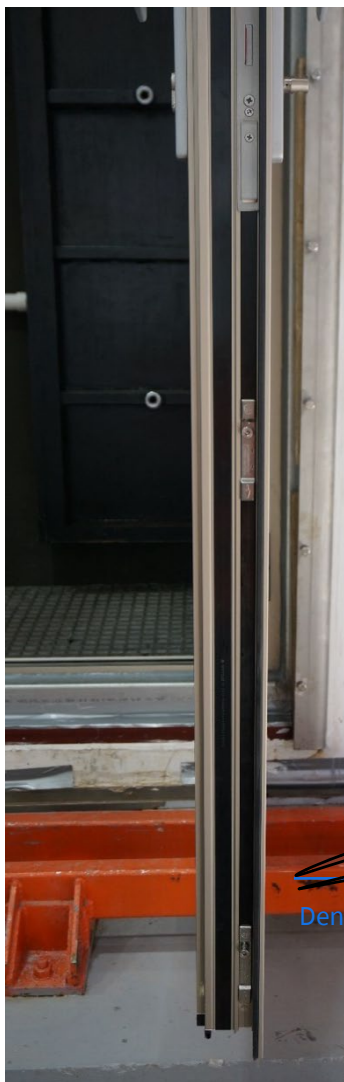
Figure 10 Photo of Lock Stile (Bottom)

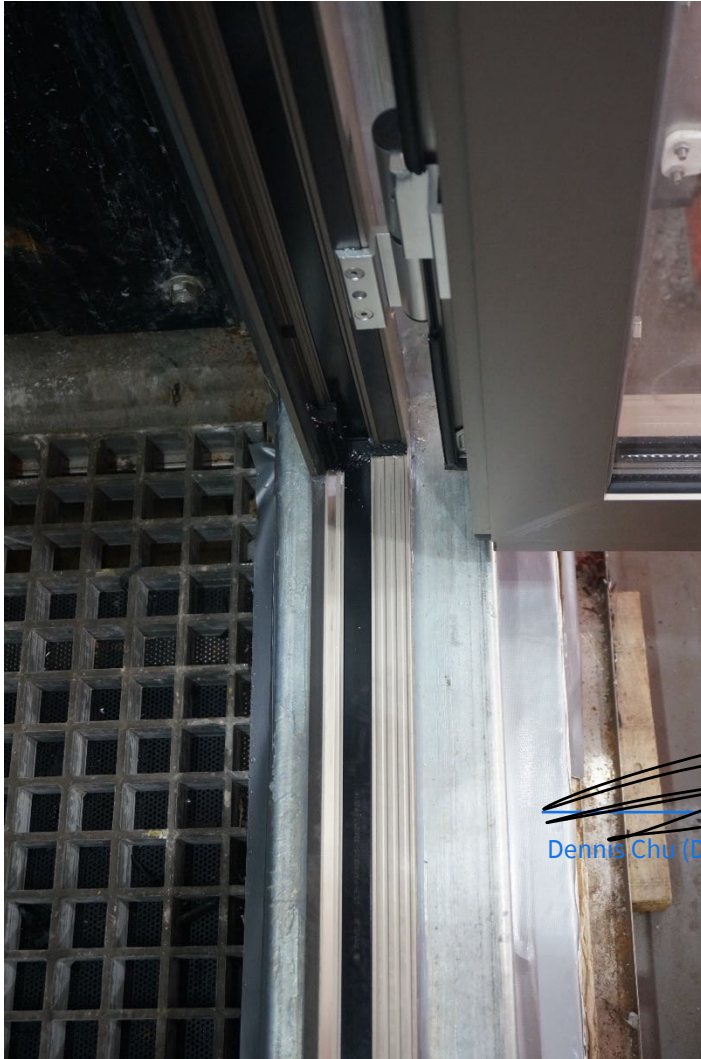
Figure 11 Photo of Threshold and Lock Stile

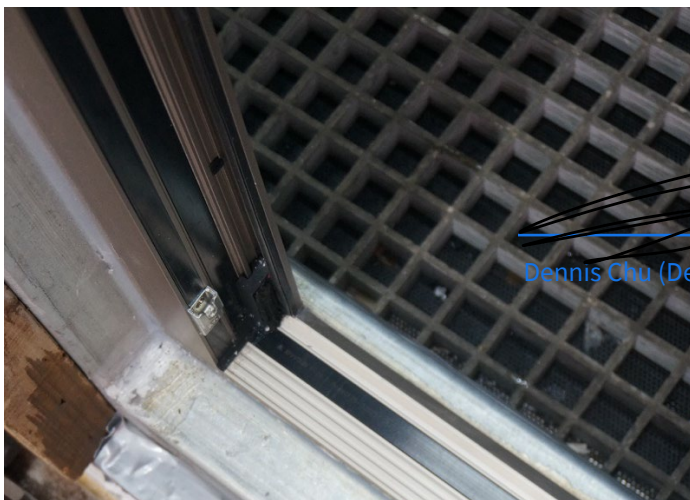
Figure 12 Photo of Threshold and Jamb

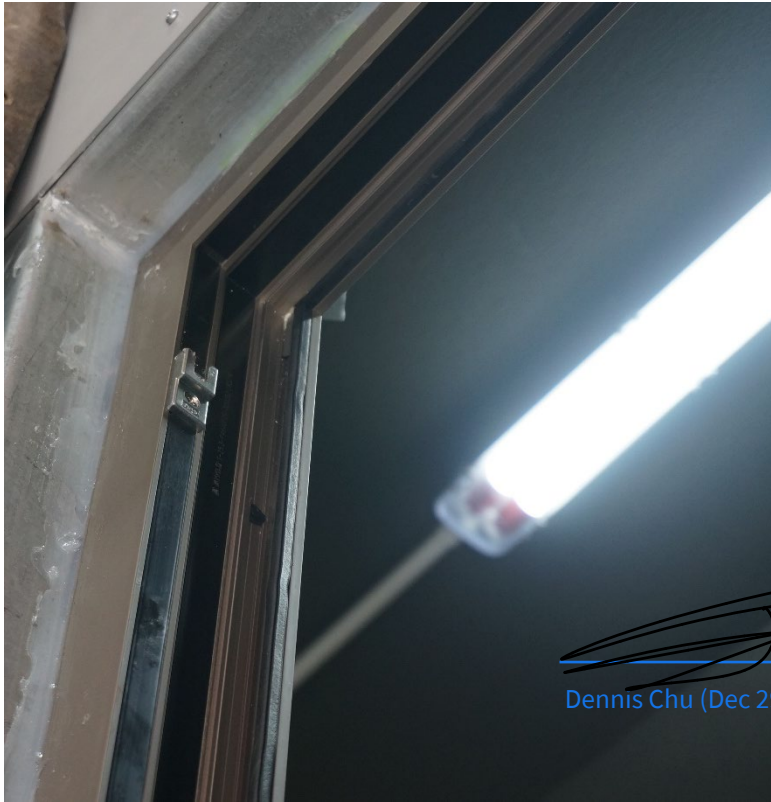
Figure 13 Photo of Top Left Corner of Door Frame

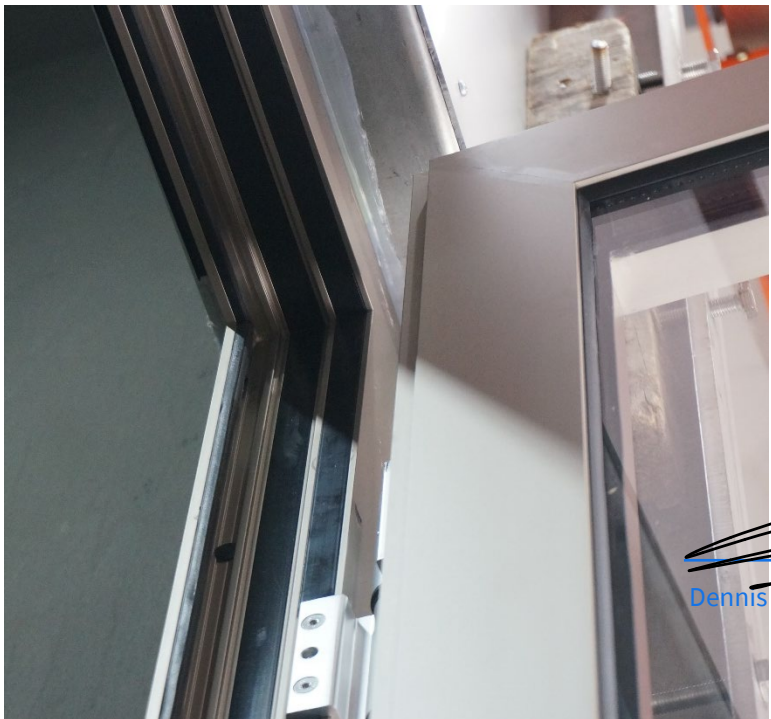
Figure 14 Photo of Top Right Corner of Door Frame

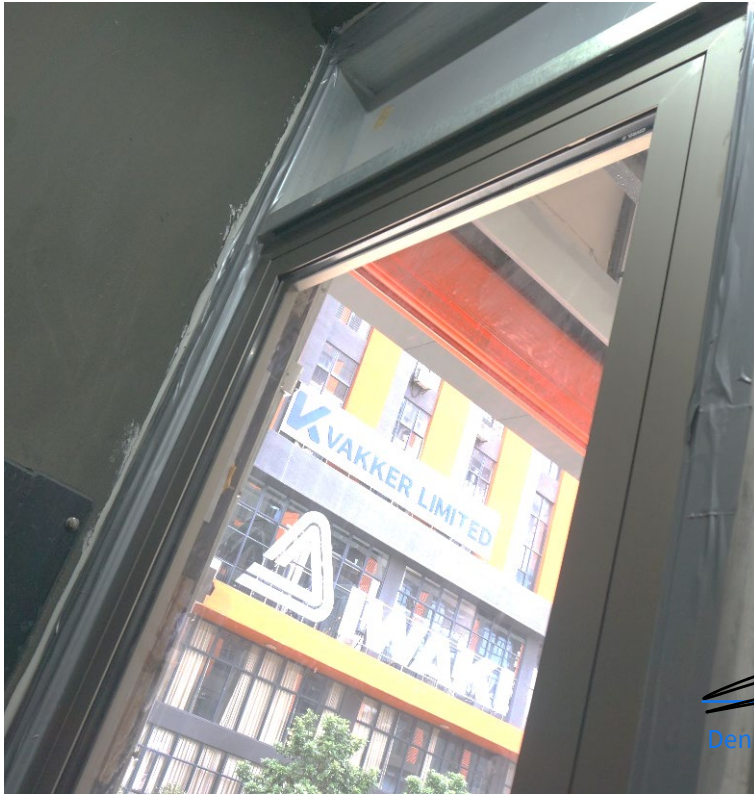
Figure 15 Photo of Upper Section of Door (View from Exterior)

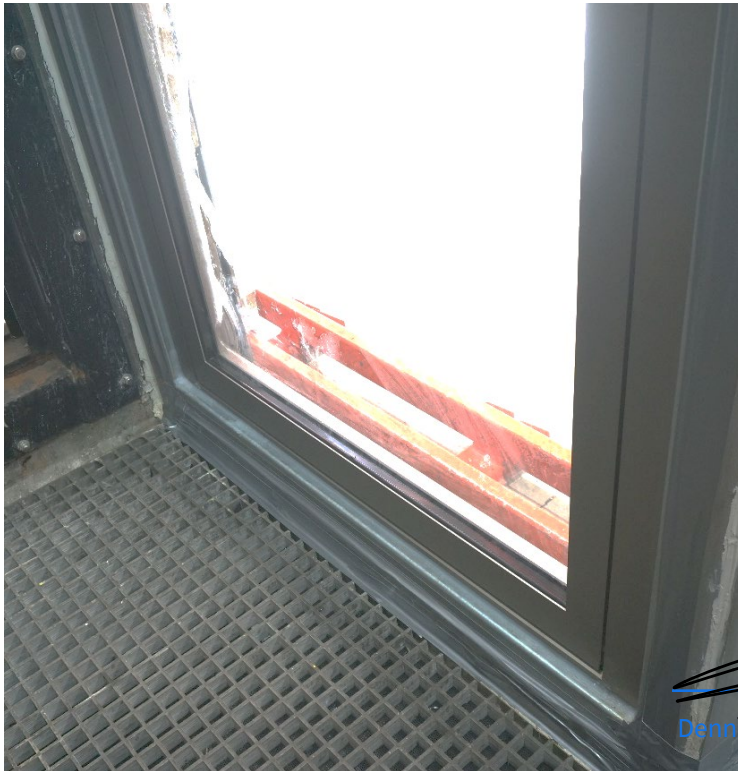
Figure 16 Photo of Lower Section of Door (View from Exterior)

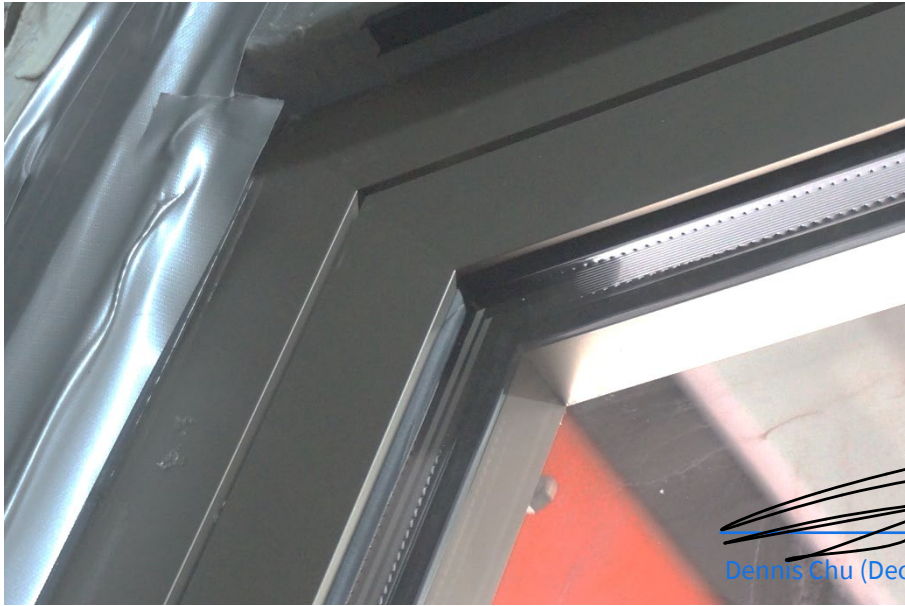
Figure 17 Photo of Top Left Corner of Door Frame, Top Rail and Stile (View from Exterior)

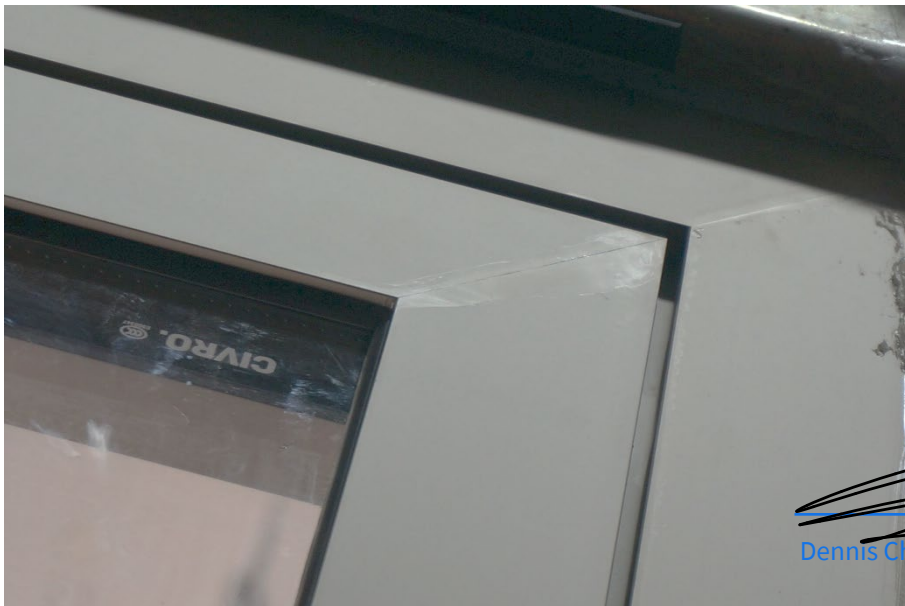
Figure 18 Photo of Top Right Corner of Door Frame, Top Rail and Stile (View from Exterior) (Showing White Traces Left by Transparent Waterproof Coating on Surface)

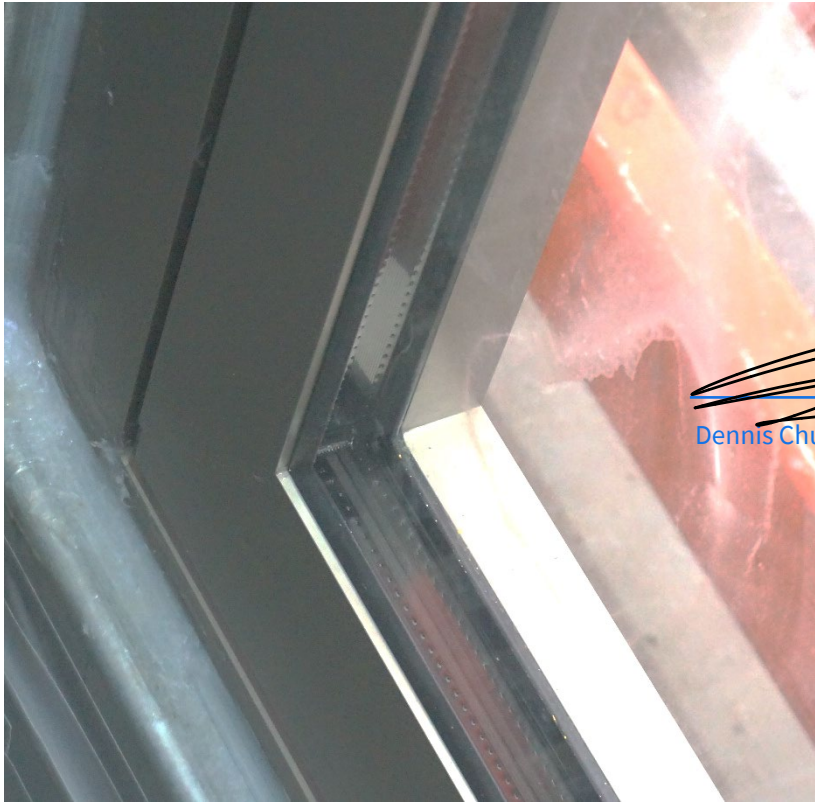
Figure 19 Photo of Bottom Left Corner of Door Frame, Bottom Sill and Stile (View from Exterior)

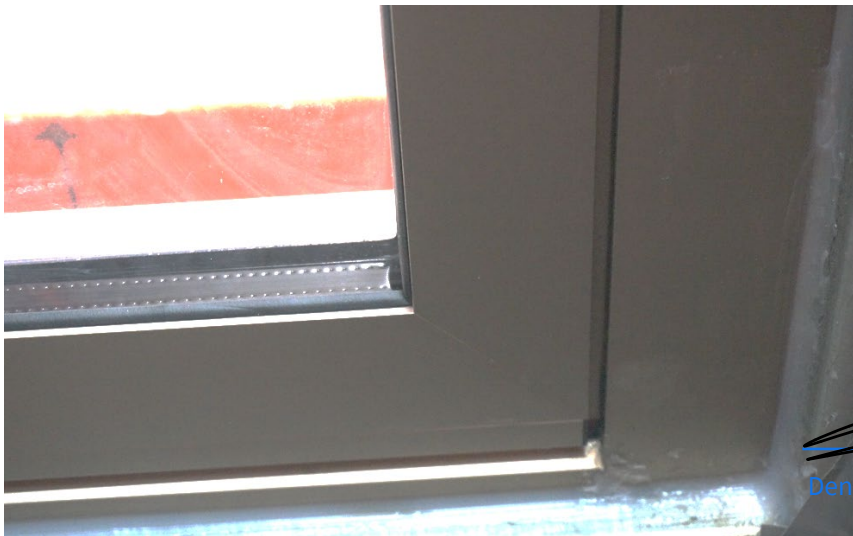
Figure 20 Photo of Bottom Right Corner of Door Frame, Bottom Sill and Stile (View from Exterior) (Showing White Traces Left by Transparent Waterproof Coating on Surface)

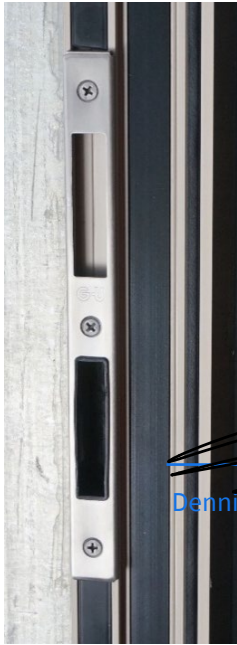
Figure 21 Photo of Strike Plate

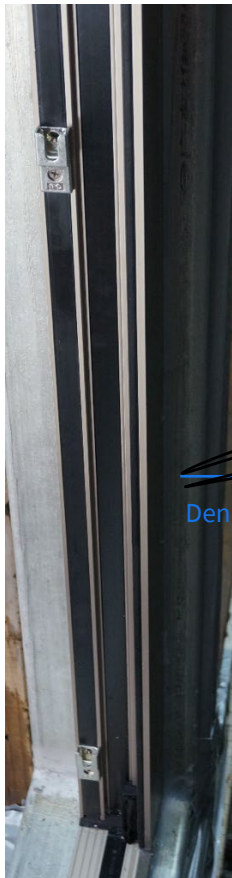
Figure 22 Photo of Locking keeper

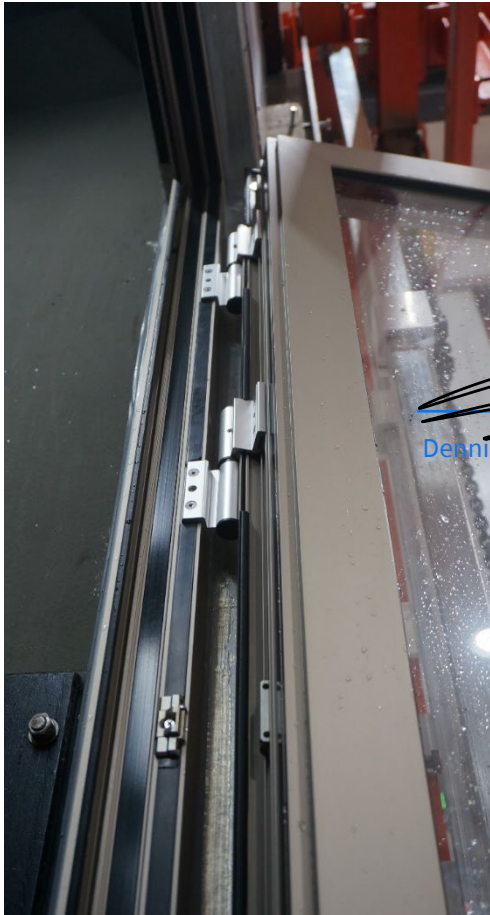
Figure 23 Photo of Hinges (Upper Section)

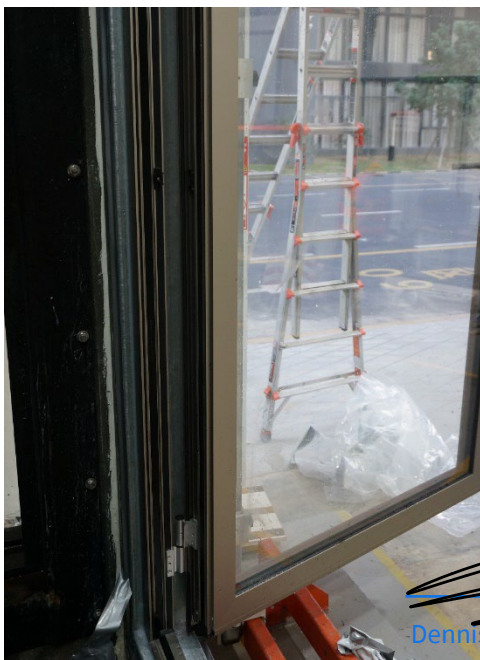
Figure 24 Photo of Hinges (Lower Section)

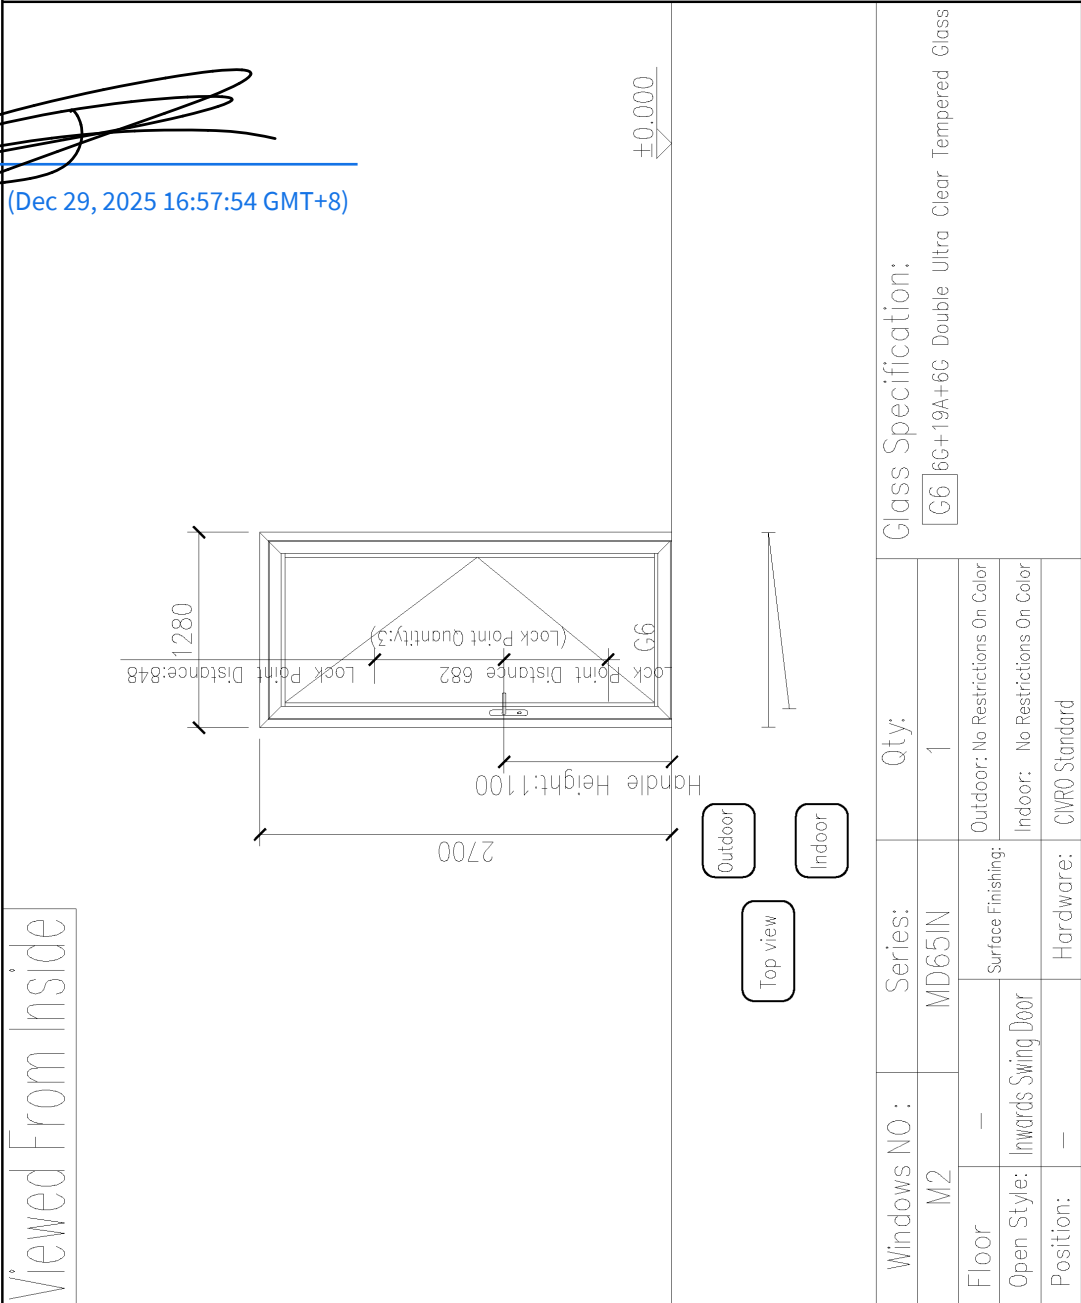
Figure 26 Drawing of Interior View – Location of Hardware

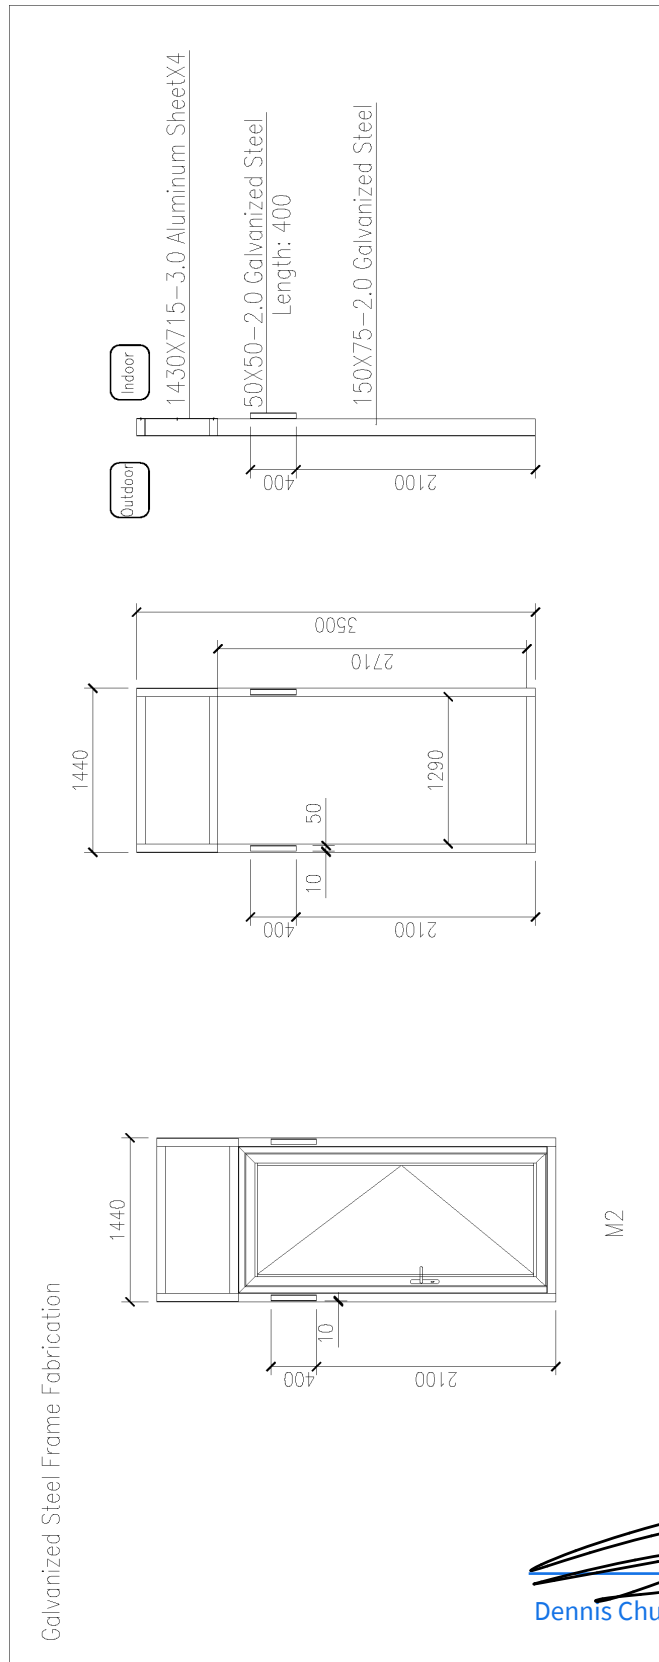
Figure 27 Drawing of Test Frame Fabrication

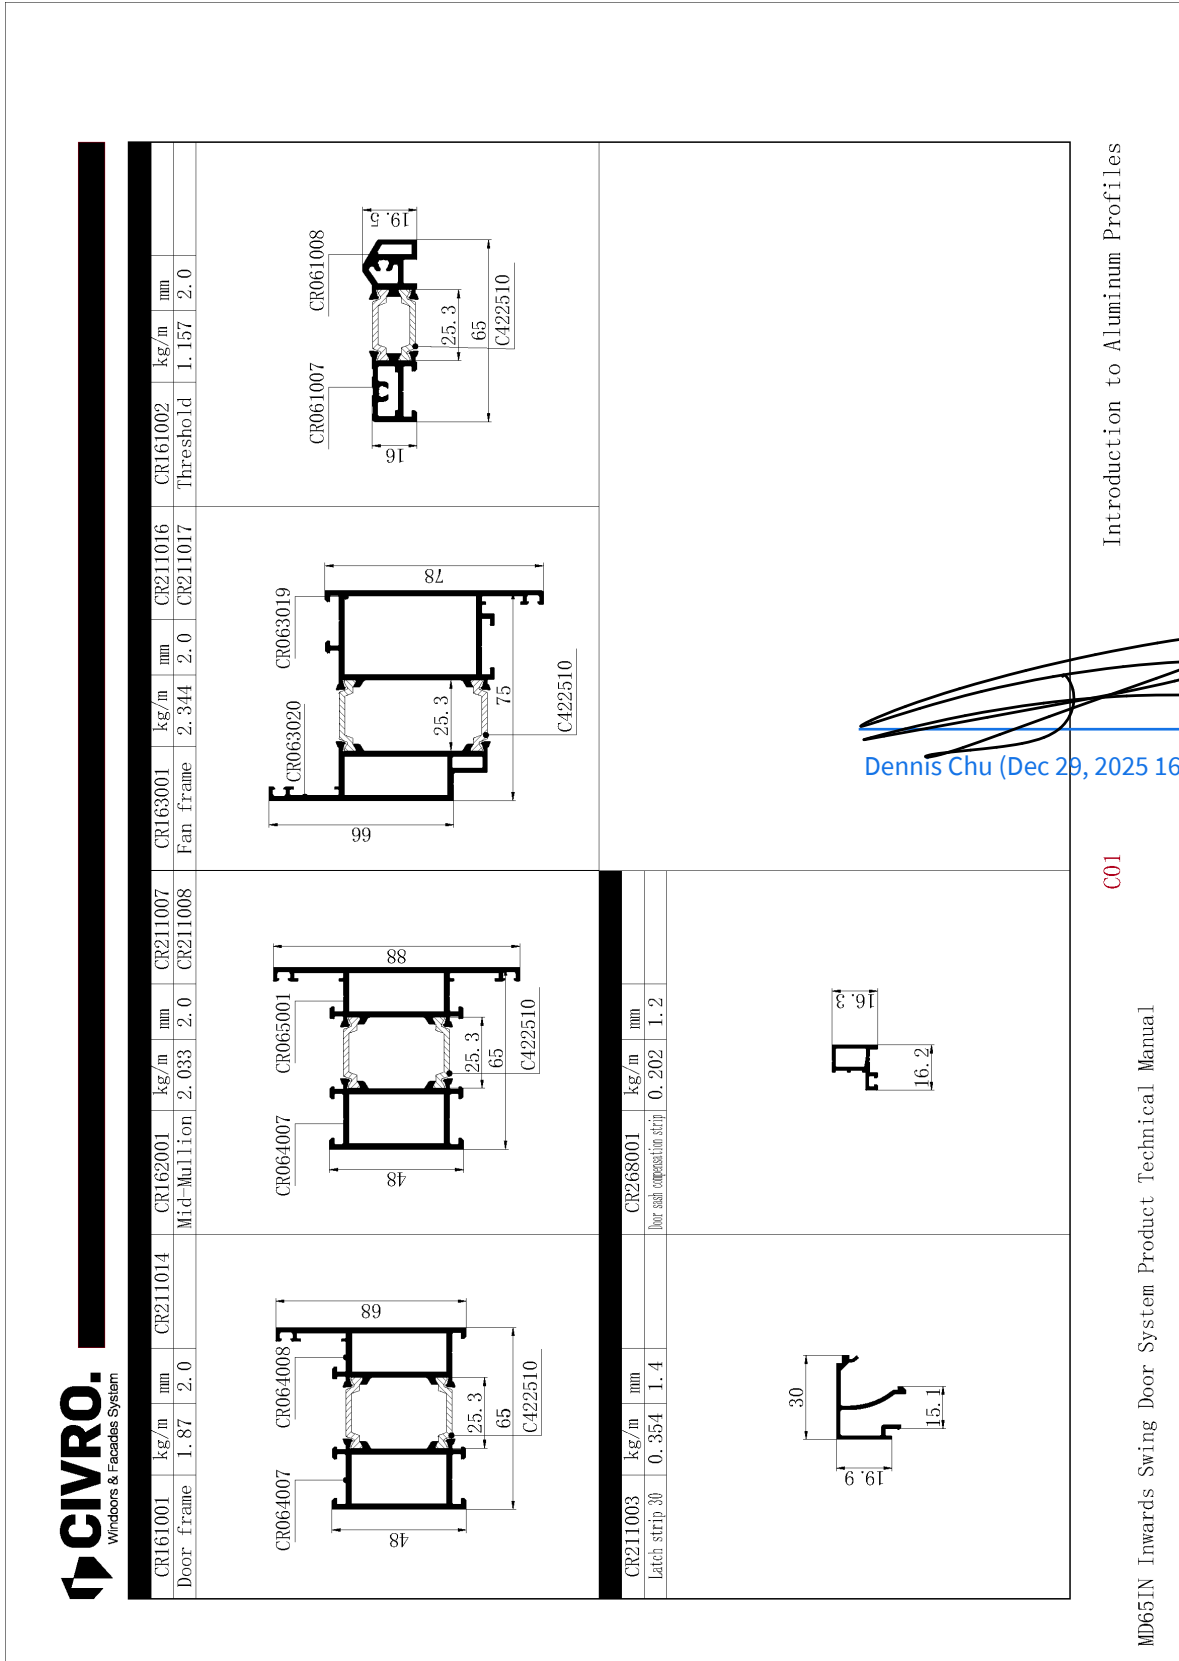
Figure 31 Drawing of Profile Section Details

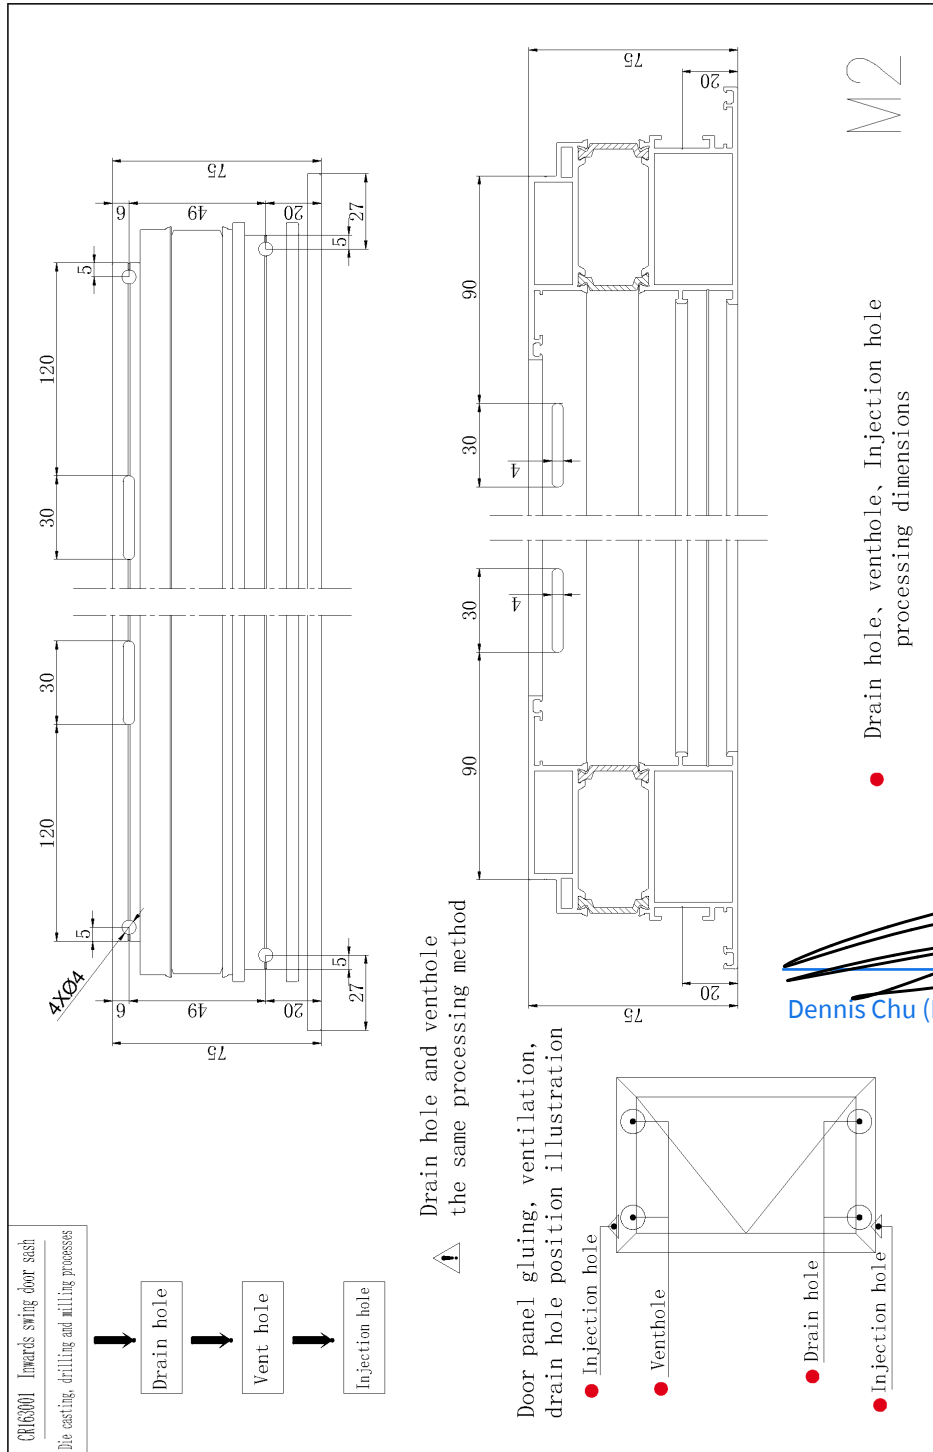
Figure 36 Cross-Section of Bottom Rail with Drainage System Details

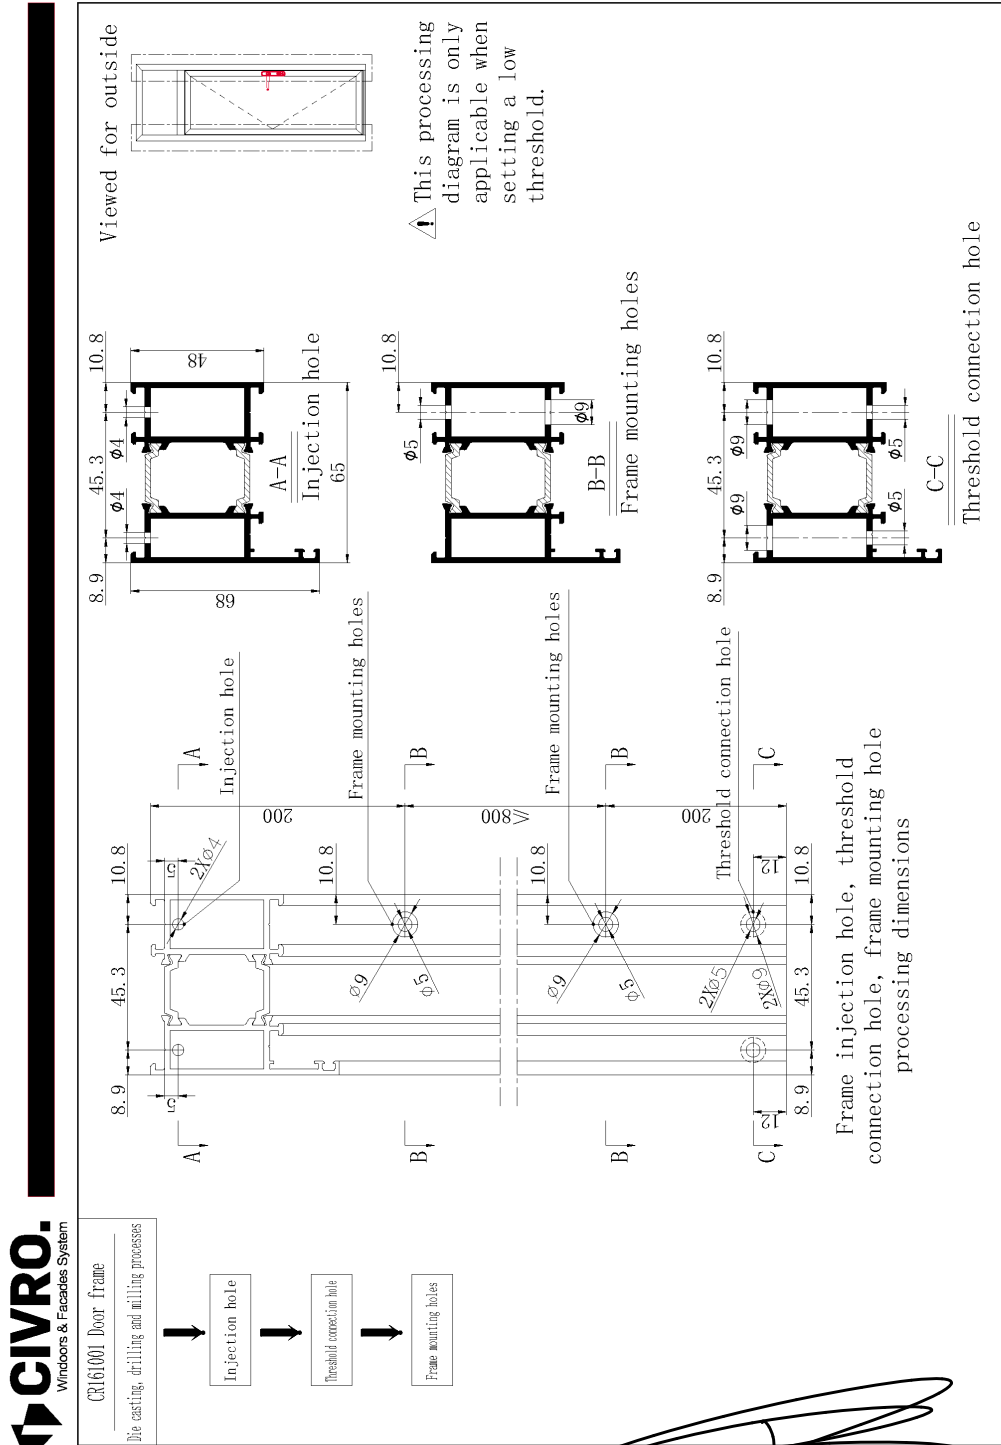
Figure 37 Cross-Section of Jambas
