WIND AND WATER TEST TO THE REQUIREMENTS OF AS2047

PRODUCT – MW65OU Awning Window

REPORTED BY – AZUMA TESTING LIMITED

REPORT NO. – AZHK251208

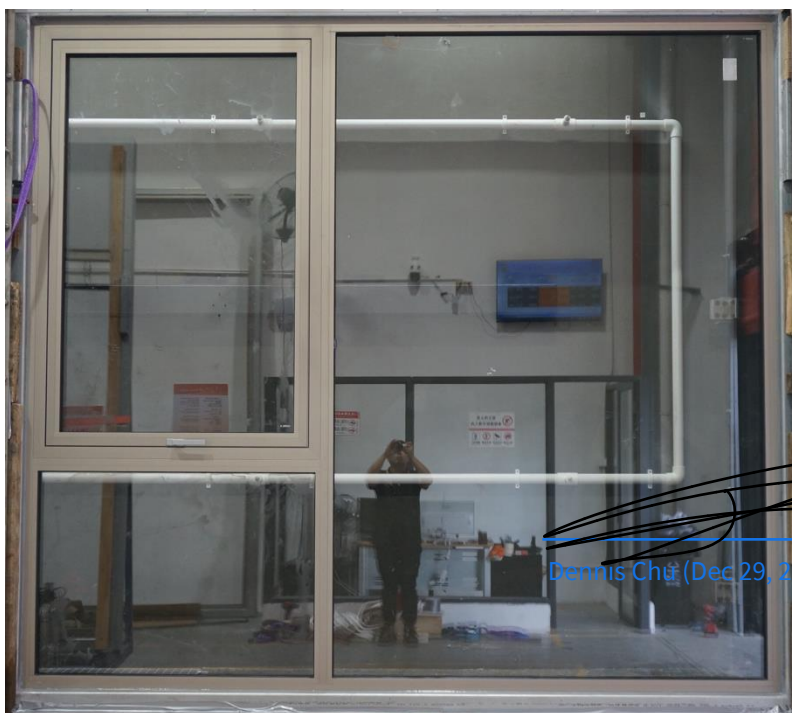
Figure 2 Photo of the test specimen Before testing (Fully Closed)

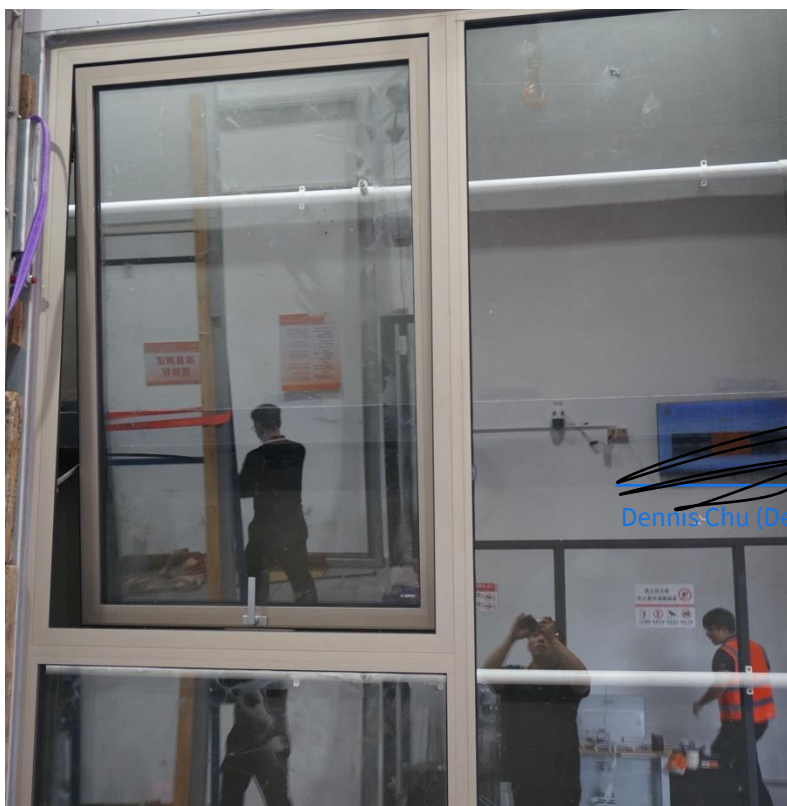
Figure 3 Photo of the test specimen Before testing (Fully Opened)

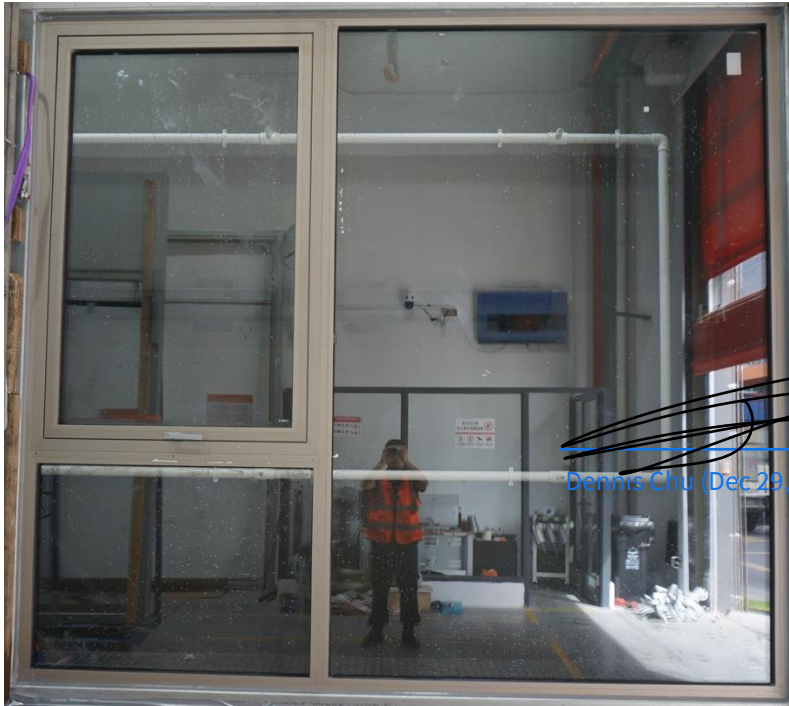
Figure 4 Photo of the test specimen After testing (Fully Close)

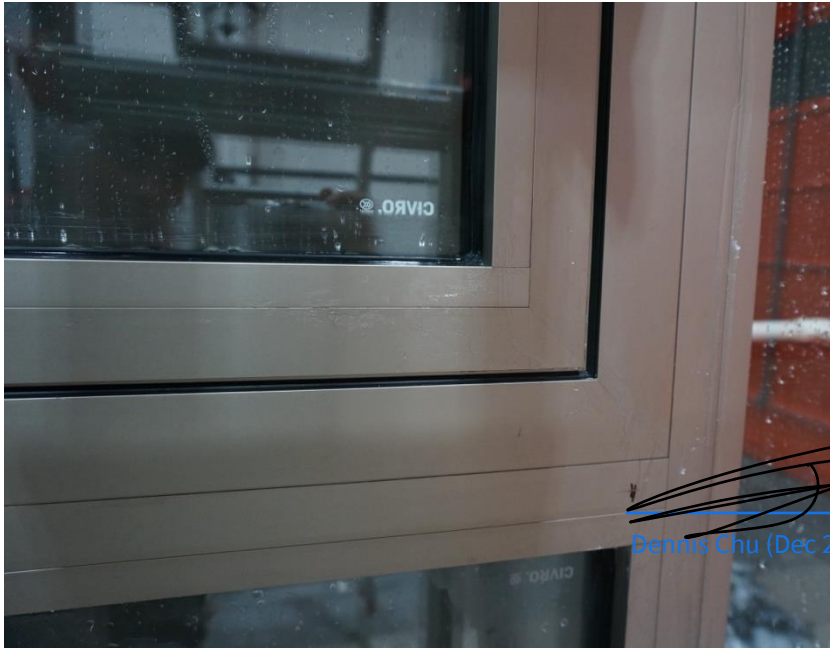
Figure 6 Connection Detail Between Operable Sash, Mullion, and Fixed Window (Middle Section)

Wet Down Complete – 5 minutes	Yes
Maximum Pressure Applied to Sample	600 Pa
Time Pressure Held for	15 minutes
Leakages Observed	Nil
Observations	No Observable Water Leakage Transparent Waterproof Coating Applied Both Exterior and Interior Surfaces of Window Assembly (Figure 5,6, 8, 9, 10, 18, 19, 20, 21, 22, 26 ,27 & 31)

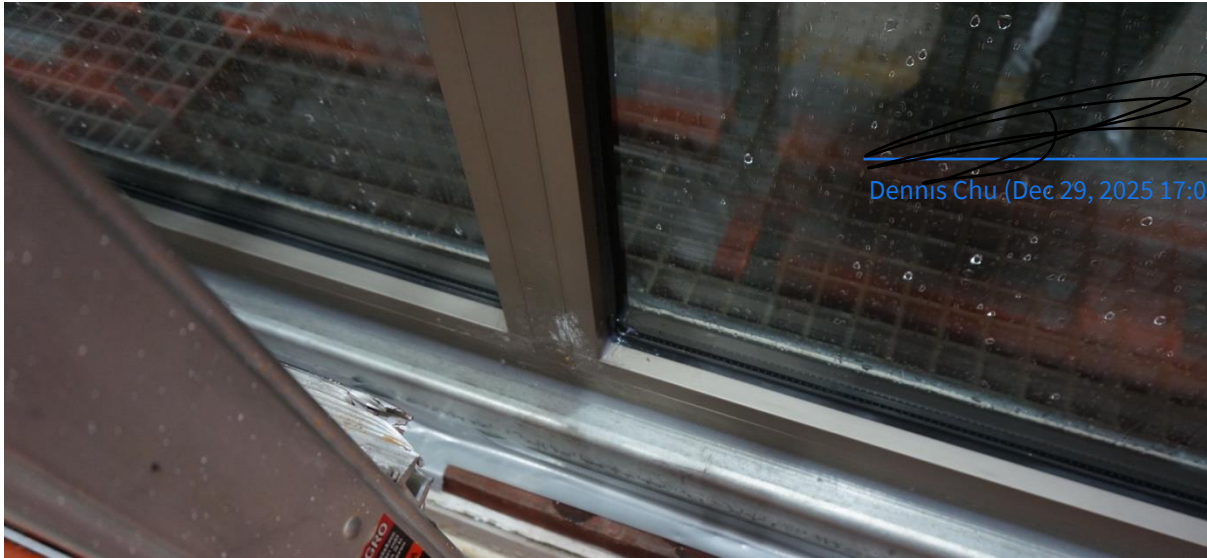
Figure 8 Connection Detail Between Mullion and Bottom Rail

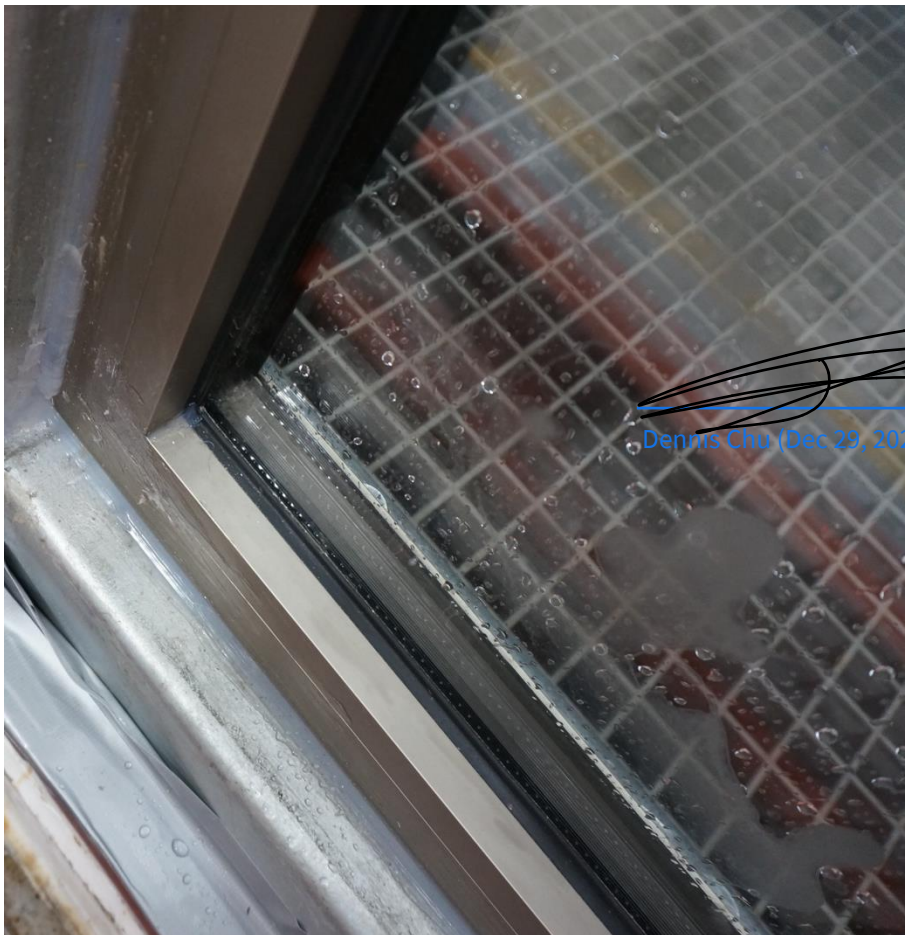
Figure 9 Connection Detail Between Left Side Jamb and Bottom Rail

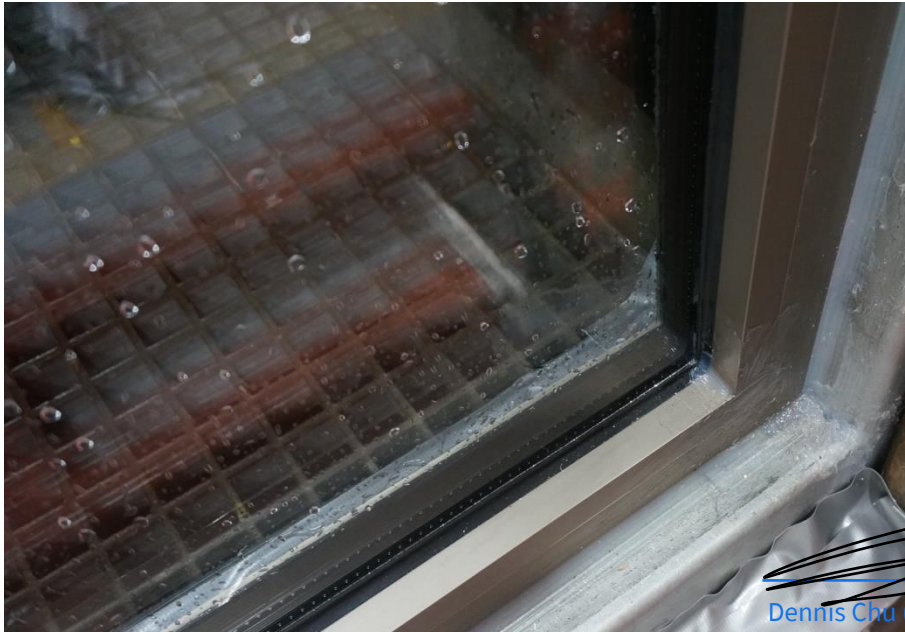
Figure 10 Connection Detail Between Right Side Jamb and Bottom Rail

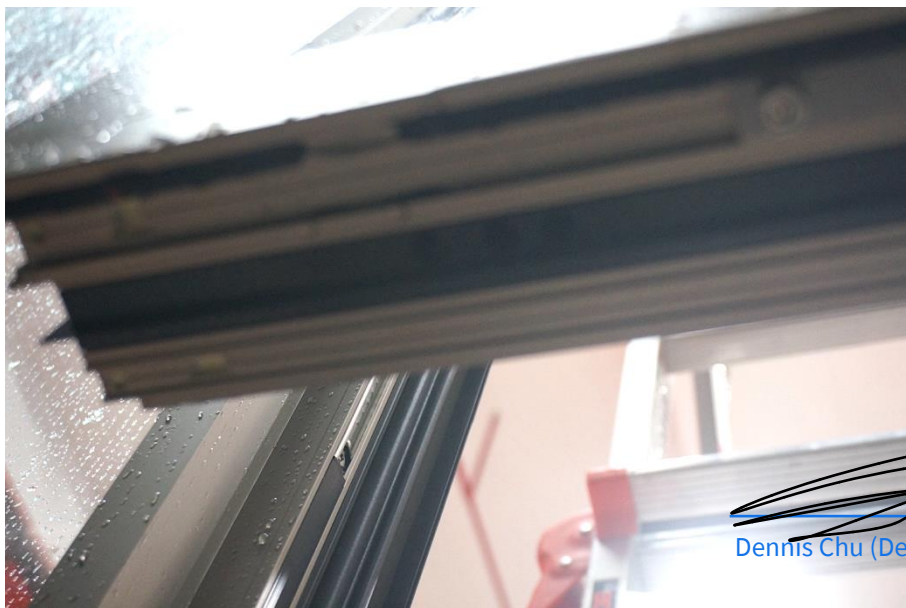
Figure 12 Photo of Bottom Rail (Taken from Bottom-to-Top Angle) Showing Weather Strip Detail

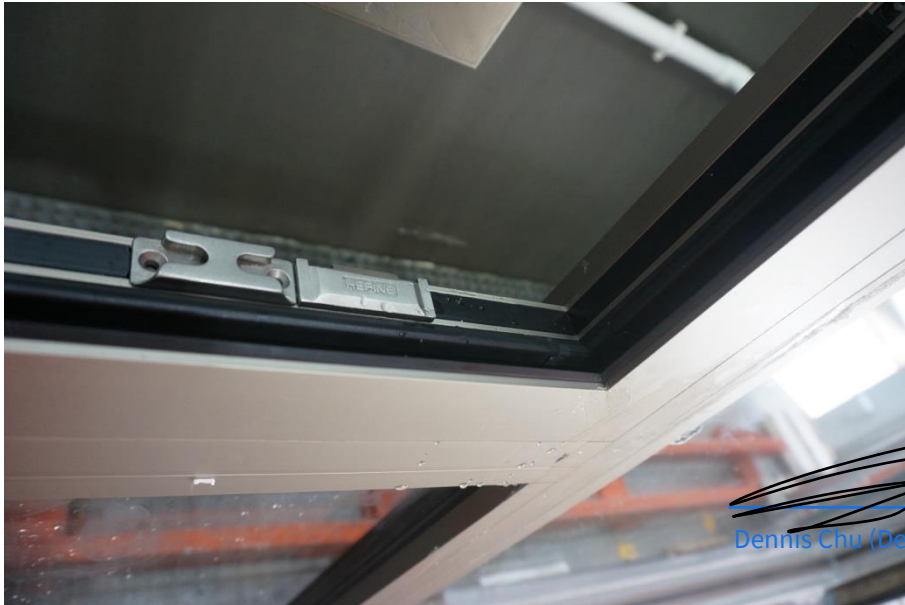
Figure 14 Photo of Locking Point and Locking Keeper (Right Side)

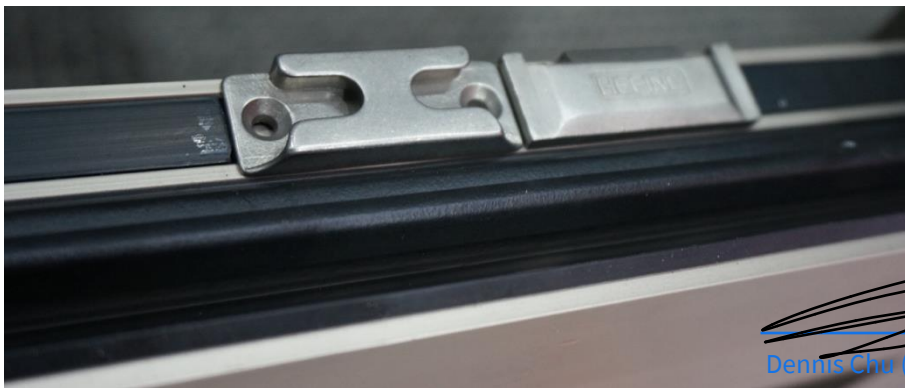
Figure 15 Photo of Locking Point and Locking Keeper (Right Side)

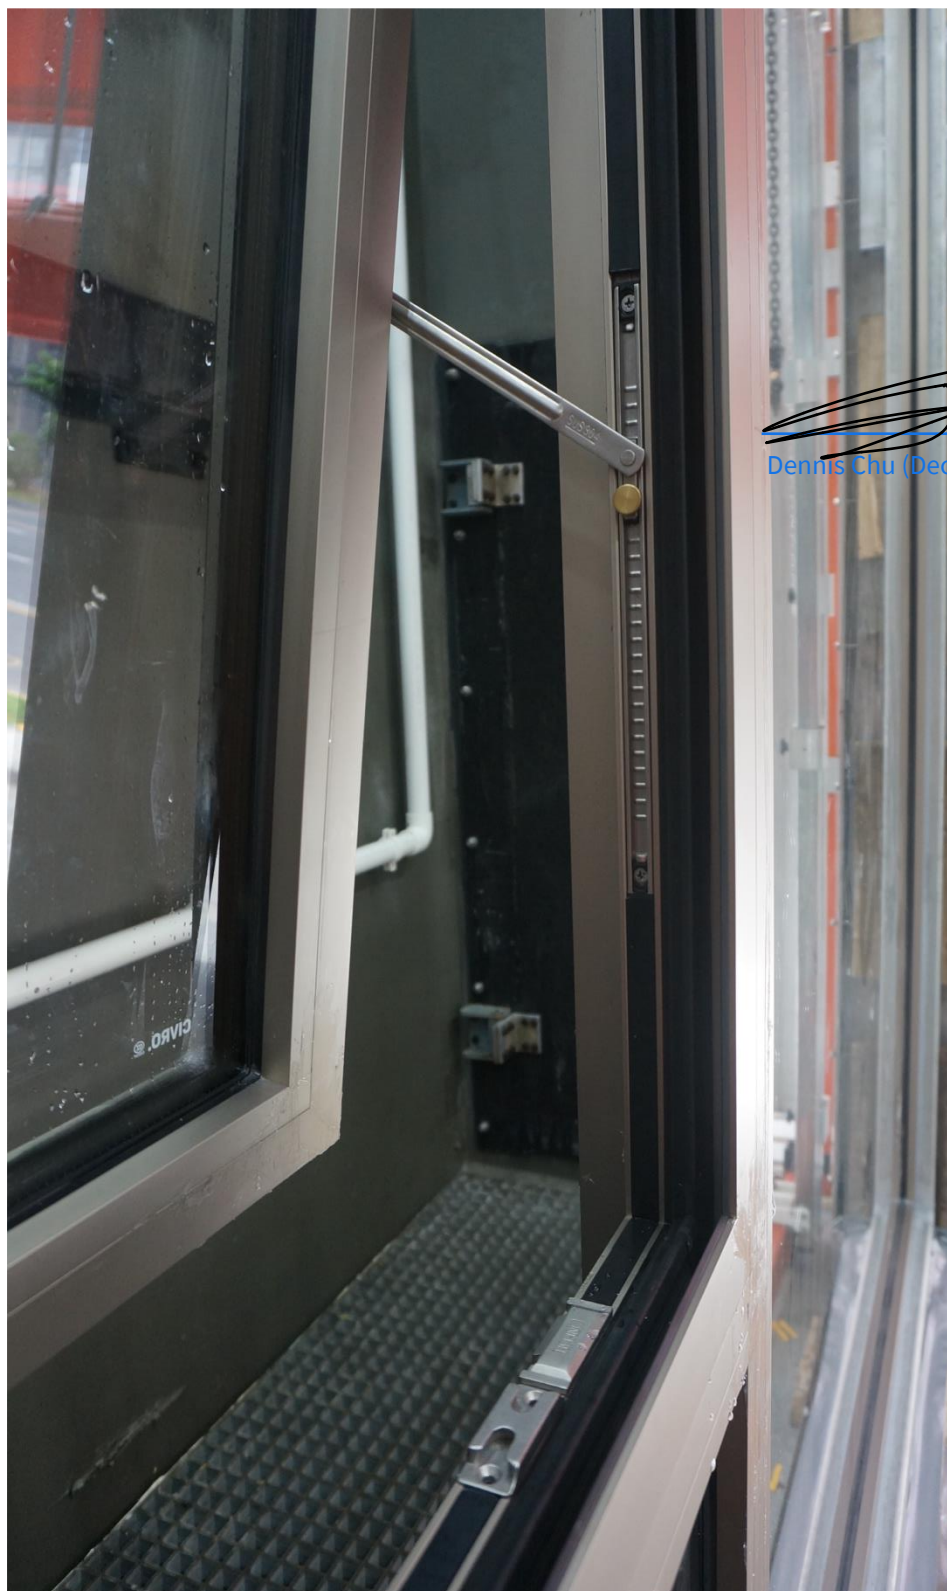
Figure 17 Awning Window in Opened Position Showing the Friction Stay Hinges, Locking Point and Keeper (Left Side)

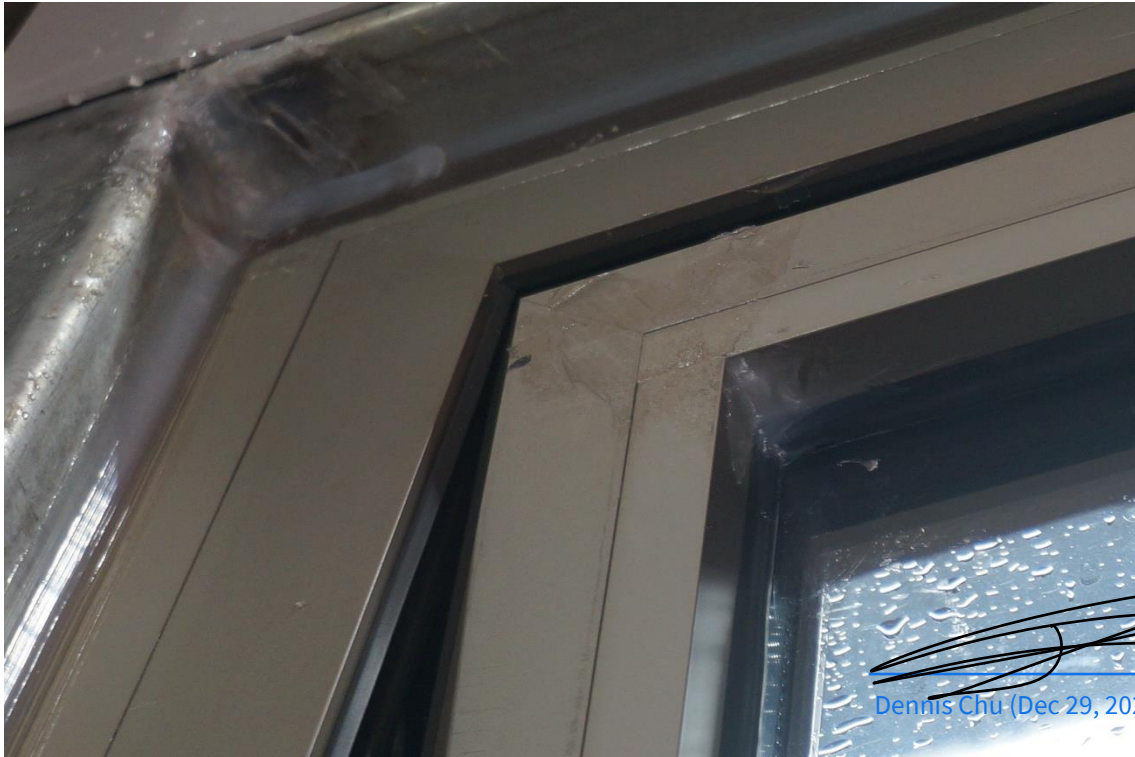
Figure 19 Connection Detail of Left Side Jamb, Head Jamb, and Operable Sash (Opened Position)

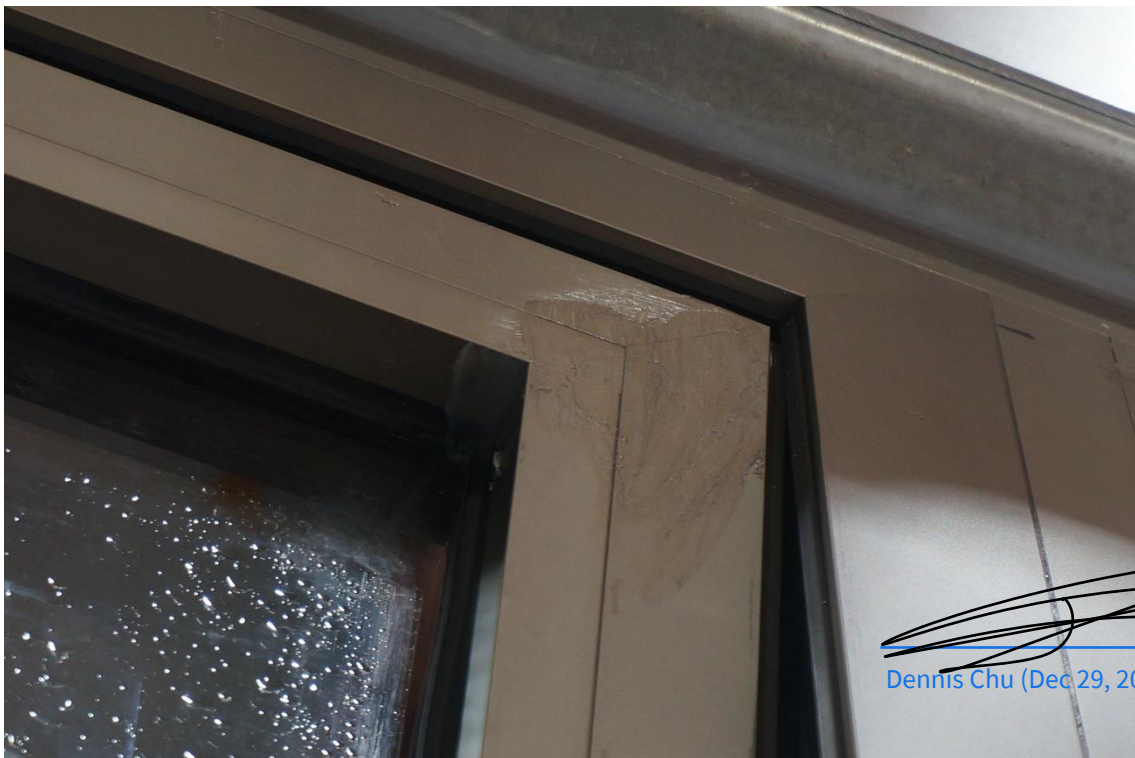
Figure 20 Connection Detail of Mullion, Head Jamb, and Operable Sash (Opened Position)

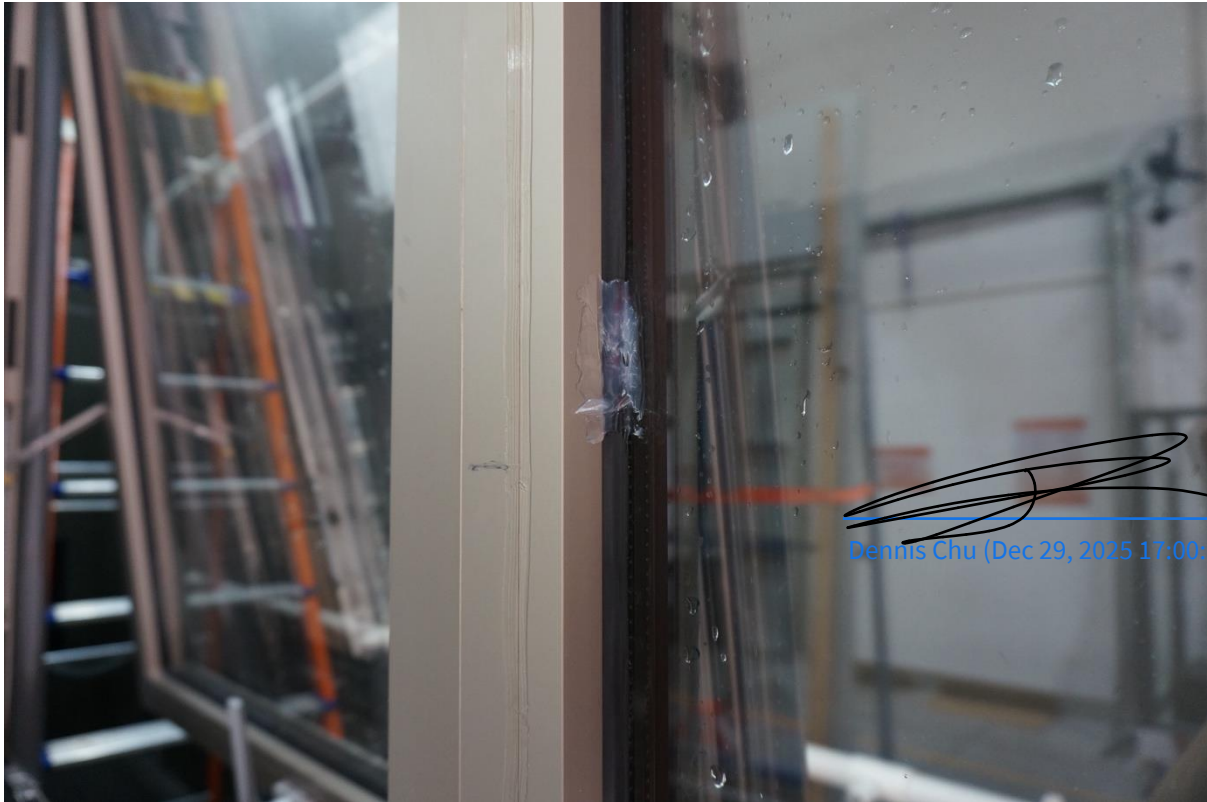
Figure 21 Photo of Mullion

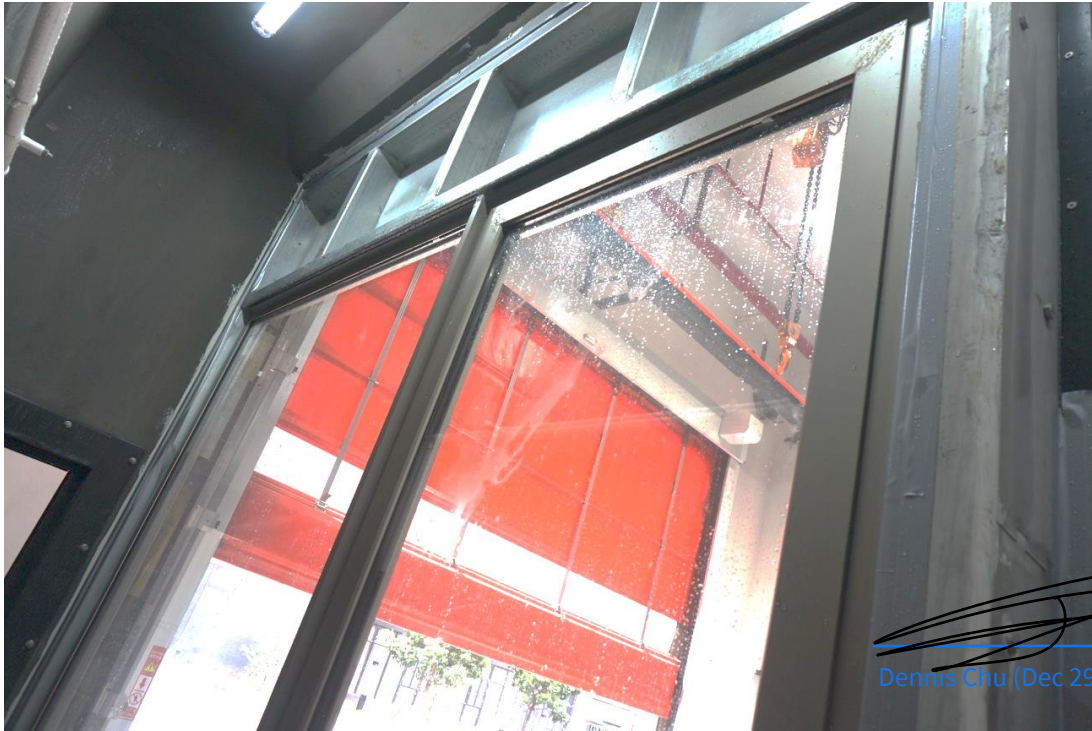
Figure 23 Photo of Upper Section of Window Assembly (View from Exterior)

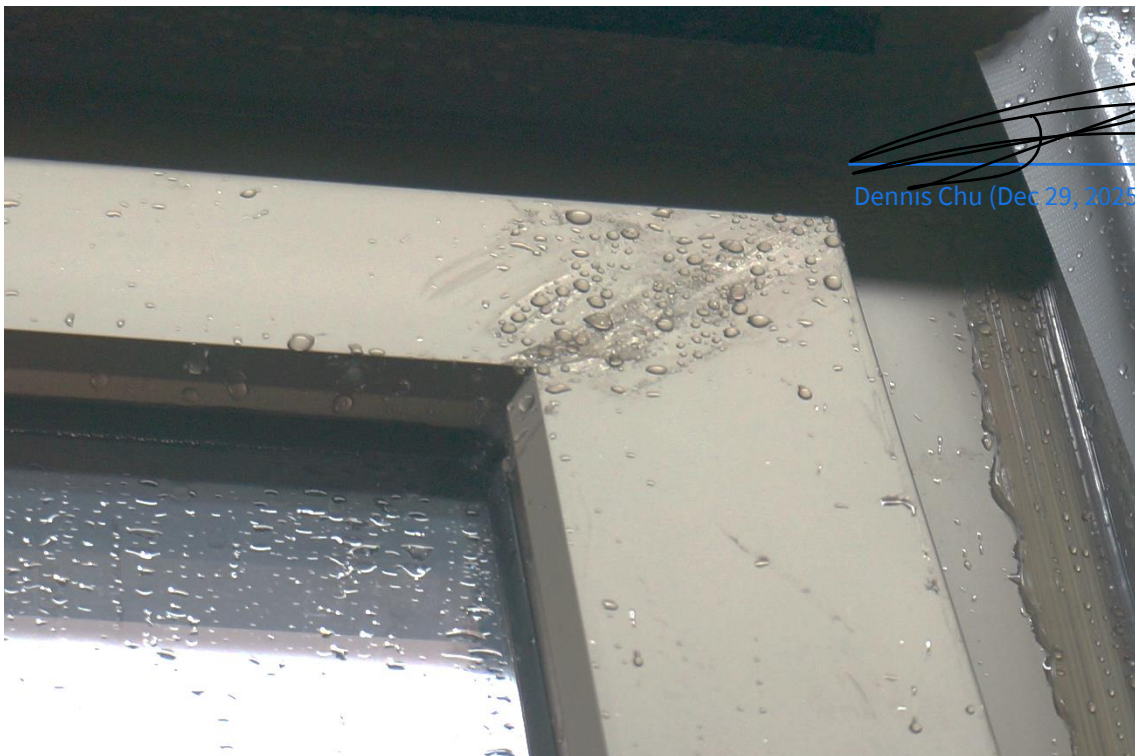
Figure 27 Corner Detail Between Top Rail and Stile of Operable Sash (Right Side, View from Exterior)

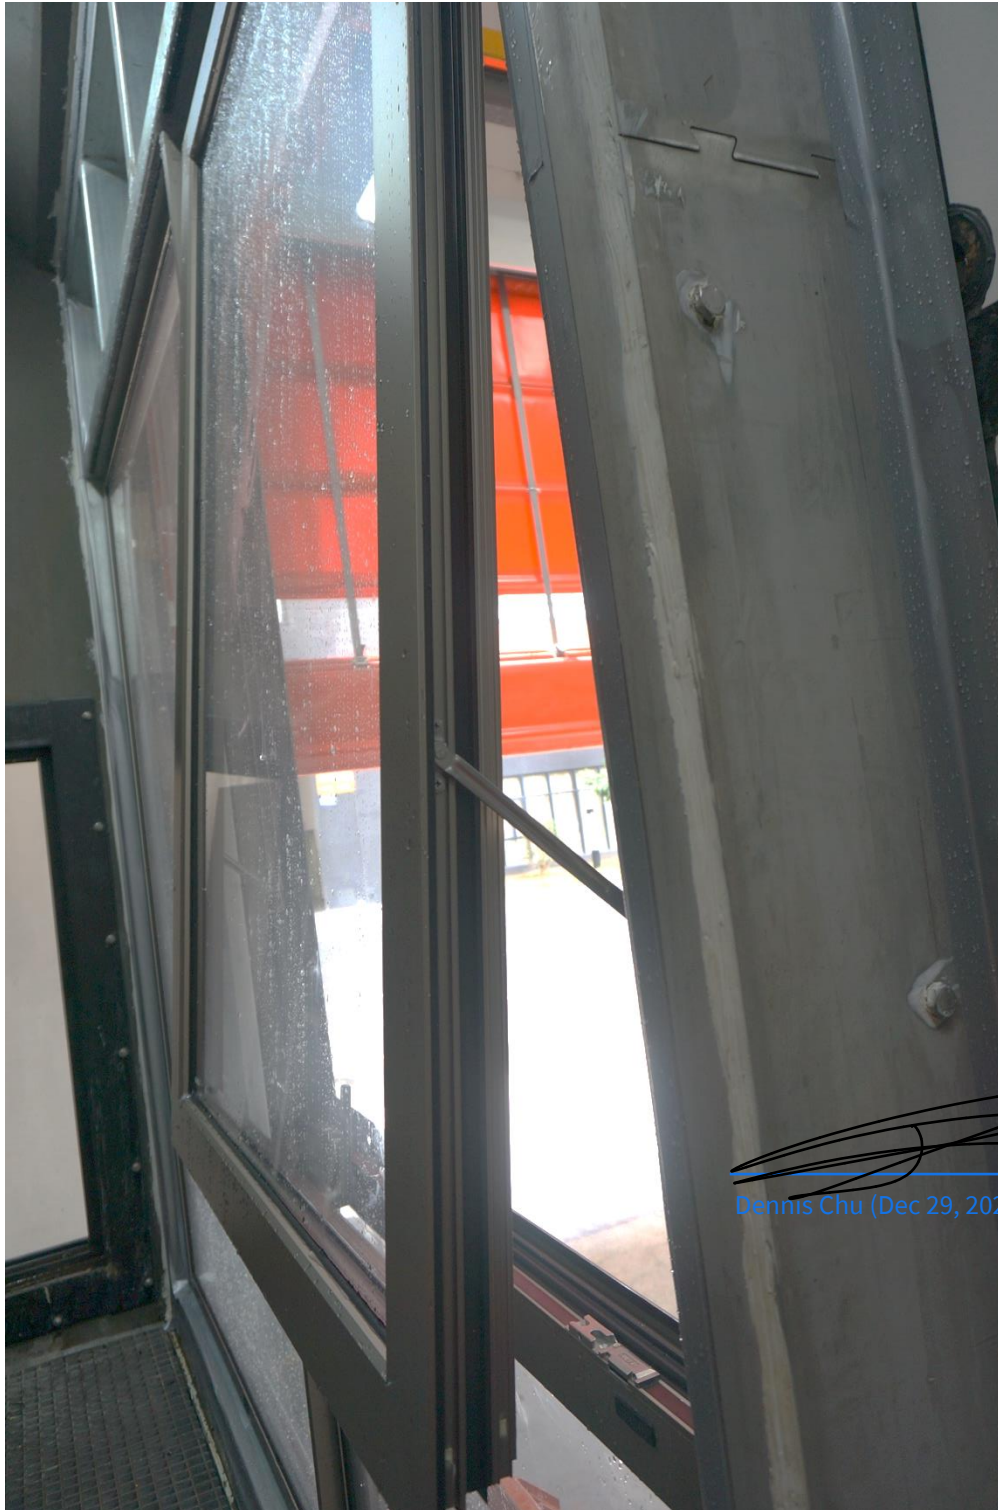
Figure 30 Photo of Operable Sash in Open Position (View from Bottom and Exterior) Showing Detail of Hardware – locking points & Limit Stay

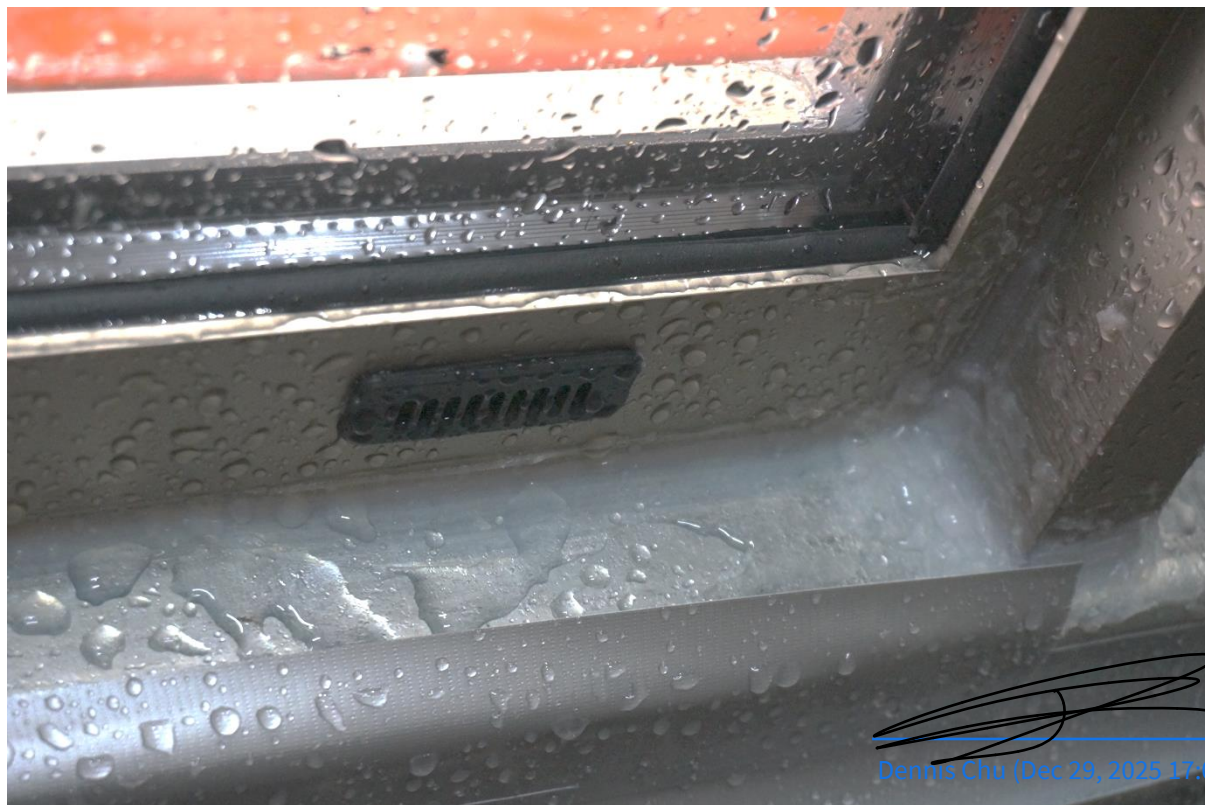
Figure 31 The Bottom Sill of Window Assembly (View from Exterior)
