Test Report

WIND AND WATER TEST TO THE REQUIREMENTS OF AS2047

PRODUCT – XD63LS Lift Sliding Door

REPORT NO. – AZHK251209

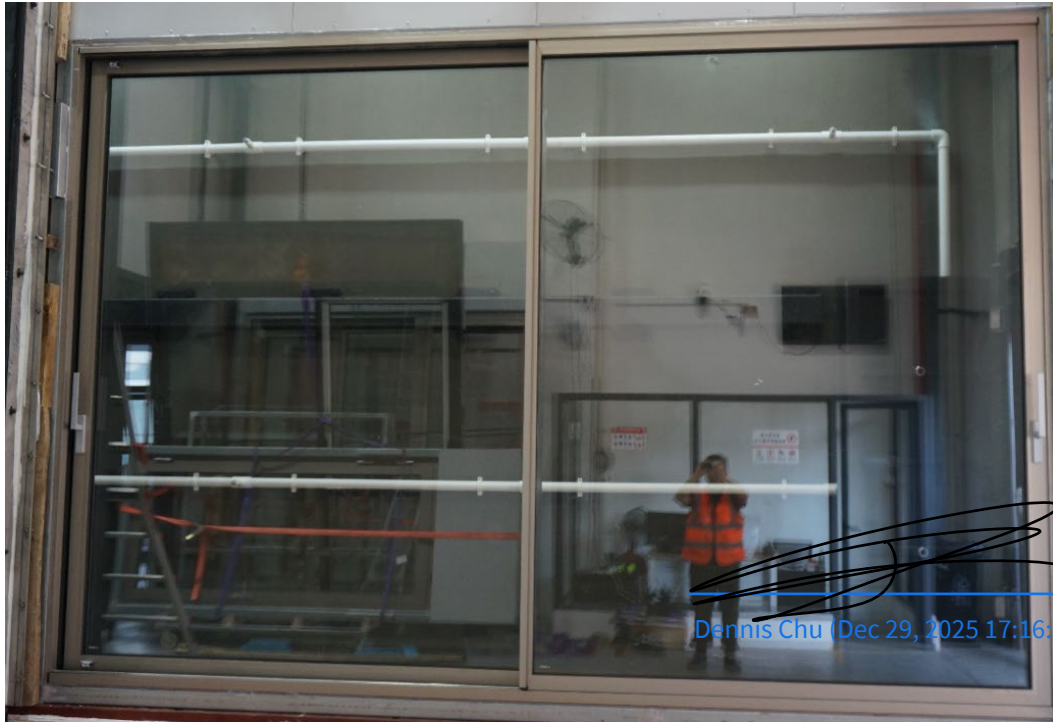
Figure 2 Photo of the test specimen Before testing (Fully Closed)

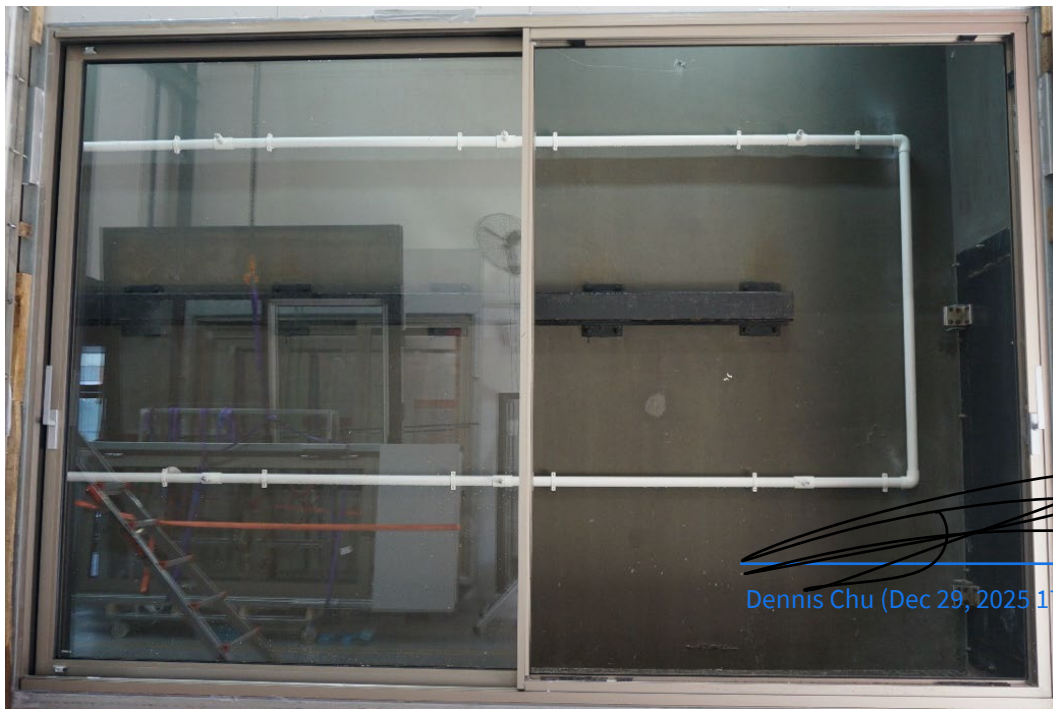
Figure 3 Photo of the test specimen After testing (Fully Closed)

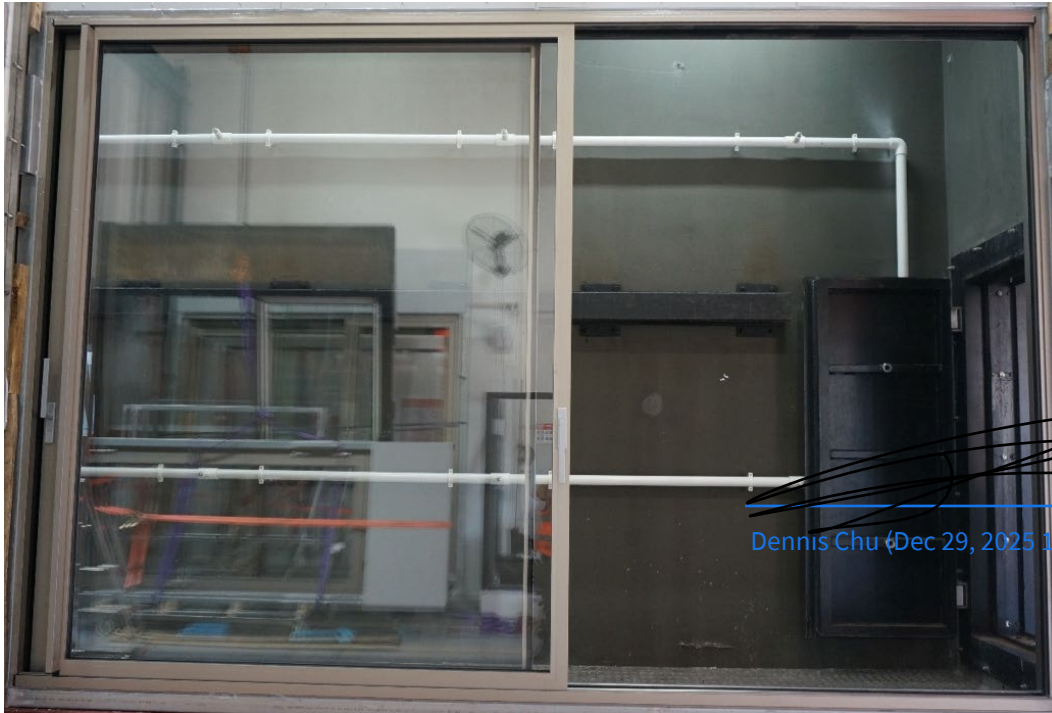
Figure 4 Photo of the test specimen After testing (Fully Opened)

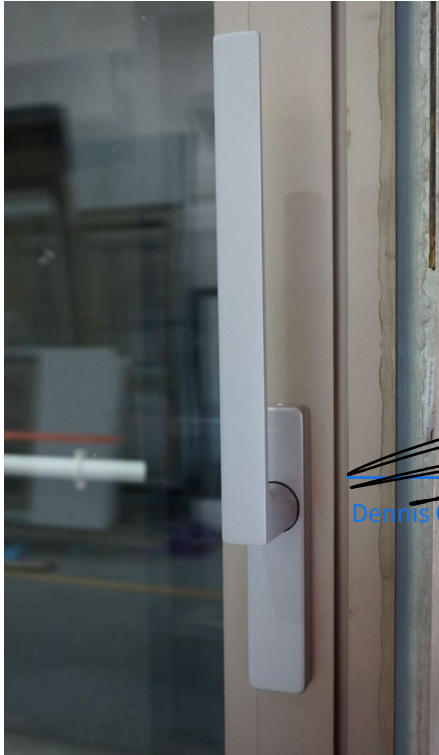
Figure 5 Photo of the Hardware (Handle)

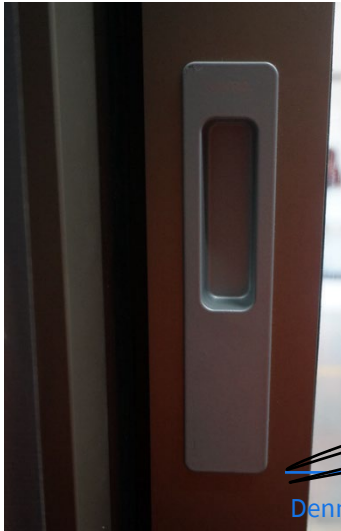
Figure 6 Photo of the Hardware (Recessed Pull)

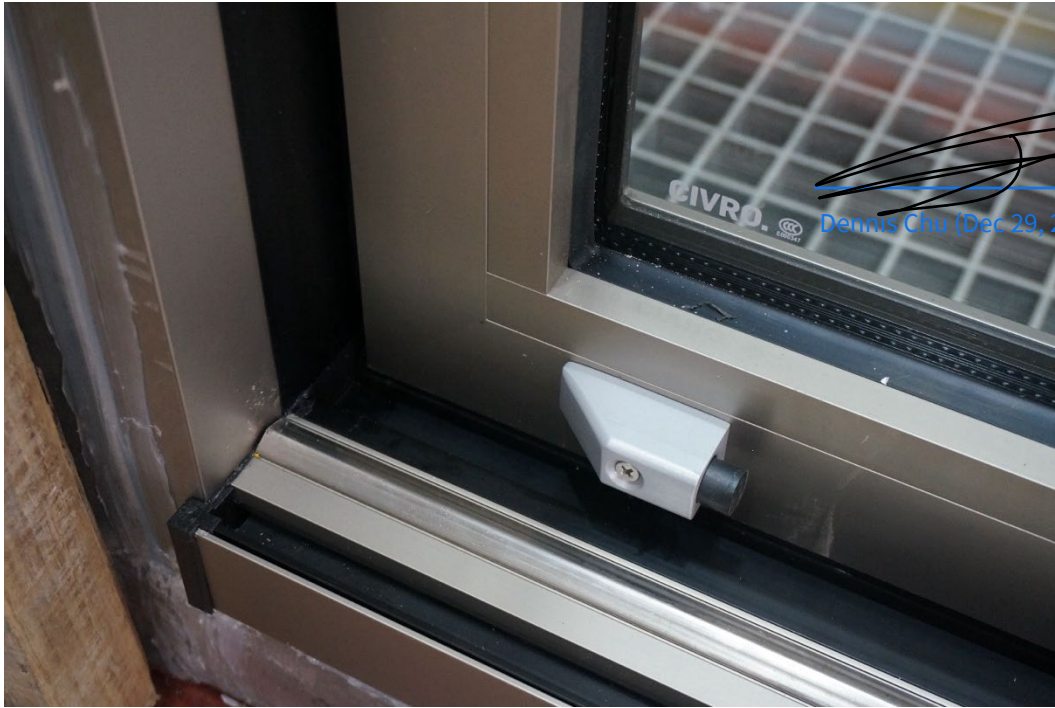
Figure 8 Connection Detail Between Left Side Jamb, Bottom Sill, Lock Stile and Bottom Rail

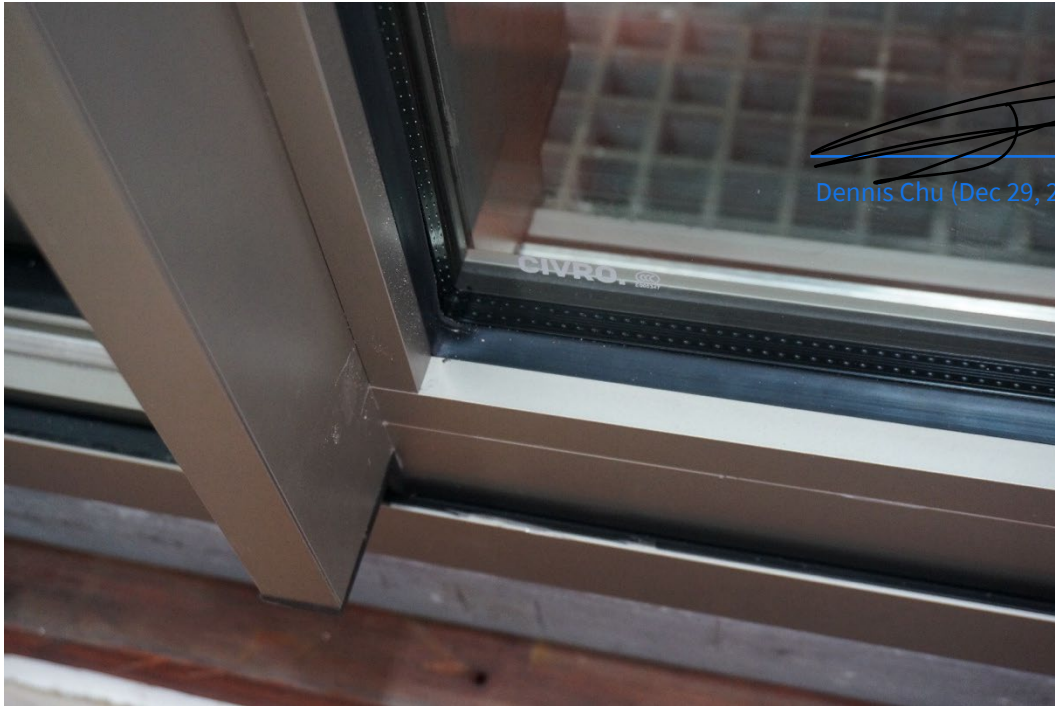
Figure 10 Connection Detail Between Bottom Sill, Interlock Stile, Door Track, Bottom Rail and Right Panel (Showing White Traces Left by Transparent Waterproof Coating on Surface)

Wet Down Complete – 5 minutes	Yes
Maximum Pressure Applied to Sample	700 Pa
Time Pressure Held for	15 minutes
Leakages Observed	Nil
Observations	No Observable Water Leakages Transparent Sealant applied on site on exterior and interior surfaces of Window Assembly (See Figures 10, 11, 12 & 17)

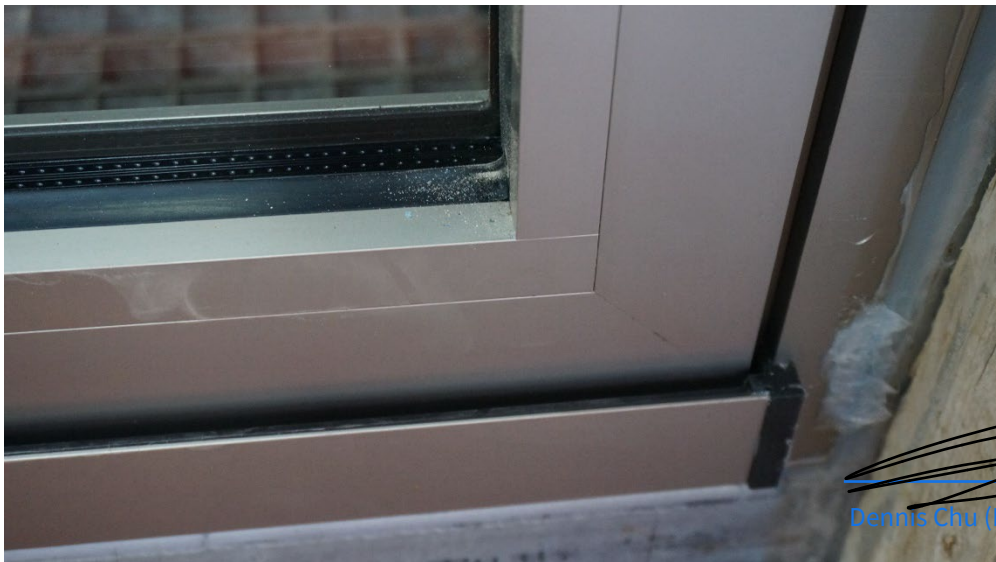
Figure 11 Connection Detail Between Right Side Jamb, Bottom Sill, Bottom Rail and Right Lock Stile (Showing White Traces Left by Transparent Waterproof Coating on Surface)

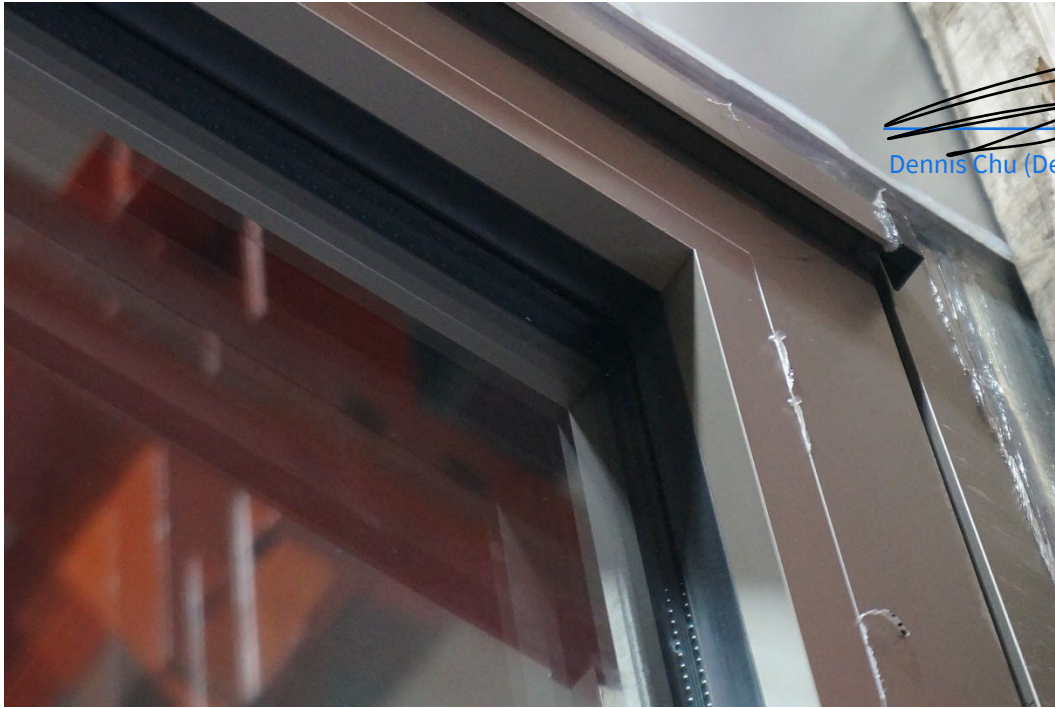
Figure 12 Connection Detail Between Right Side Jamb, Head, Top Rail, and Right Lock Stile (Showing White Traces Left by Transparent Waterproof Coating on Surface)

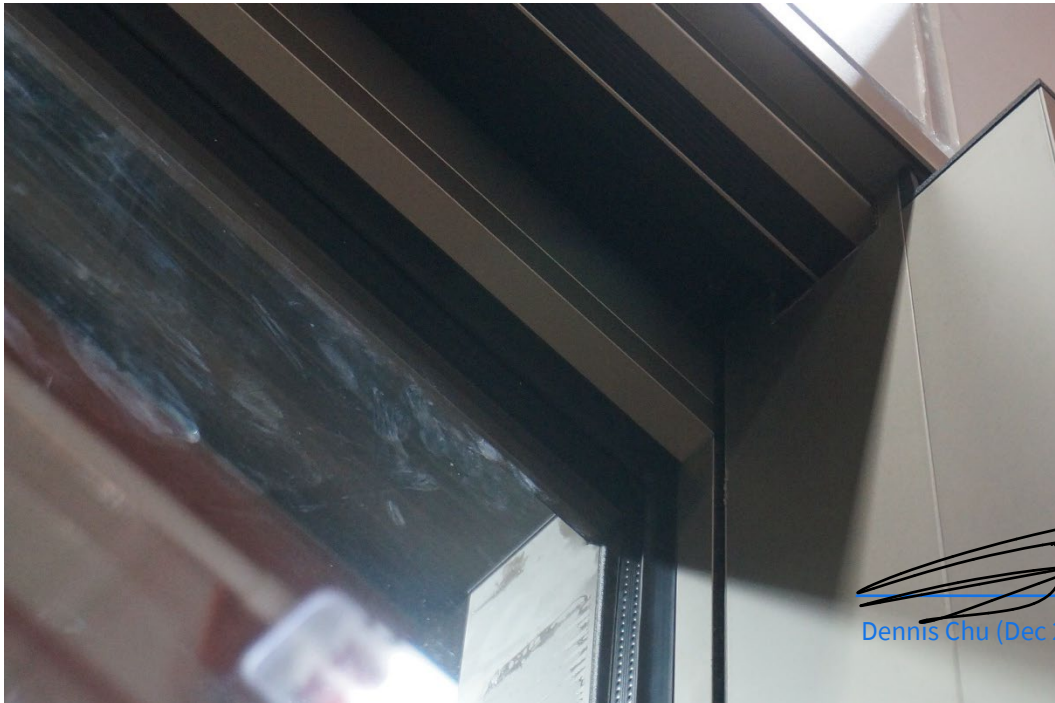
Figure 13 Connection Detail Between Head and Interlock Stile

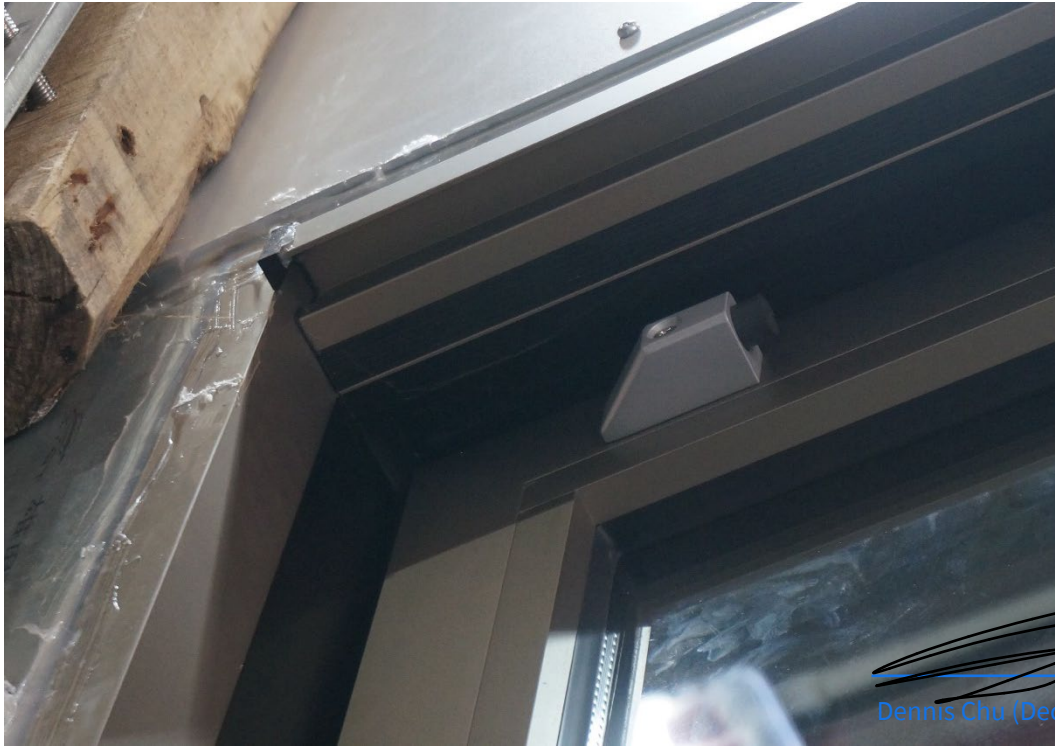
Figure 14 Door Bumper Stop Installed on Top Rail of Left Panel

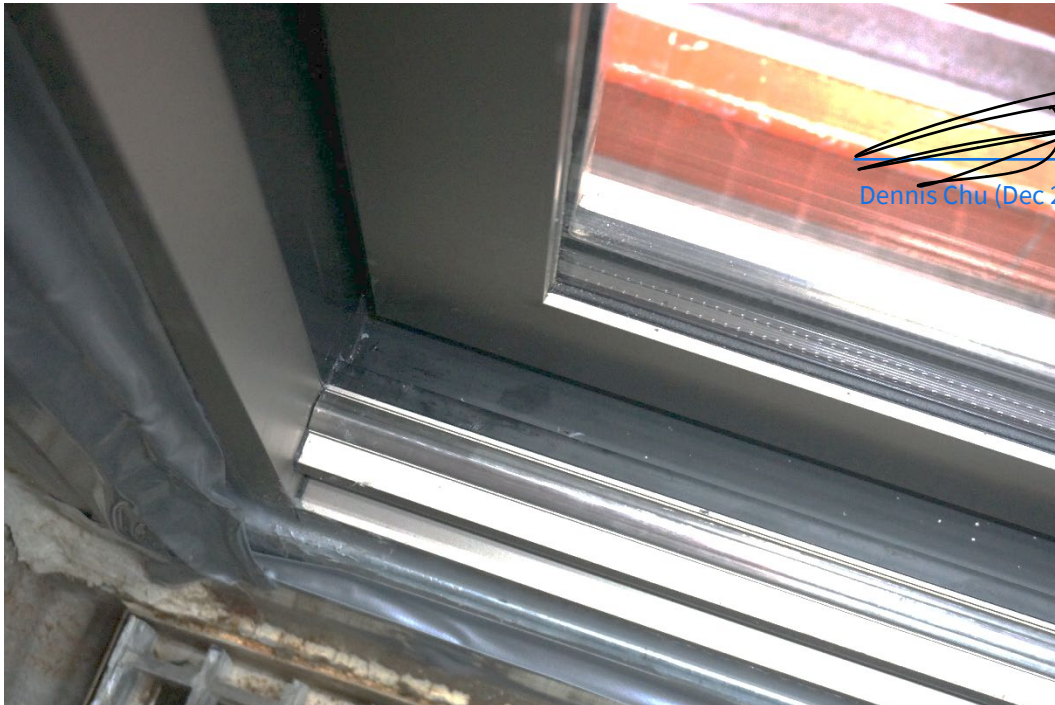
Figure 15 Connection Detail Between Bottom Sill, Lock Stile, Door Track, Bottom Rail and Jamb (View from Exterior)

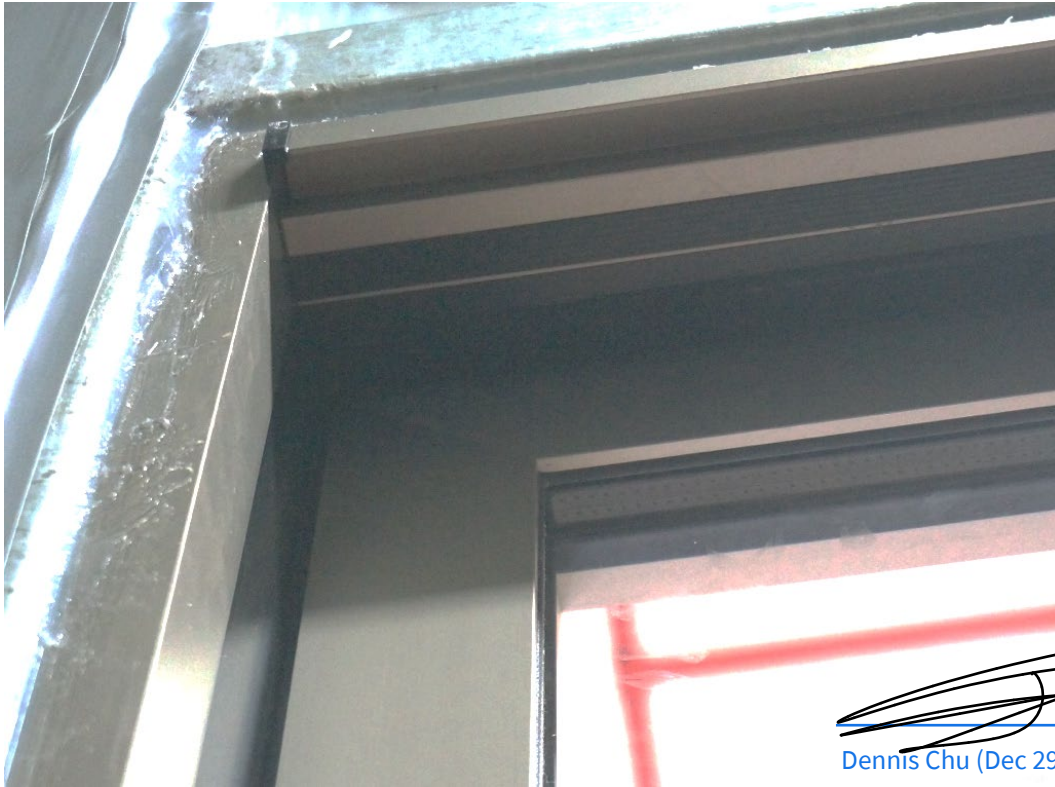
Figure 16 Connection Detail Between Top Rail, Lock Stile, Door Track, Bottom Rail and Left-Side Jamb (View from Exterior)

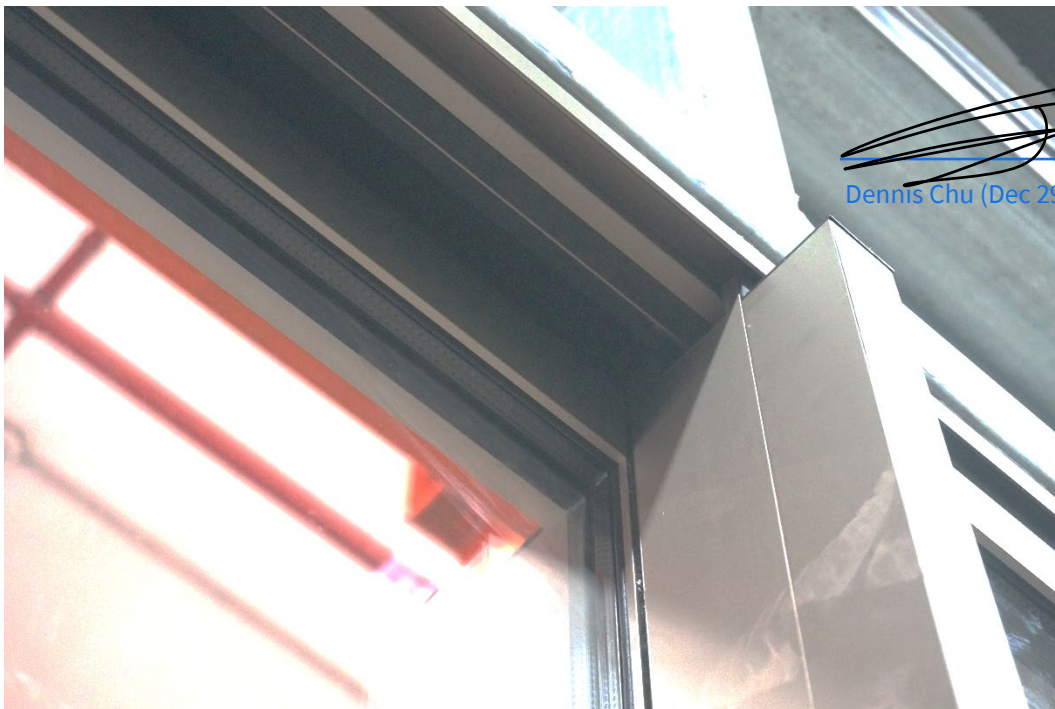
Figure 17 Connection Detail Between Top Rail, Interlock Stile and Head (Showing White Traces Left by Transparent Waterproof Coating on Surface)

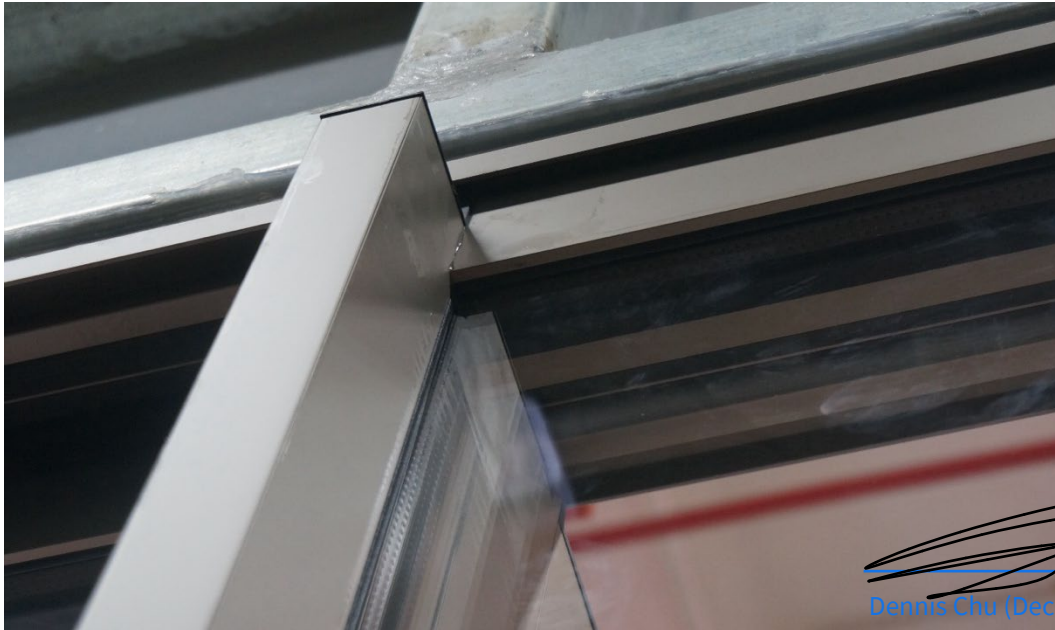
Figure 18 Connection Detail Between Two Panels

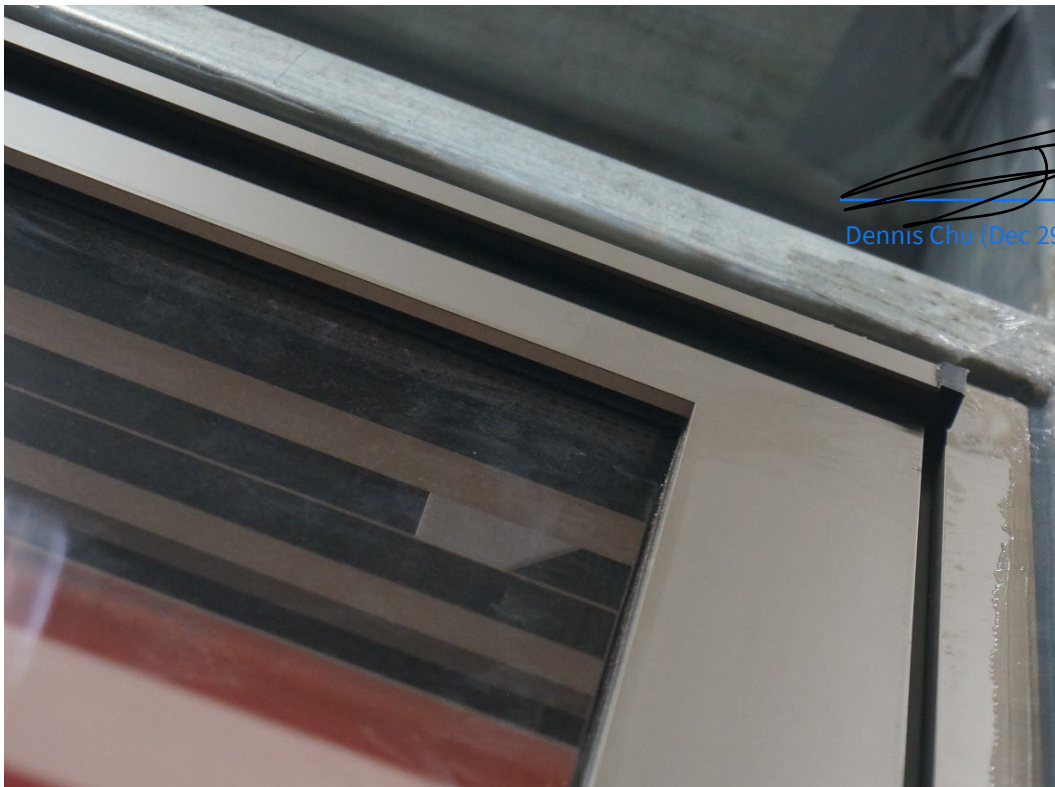
Figure 19 Connection Detail Between Top Rail, Lock Stile, Door Track, Bottom Rail and Right-Side Jamb (View from Exterior)

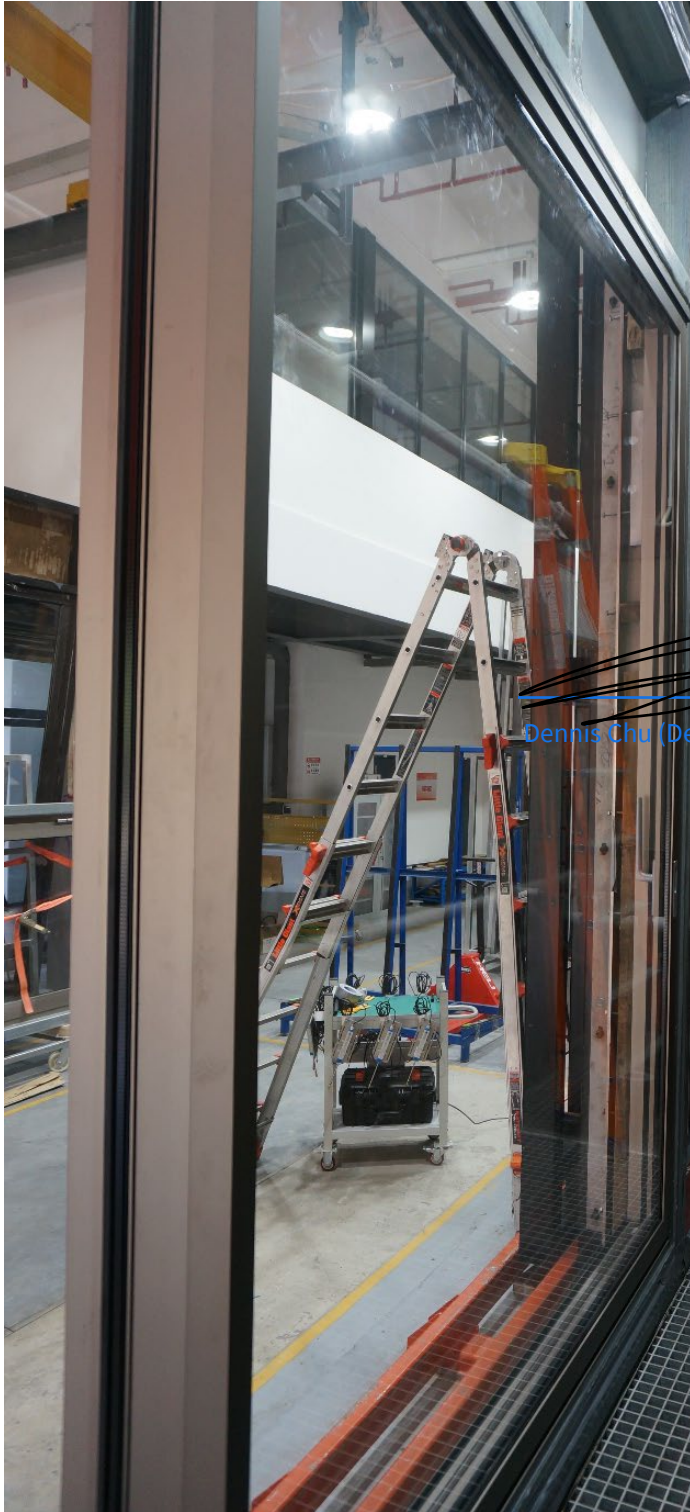
Figure 20 Right Panel (View from Exterior)

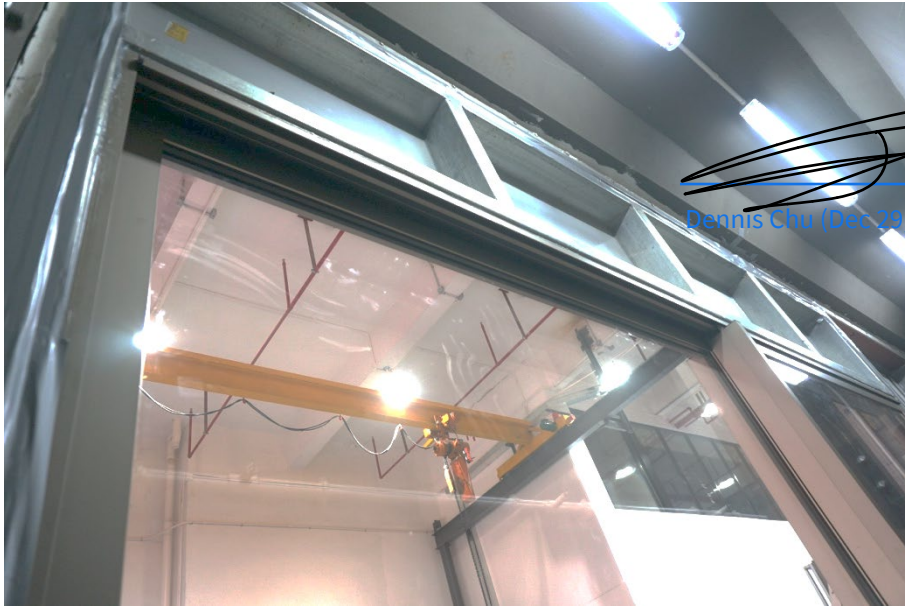
Figure 21 Upper Section of Left Panel (View from Exterior)

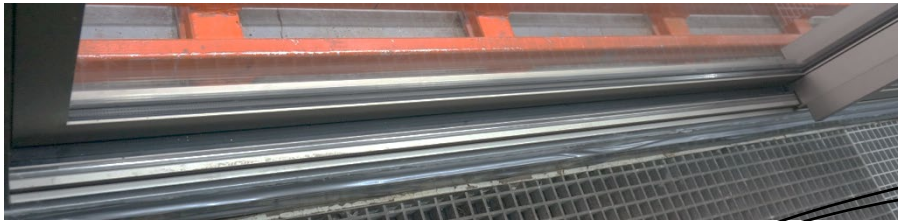
Figure 22 Door Track of Left Panel (View from Exterior)

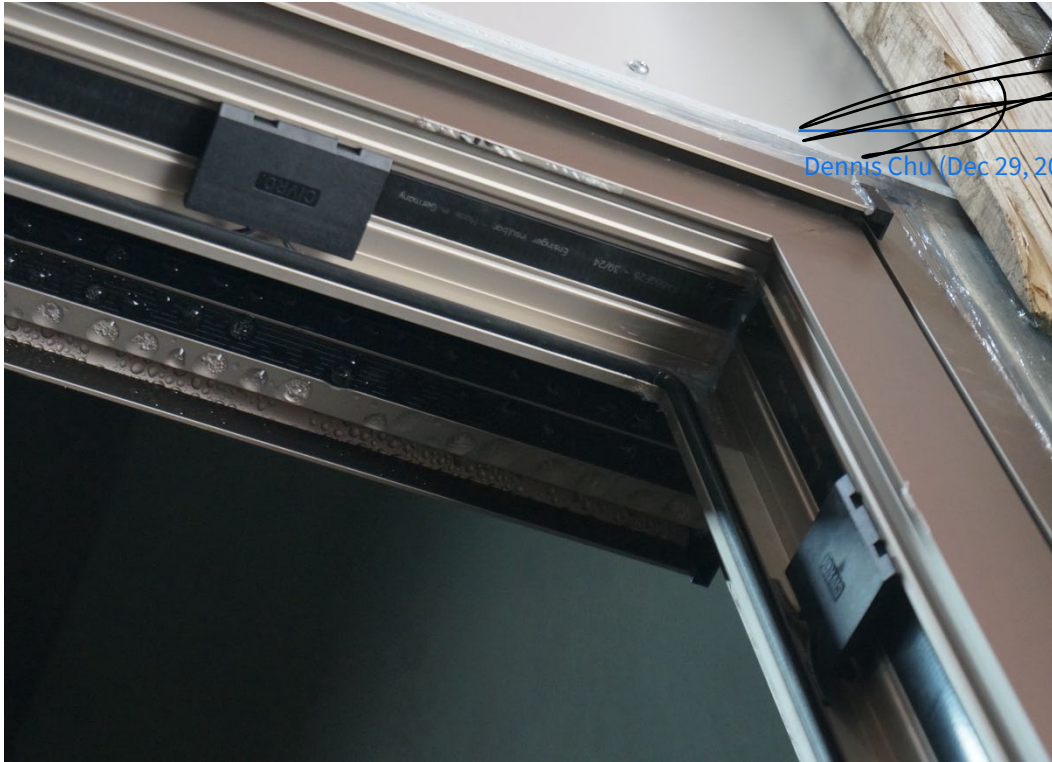
Figure 24 Connection Detail Between Head, Right-Side Jamb and Door Track

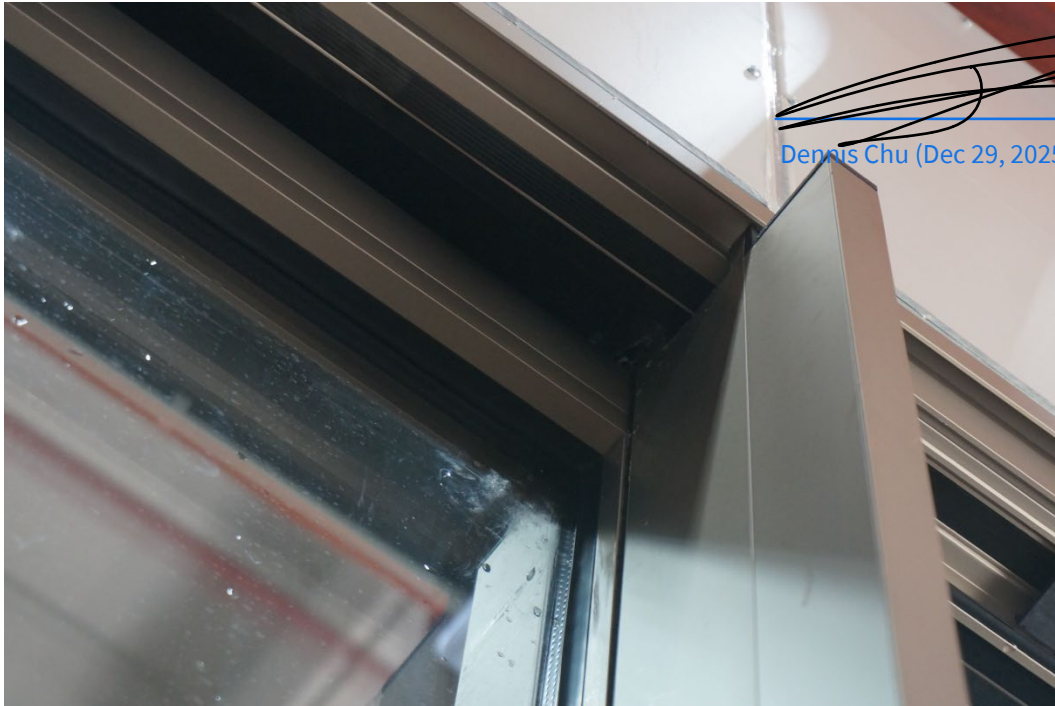
Figure 26 Connection Detail Between Head, Interlock Stile and Door Track (Left Panel)

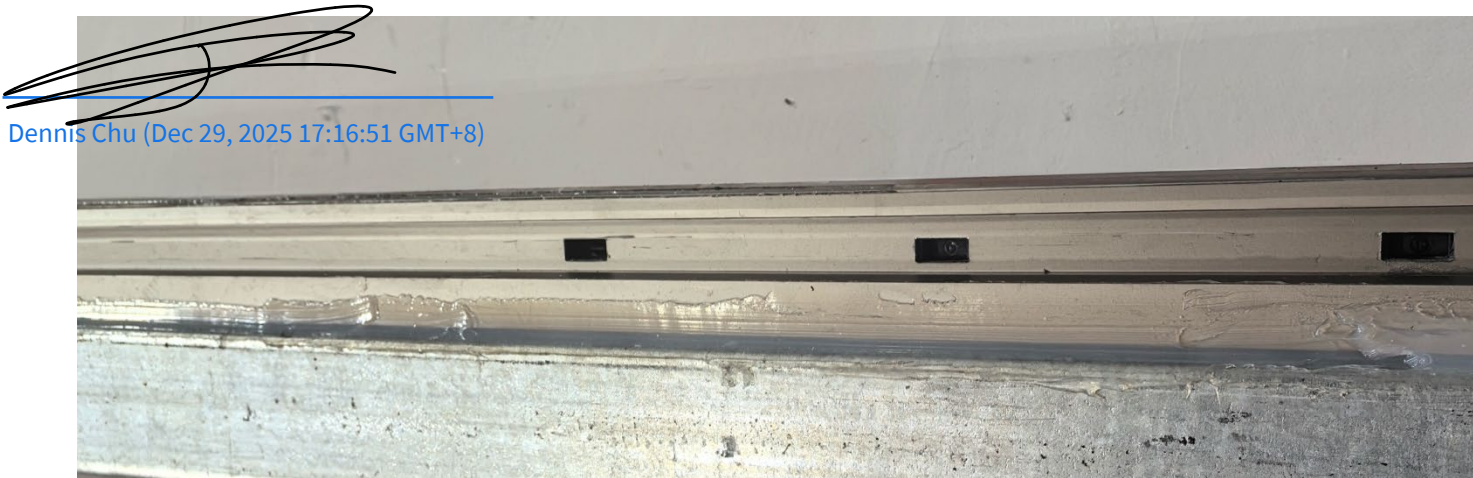
Figure 28 Zoom-in of Main Frame (Drain Holes on Threshold)

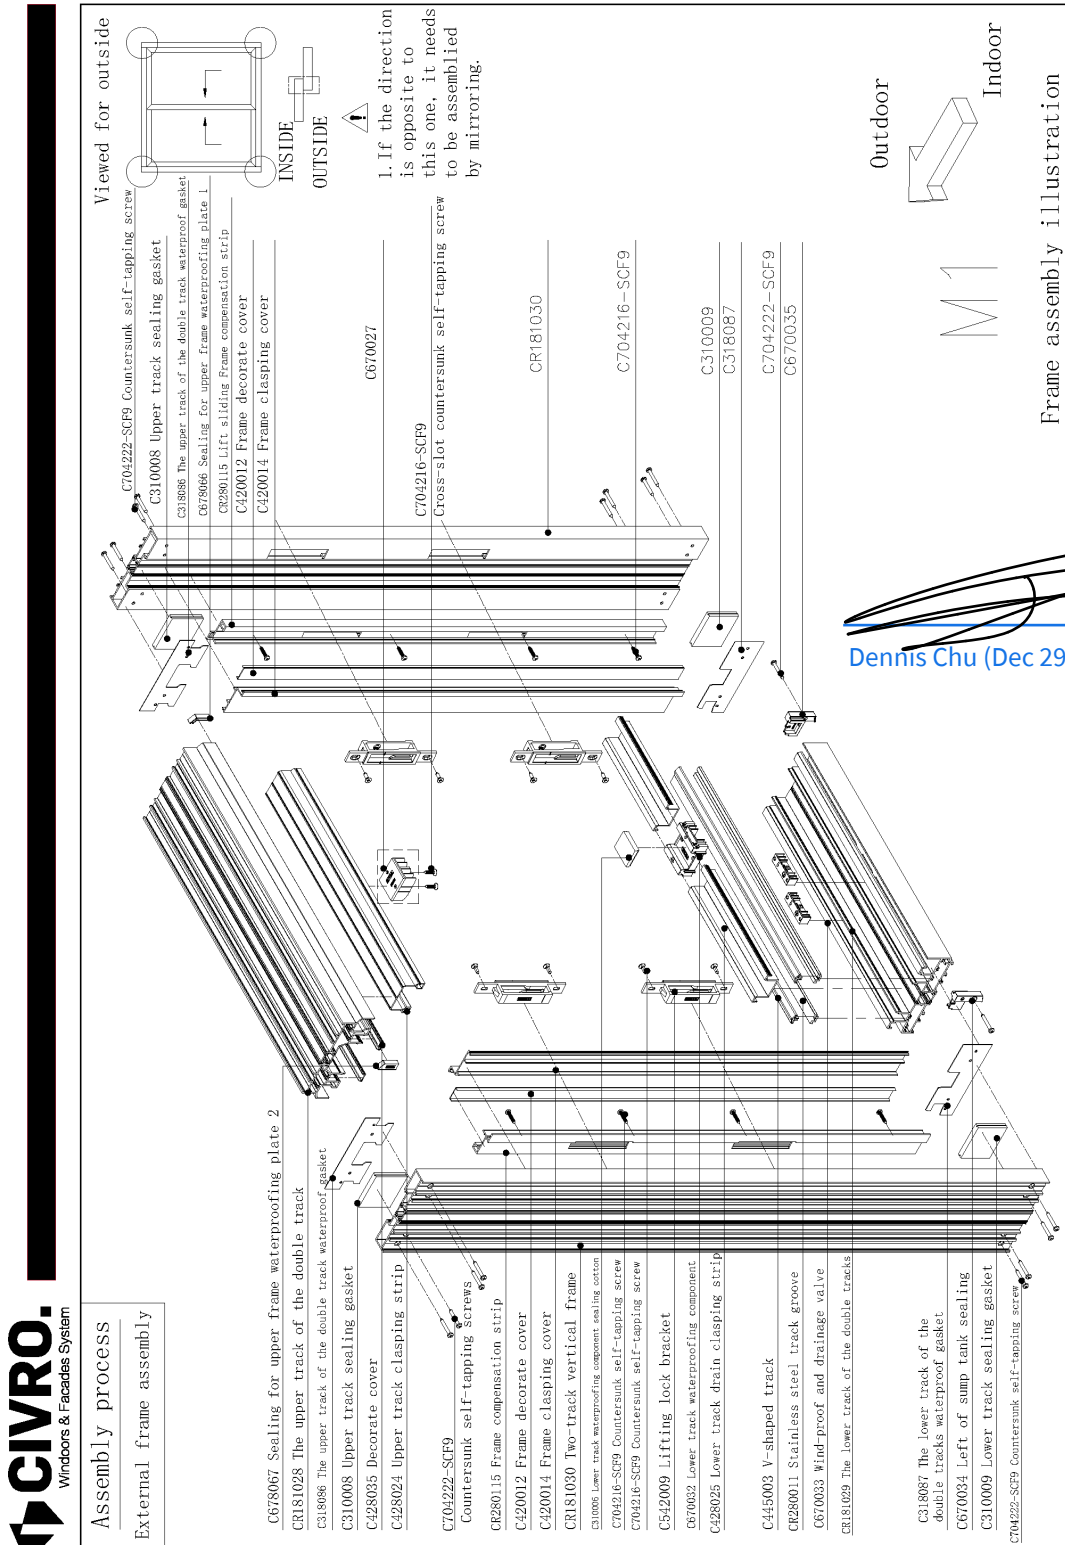
Figure 48 Drawing of External Frame Assembly Procedure
