# Test Report

## WIND AND WATER TEST TO THE REQUIREMENTS OF AS2047

PRODUCT – XWS115OU Awning Window

REPORT NO. – AZHK260830

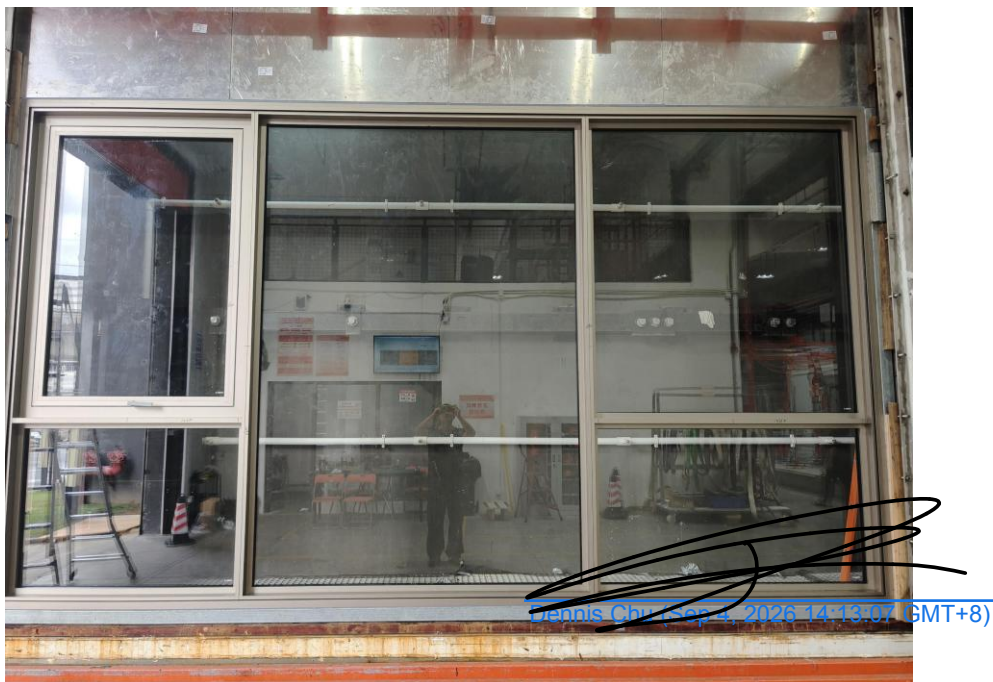
Figure 2 Photo of Test Specimen Closed (Interior)

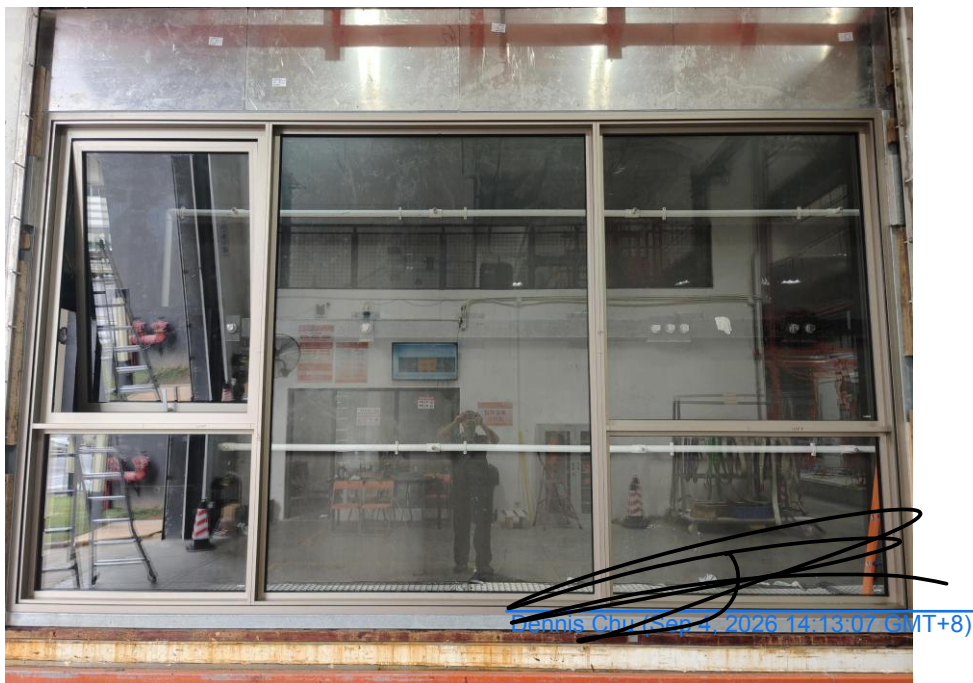
Figure 3 Photo of Test Specimen Open (Interior)

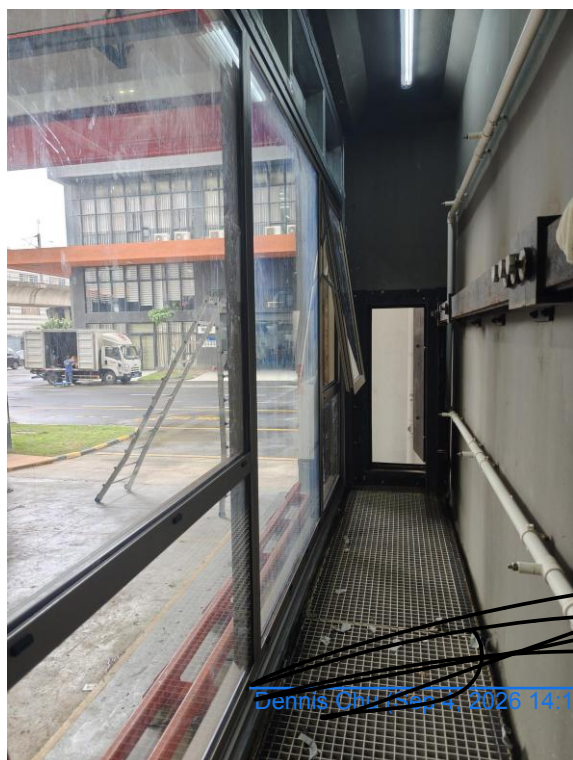
Figure 4 Photo of Test Specimen Open (Exterior)

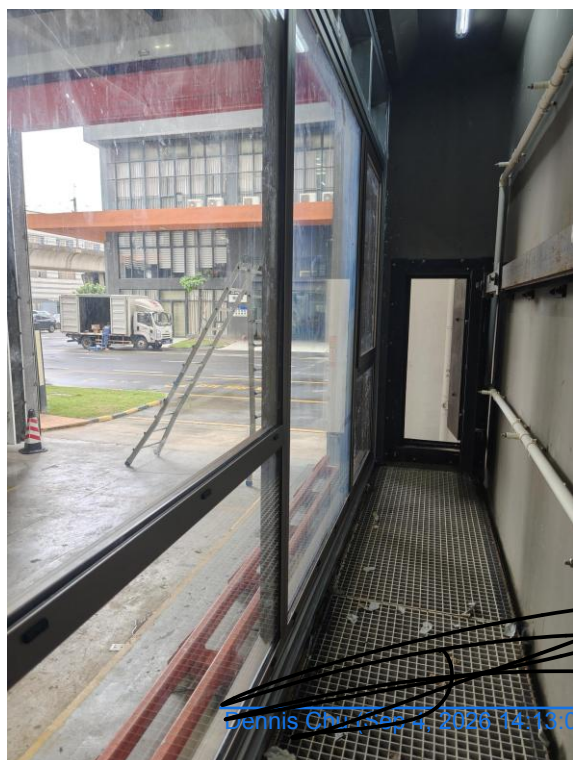
Figure 5 Photo of Test Specimen Closed (Exterior)

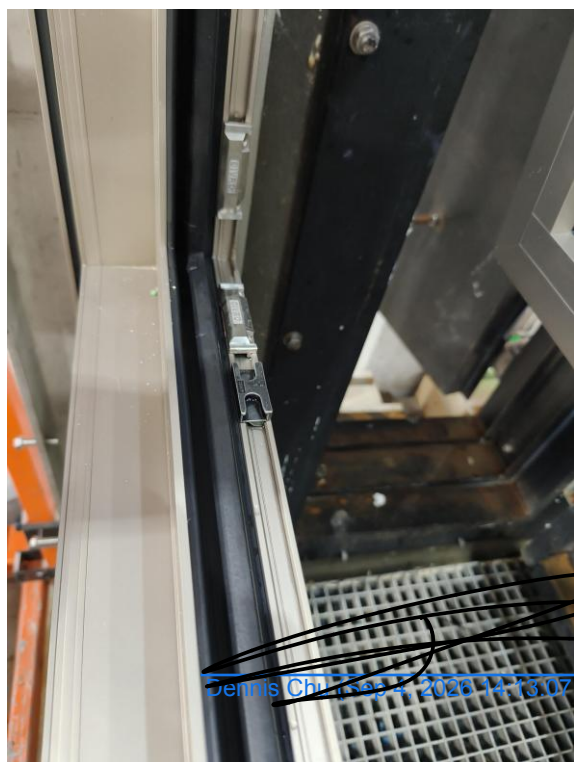
Figure 6 Photo of Hardware Details

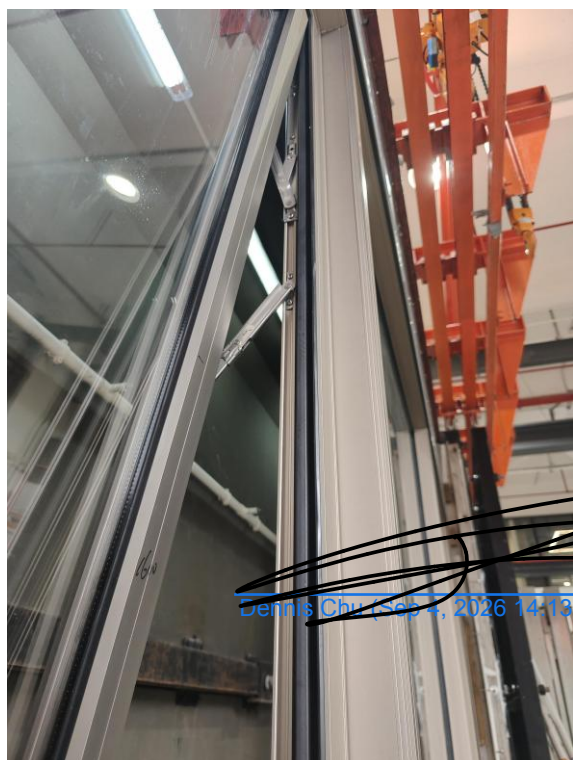
Figure 8 Photo of Hardware Details

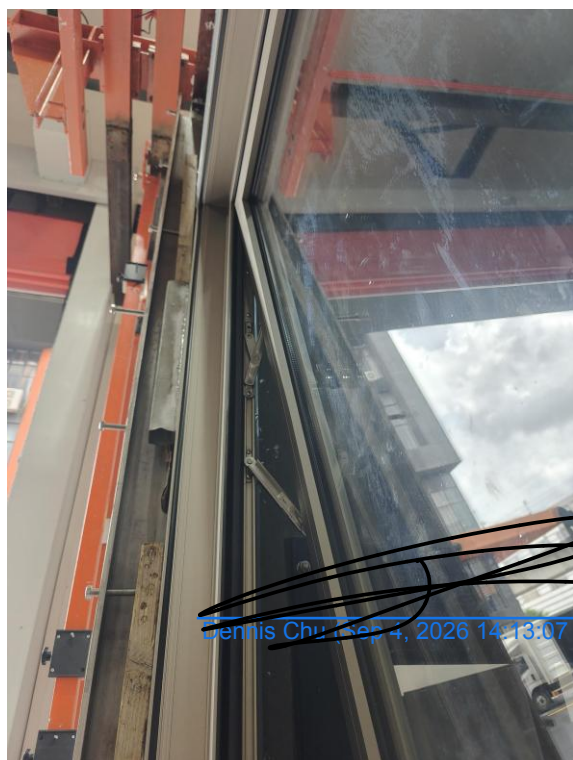
Figure 9 Photo of Hardware Details

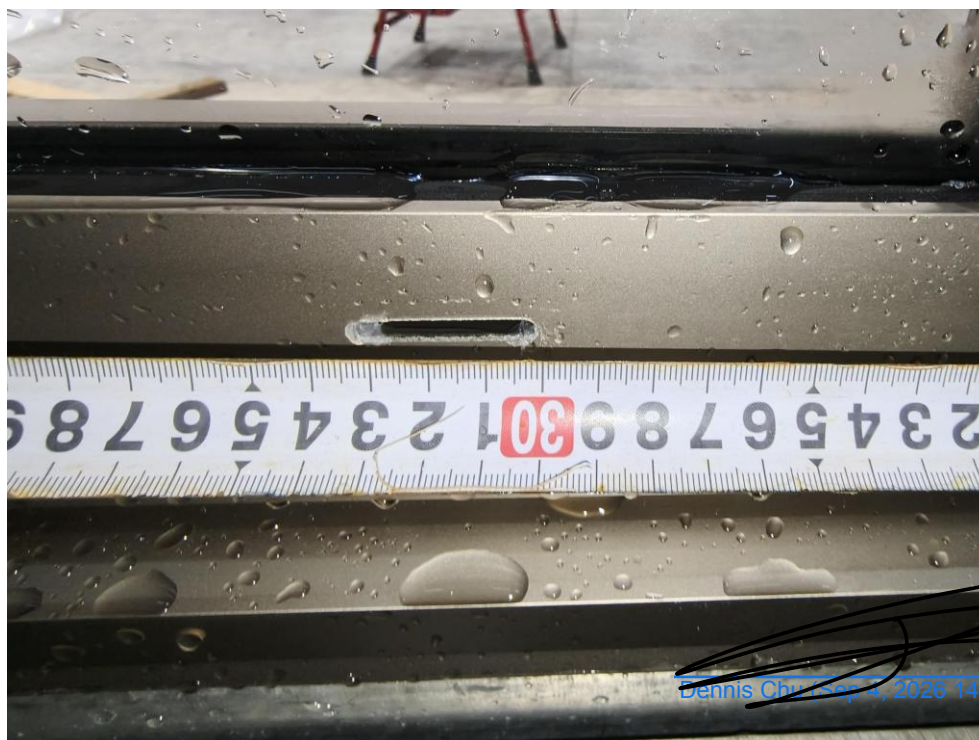
Figure 10 Photo of Drain Holes Detail

| Drain holes | <p>Size: 34mm x 4.5mm<br/>Spacing: 600mm<br/>Quantity: 4</p> <p>Size: 34mm x 10.6mm<br/>Spacing: 100mm<br/>Quantity: 2<br/>See Drawings for Details</p> |

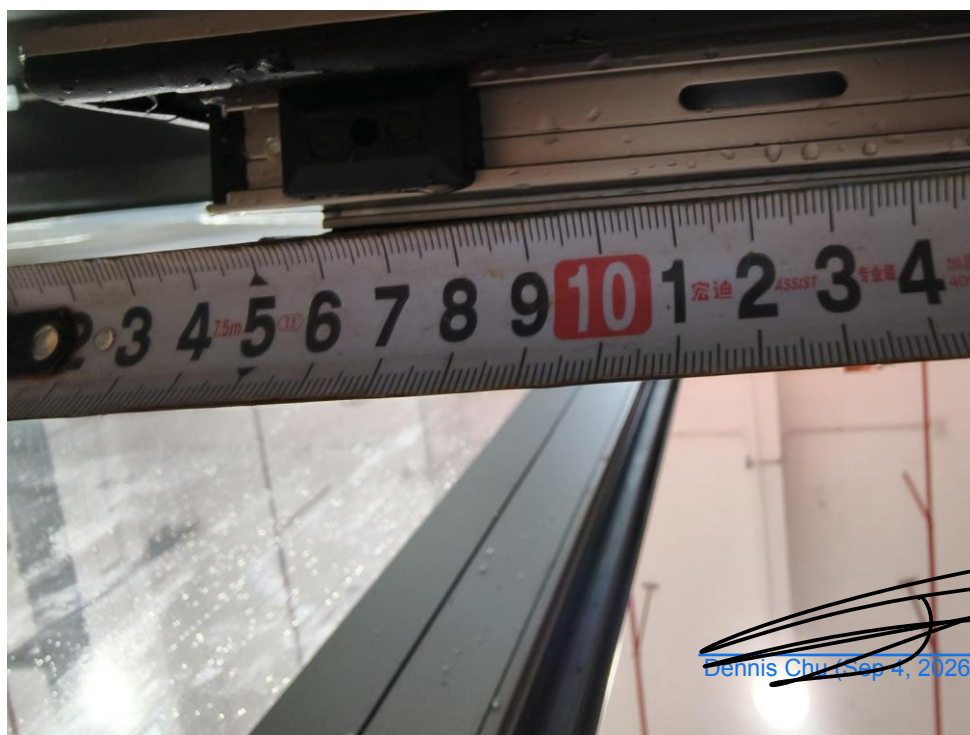
Figure 11 Photo of Drain Holes Detail

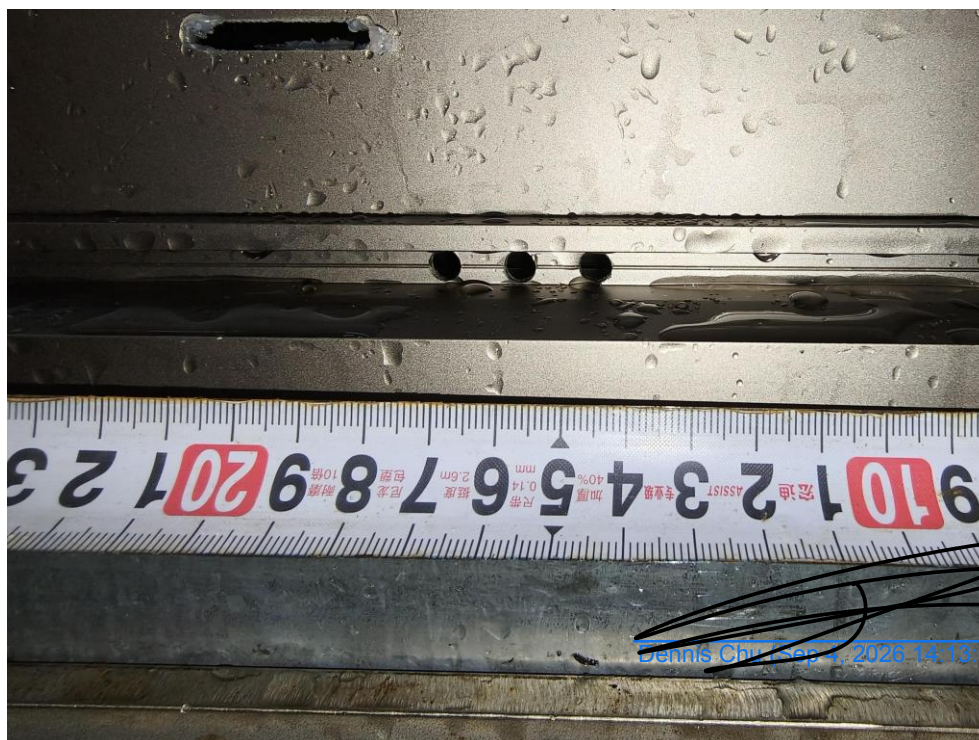
Figure 12 Photo of Weep Holes Detail

| Weep holes | <p>Size: 34mm x 5mm<br/>Spacing: 600mm<br/>Quantity: 16</p> <p>Size: ø6mm<br/>Spacing: 15mm<br/>Quantity: 6<br/>See Drawings for Details</p> |
