# Test Report

## WIND AND WATER TEST TO THE REQUIREMENTS OF SNZ TS 4211

PRODUCT – XD63LS Lift & Sliding Door

REPORT NO. – AZHK260828

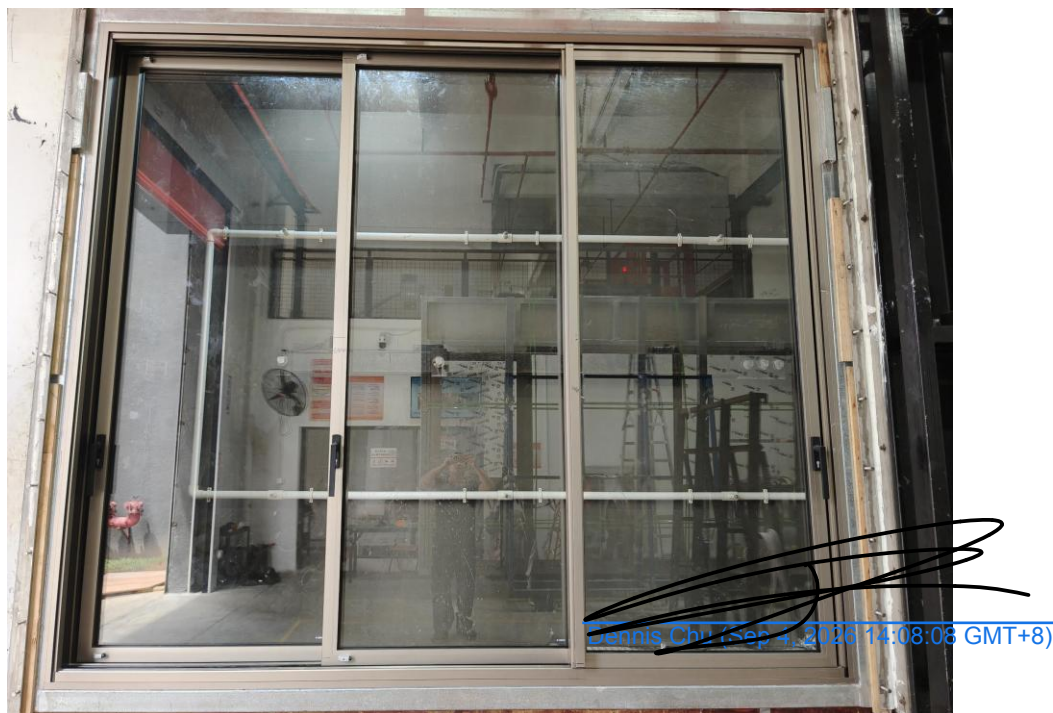
Figure 2 Photo of Test Specimen Closed (Interior) Before Test

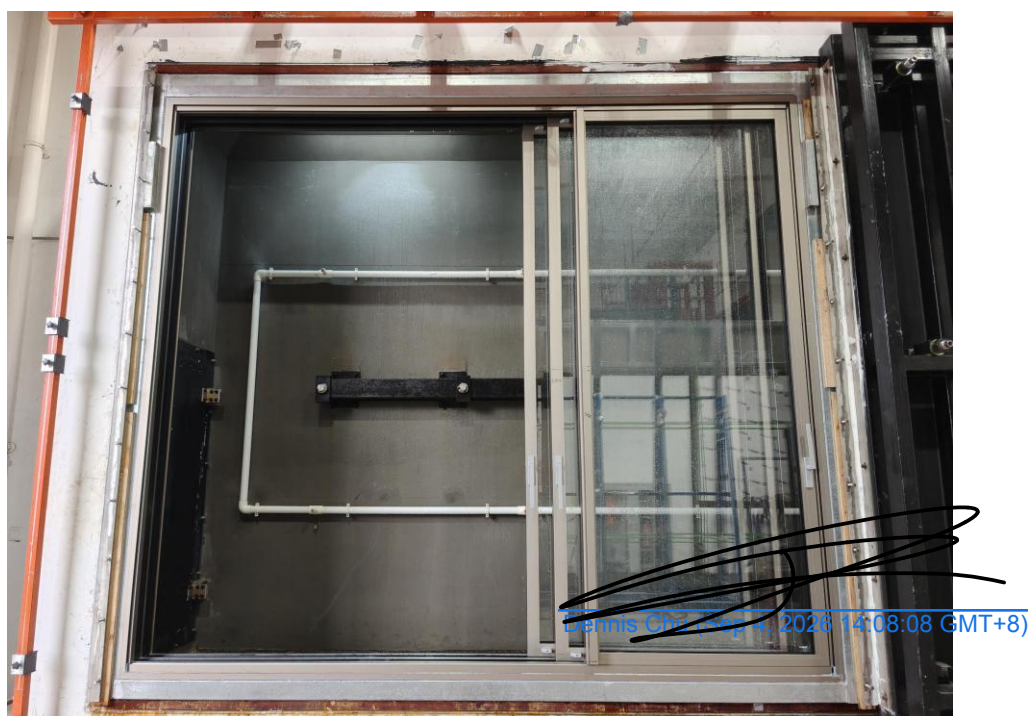
Figure 3 Photo of Test Specimen Open (Interior) Before Test

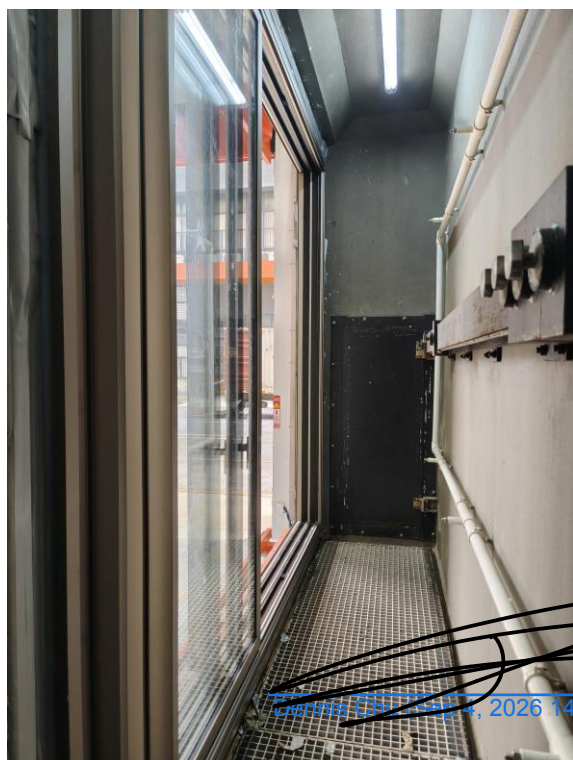
Figure 4 Photo of Test Specimen Open (Exterior) Before Test

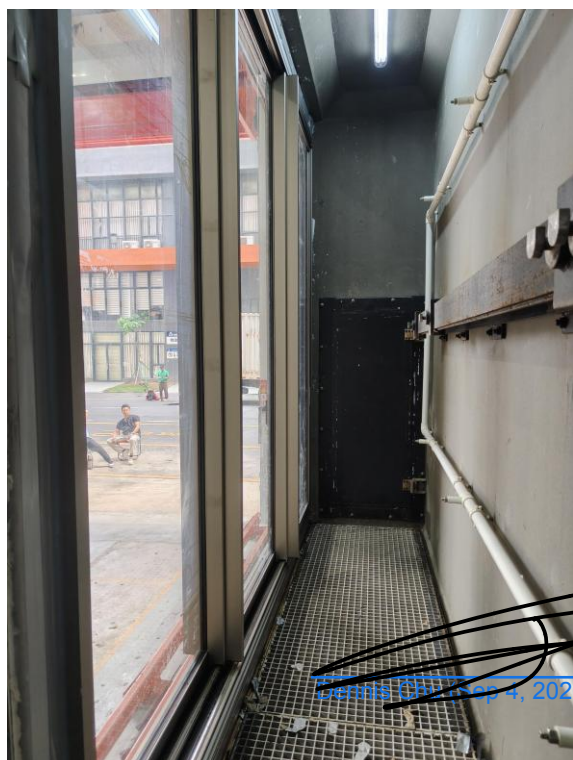
Figure 5 Photo of Test Specimen Closed (Exterior) Before Test

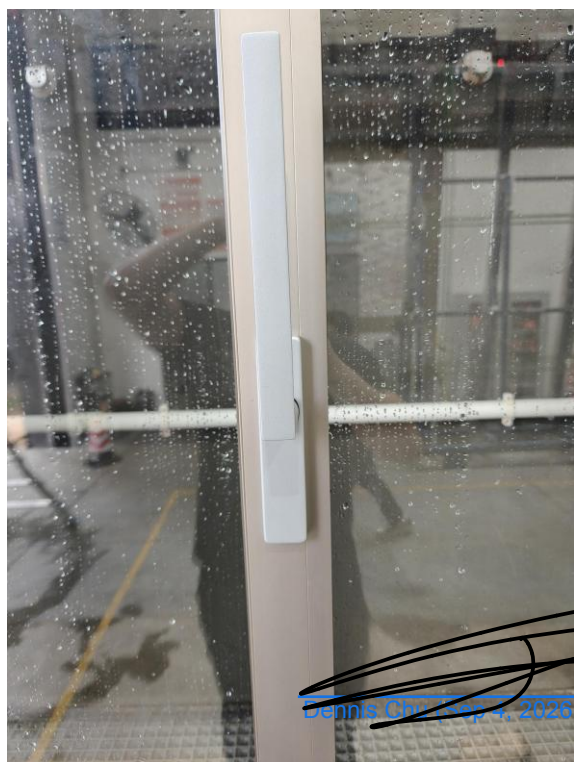
Figure 6 Photo of Hardware Details

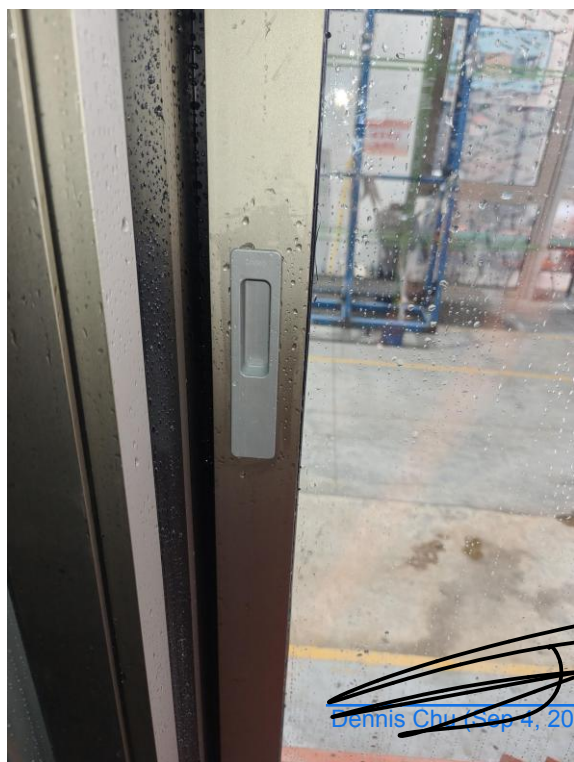
Figure 7 Photo of Hardware Details

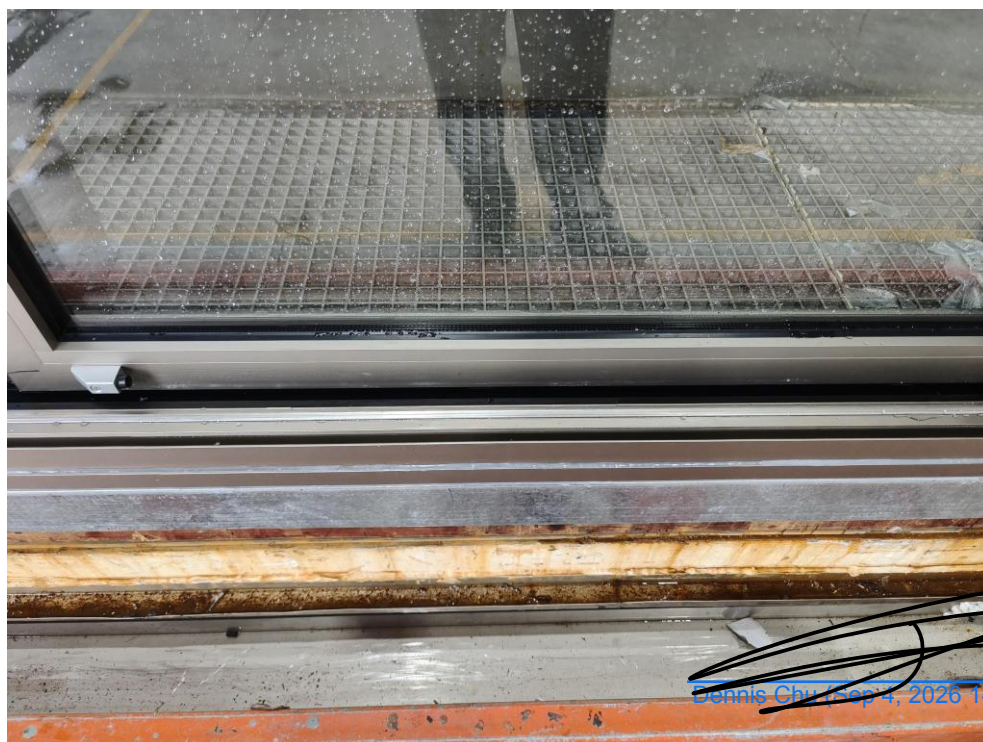
Figure 8 Photo of Hardware Details

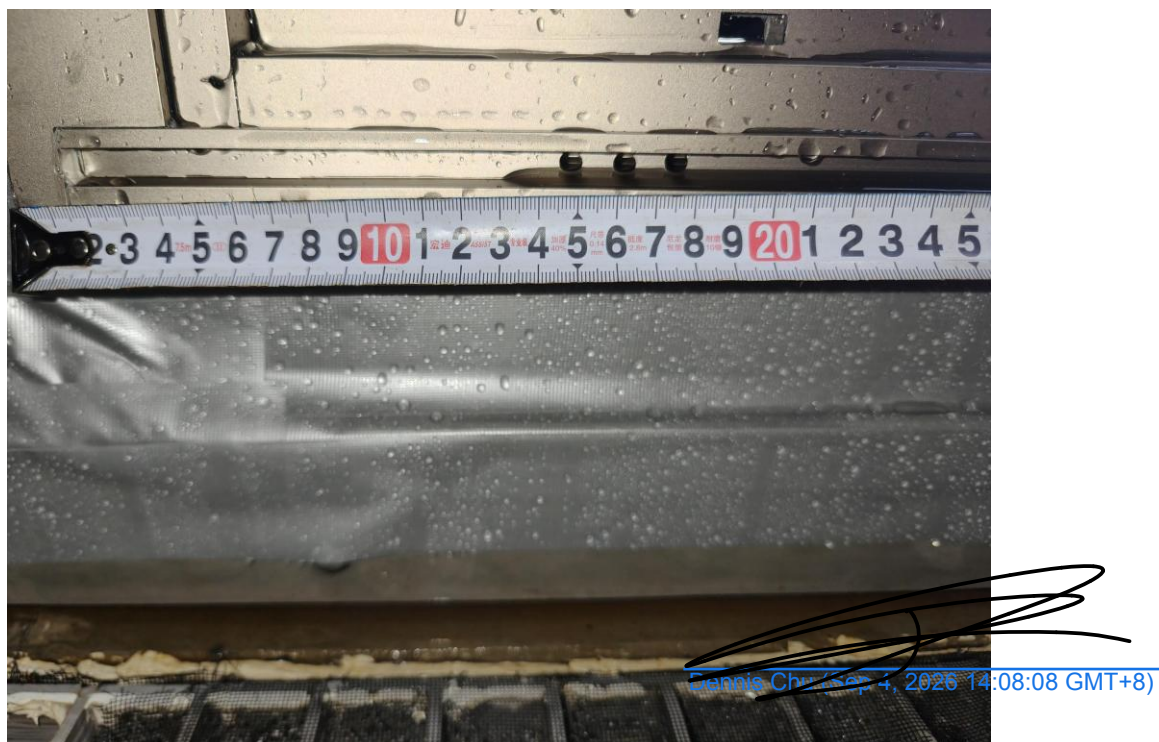
Figure 11 Photo of Drainage / Weep Holes Detail

| <b>Weep holes</b> | <p>Size: 20mm x 8mm<br/>Spacing: 500mm<br/>Quantity: 7</p> <p>Size: Ø 6mm<br/>Spacing: 15mm<br/>Quantity: 6</p> |

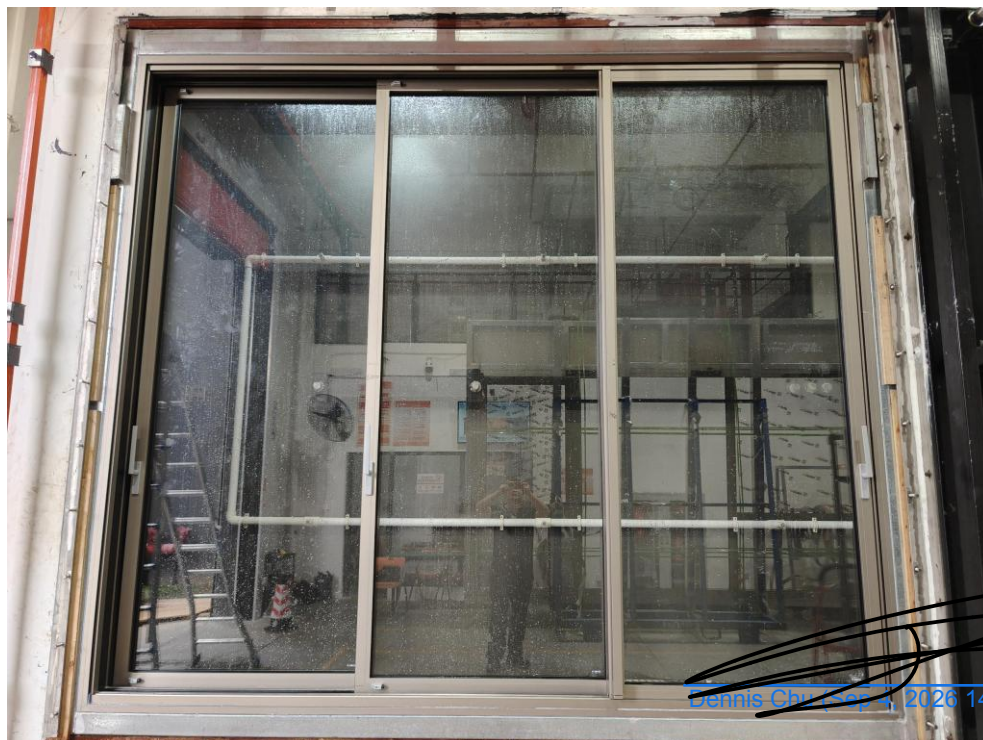
Figure 12 Photo of Test Specimen Closed (Interior) After Test

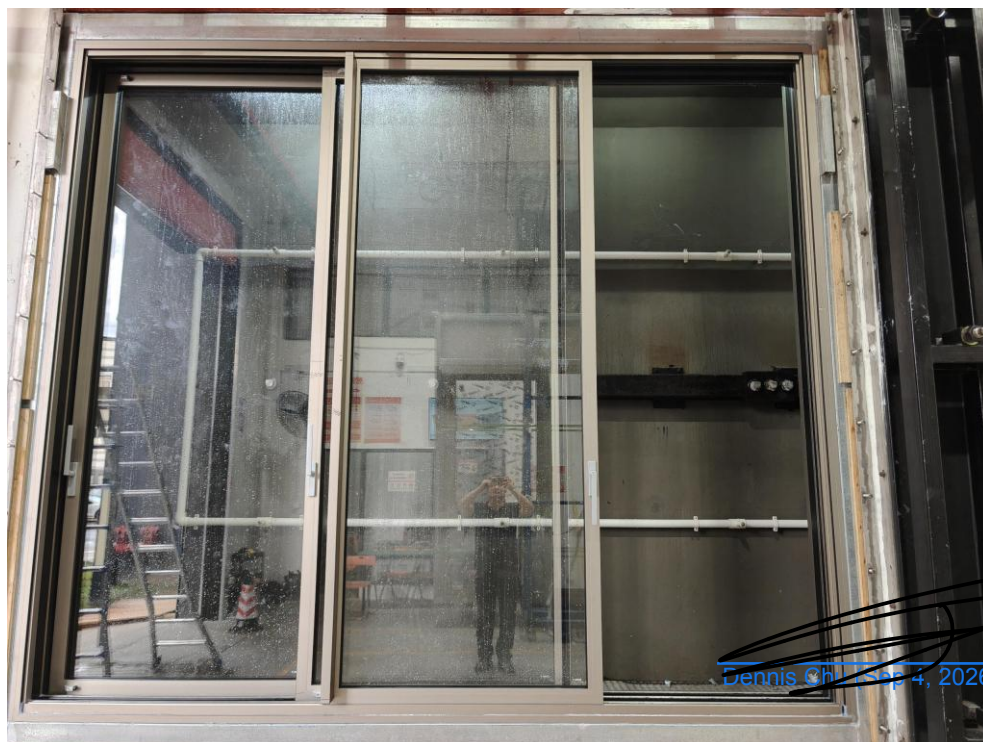
Figure 13 Photo of Test Specimen Open (Interior) After Test

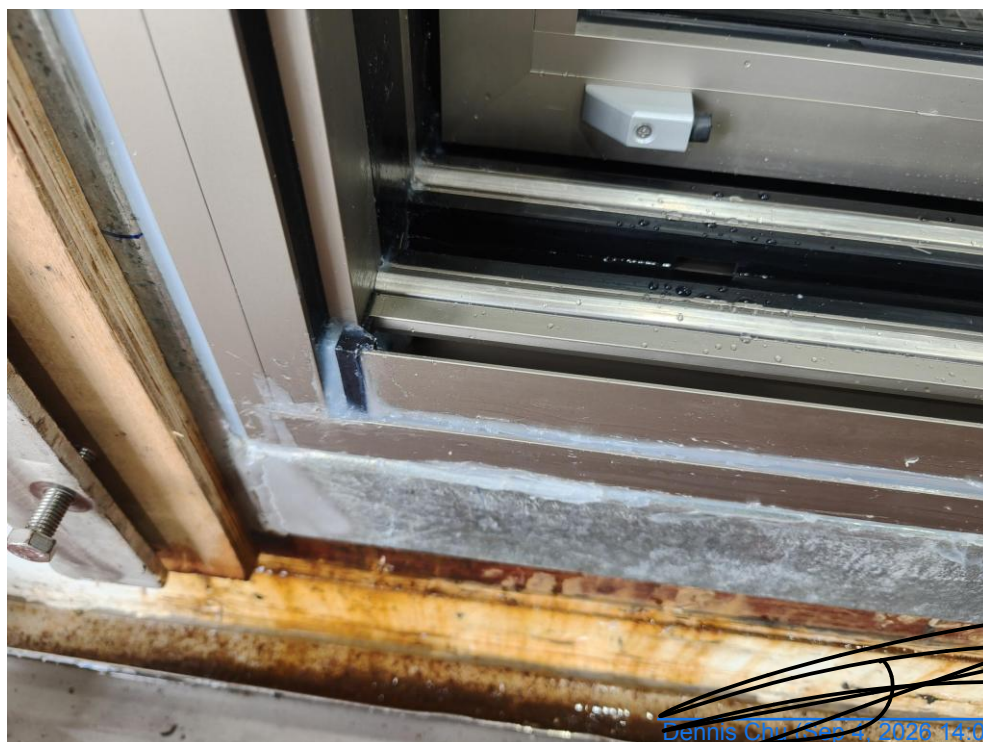
Figure 14 Photo of Joint

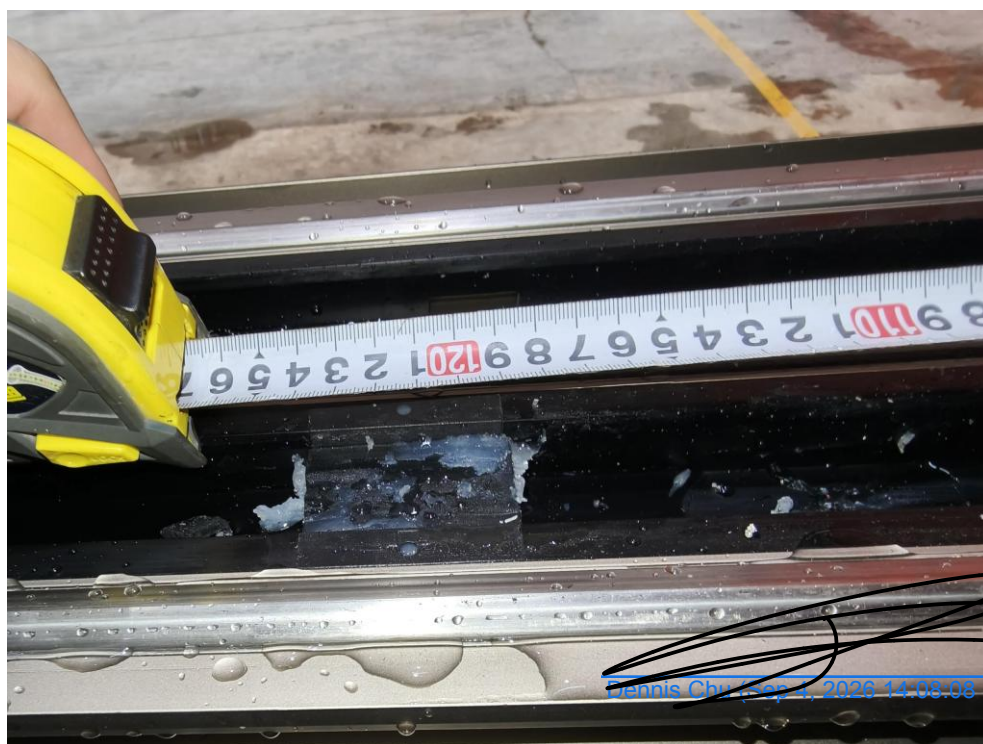
Figure 15 Photo of Seal
