# Test Report

## WIND AND WATER TEST TO THE REQUIREMENTS OF SNZ TS 4211

PRODUCT – XWS115OU Awning Window

REPORT NO. – AZHK260831

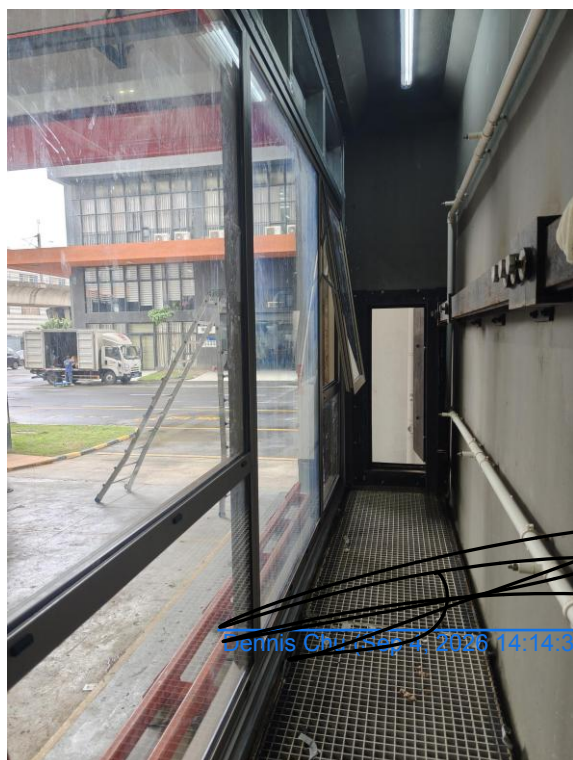
Figure 4 Photo of Test Specimen Open (Exterior)

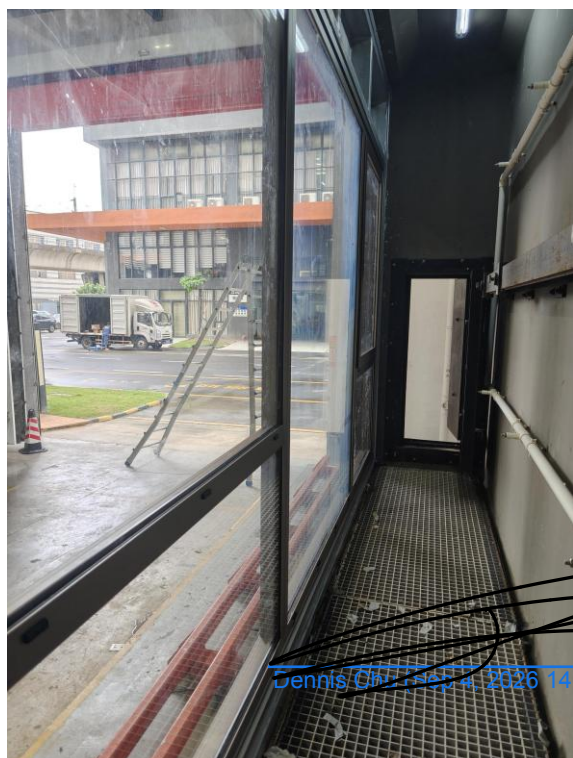
Figure 5 Photo of Test Specimen Closed (Exterior)

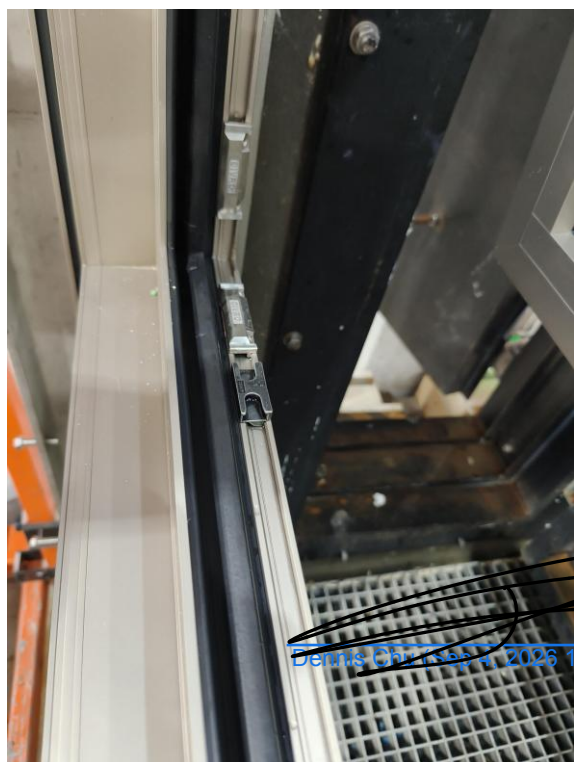
Figure 6 Photo of Hardware Details

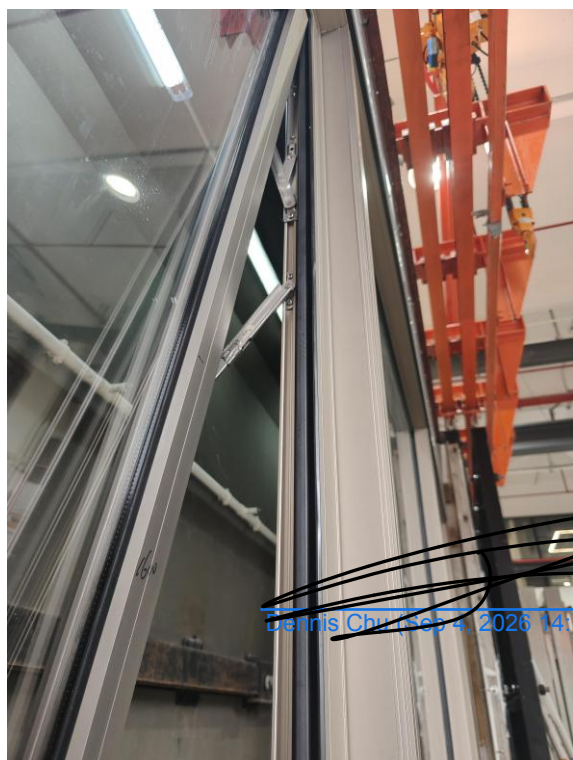
Figure 8 Photo of Hardware Details

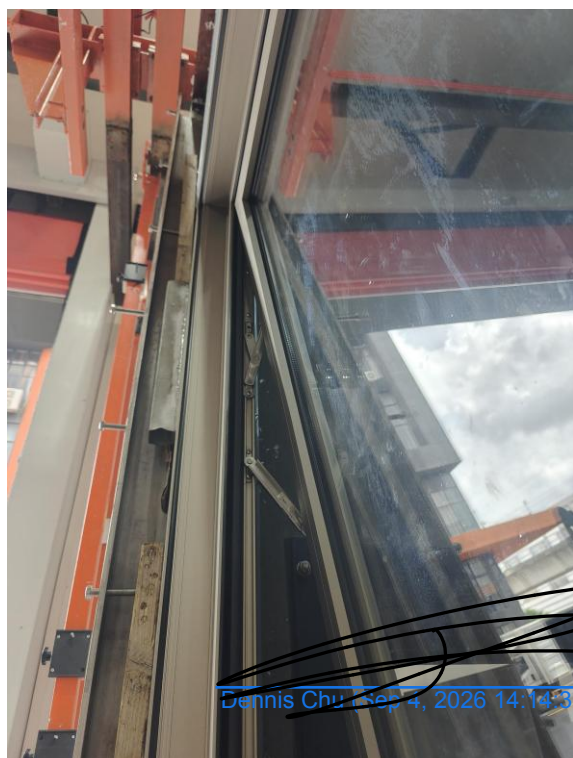
Figure 9 Photo of Hardware Details

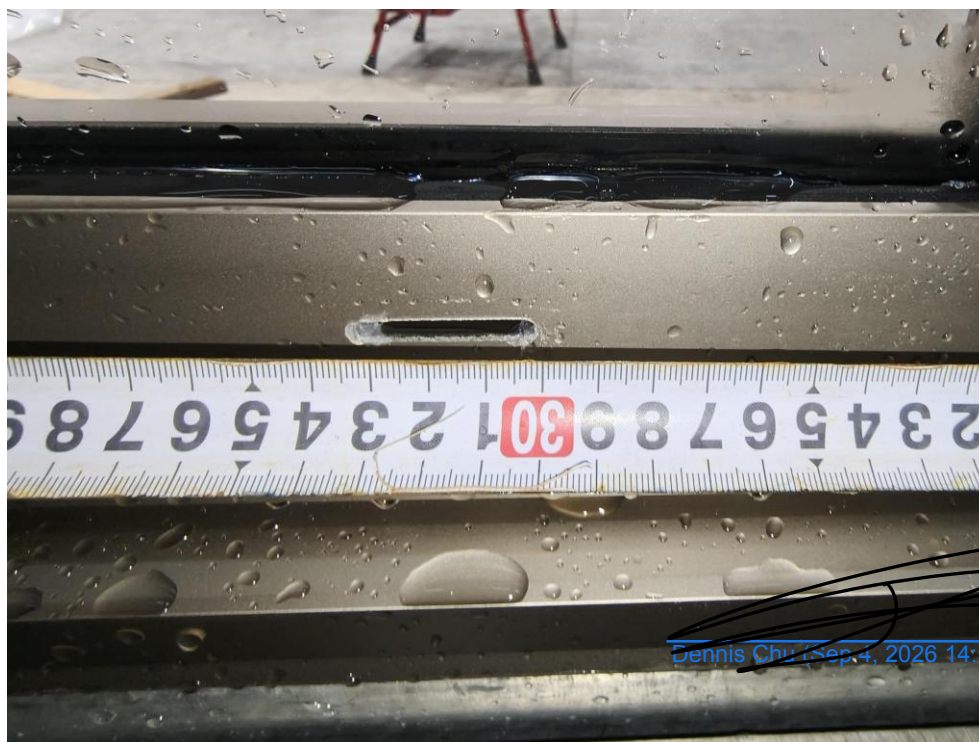
Figure 10 Photo of Drain Holes Detail

| <b>Drain holes</b> | <p>Size: 34mm x 4.5mm<br/>Spacing: 600mm<br/>Quantity: 4</p> <p>Size: 34mm x 10.6mm<br/>Spacing: 100mm<br/>Quantity: 2<br/>See Drawings for Details</p> |

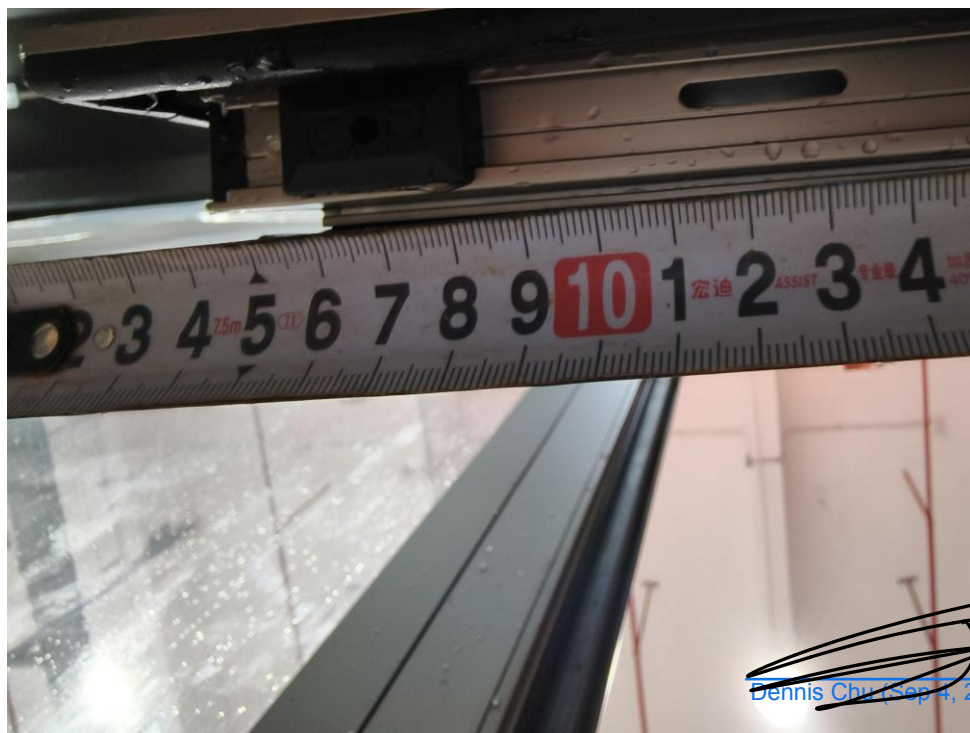
Figure 11 Photo of Drain Holes Detail

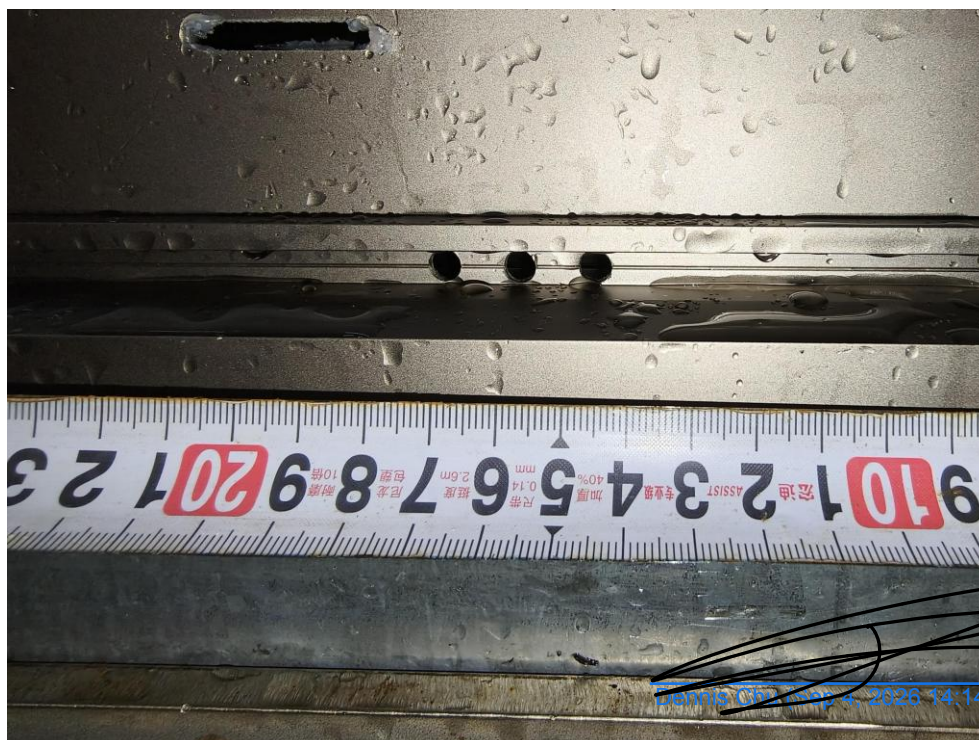
Figure 12 Photo of Weep Holes Detail

| <b>Weep holes</b> | <p>Size: 34mm x 5mm<br/>Spacing: 600mm<br/>Quantity: 16</p> <p>Size: ø6mm<br/>Spacing: 15mm<br/>Quantity: 6<br/>See Drawings for Details</p> |
